CC8™ Bulk Rolls

Greatham Beck,
Hartlepool

CC used to provide a
protective lining to a
new culvert in a tidal
stream

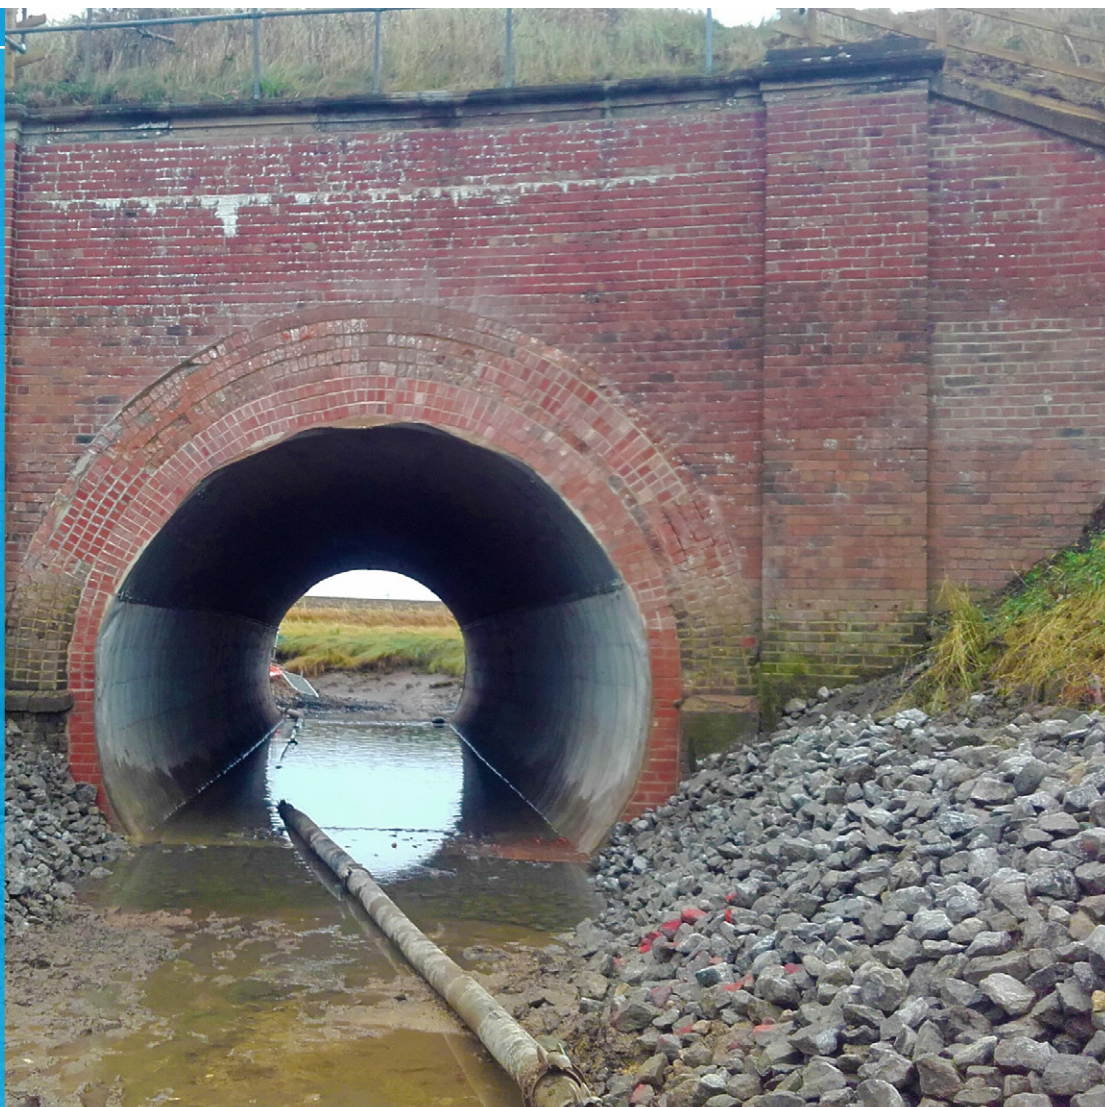
Completed CC-lined culvert structure in Hartlepool

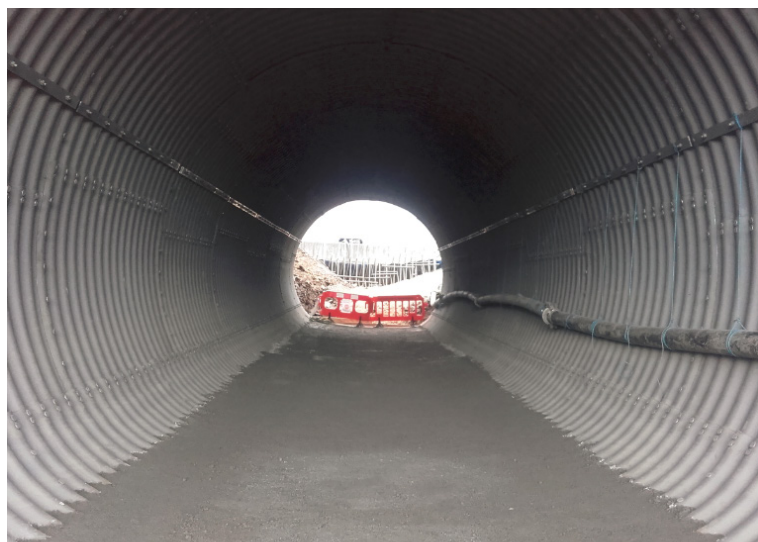
Inverts lined with concrete to support CC

In September 2018, works began. Following installation of the culvert, in accordance with CC's Four Key Principles of Installation, and as outlined in the design, the corrugations of the Multiplate® floor were filled with a ST4 concrete mix to give a smooth, void-free surface. The CC8™ material was then delivered to site and cut down to the required 9 linear metre lengths. These lengths were then wrapped around scaffold pipes, secured and transported into the culvert for deployment.

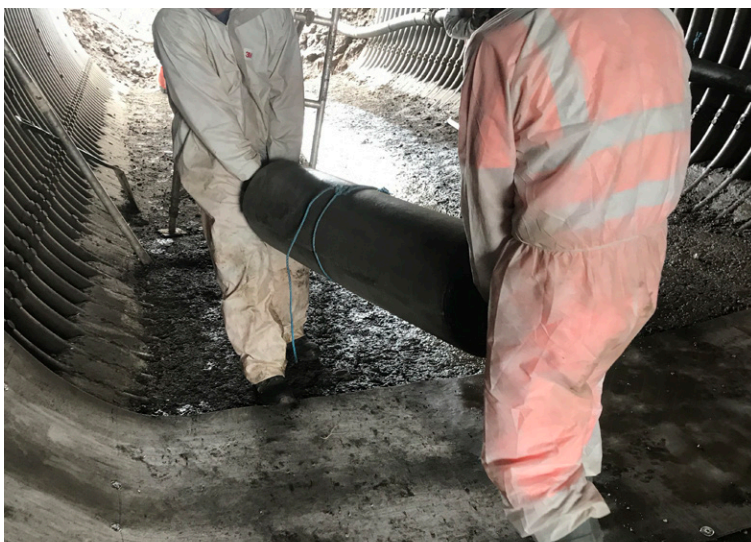
Pre-cut layers transported on side using scaffold pole

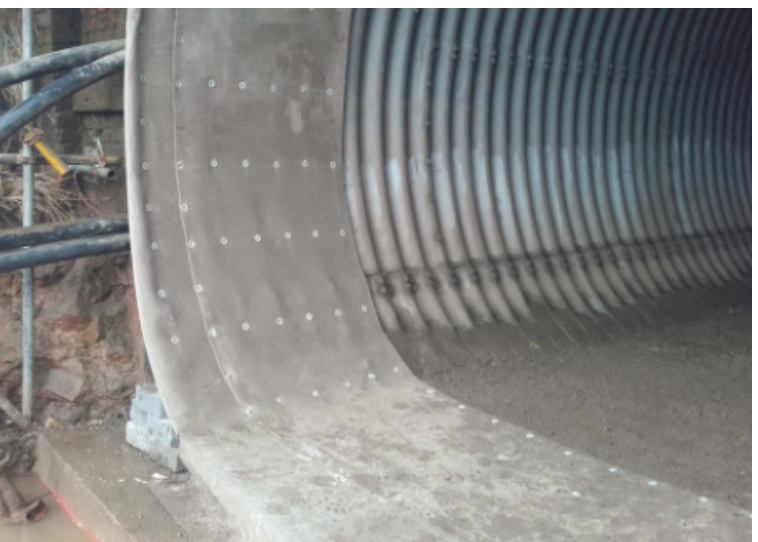
Typical end tie in detail

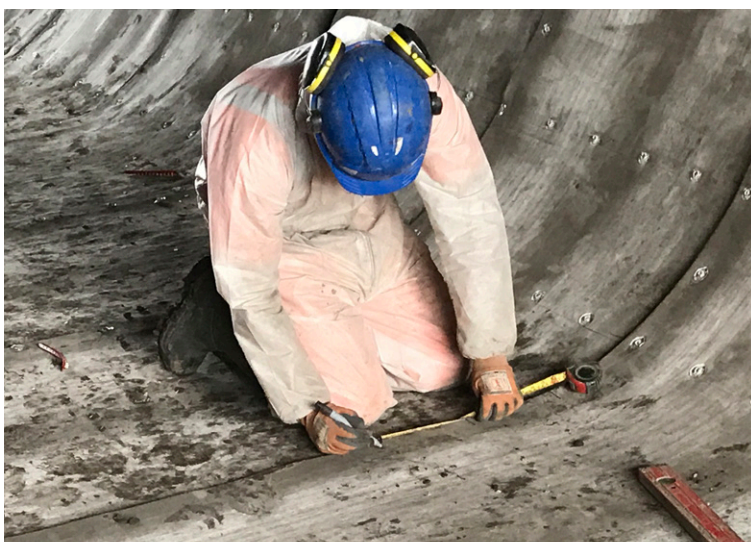
Marking CC for Hilti nails on joints

The installation crew then used sections of scaffold to help install the material above the horizontal termination at the securing plates pre-fitted to the culvert. The material was then secured to the culvert using Hilti shot fired nails and plastic washers. Different lengths of nail were used for the invert and culvert sides.

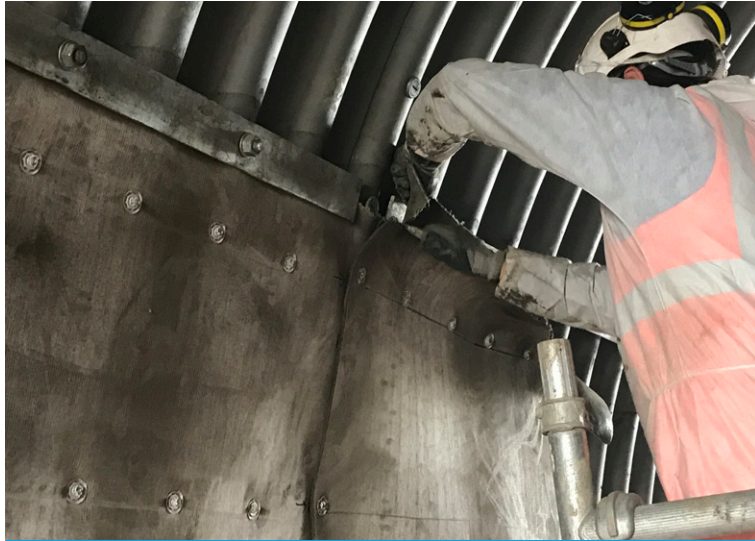
CC edges secured under pre-installed clamp bar supplied by Asset

The material was then terminated using the termination bar designed by Asset. Once installed and hydrated, the material was used as a shutter and ST4 150mm slump concrete was poured down the back of the material to fill in any voids. A pencil vibrator was then used to remove any air gaps in the concrete mix.

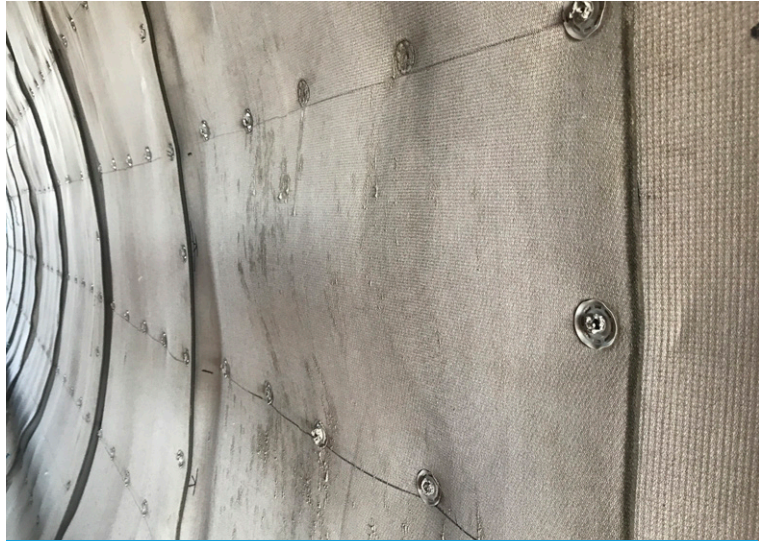
Completed wall section of CC lined culvert

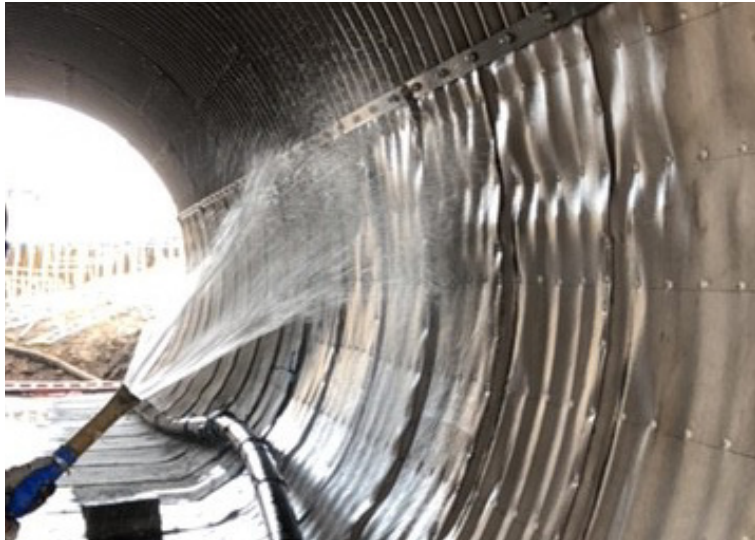
Hydration

Temporary dams were put in place during the installation to hold out most of the tidal water from Greatham Beck, however, the CC lining the culvert floor was hydrated with tidal water when the spring high tide topped the dams.

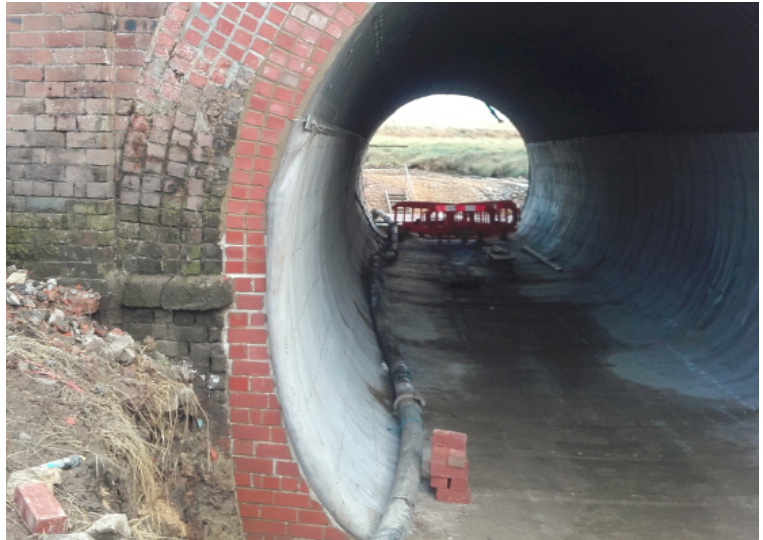
End tie in detail: CC folded around culvert end and sealed with concrete mix

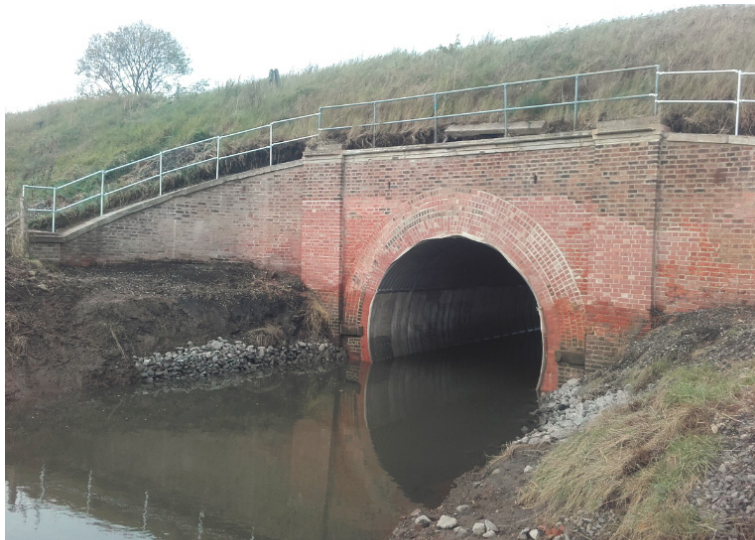
Completed culvert in use

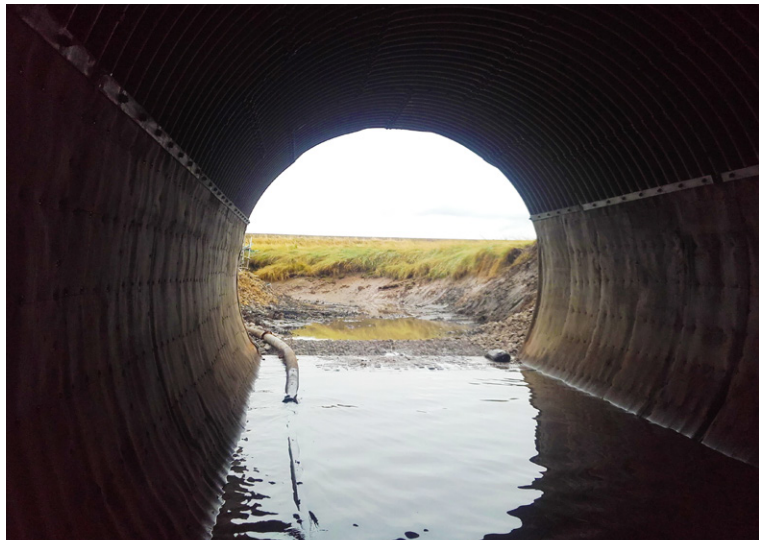
Completed CC installation

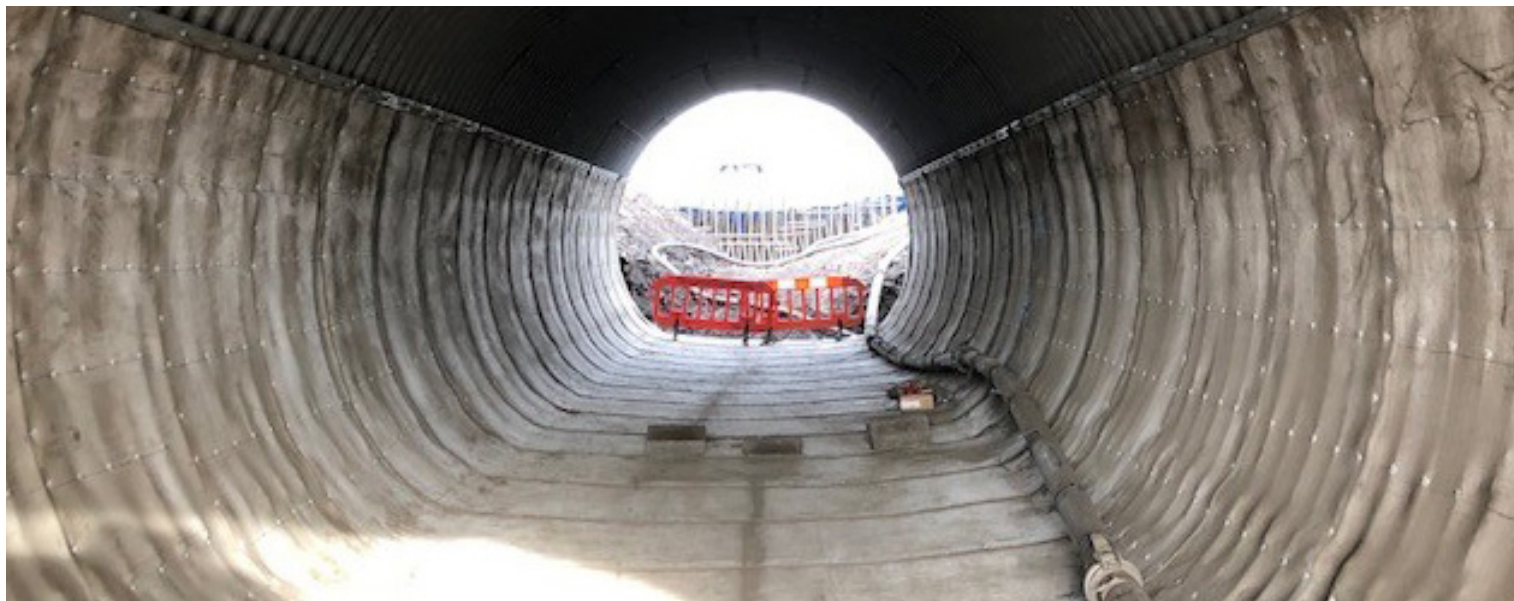
Completed installation

The installation of the 250m² of CC8™ material was carried out across several days due to the lack of access to the site during high tides. The installation was a success, with the collaborative approach to the project, and the specified CC8™ material resulting in all of the client's requirements being met.

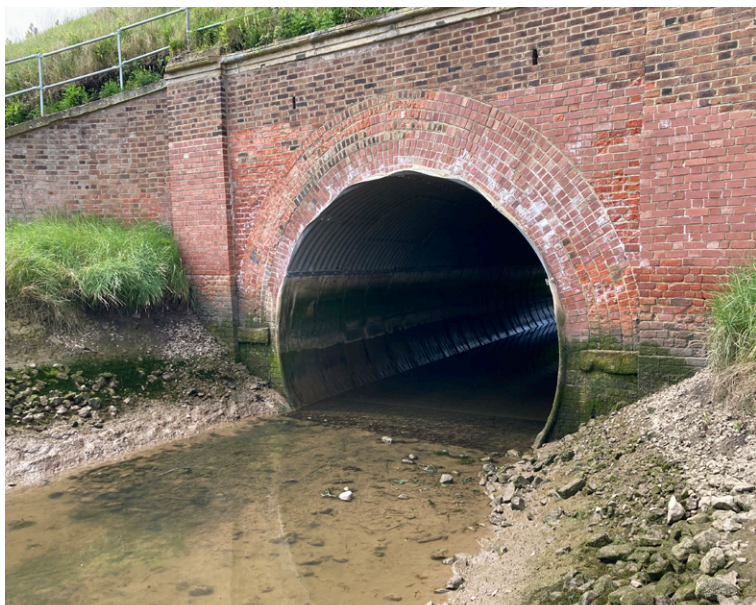
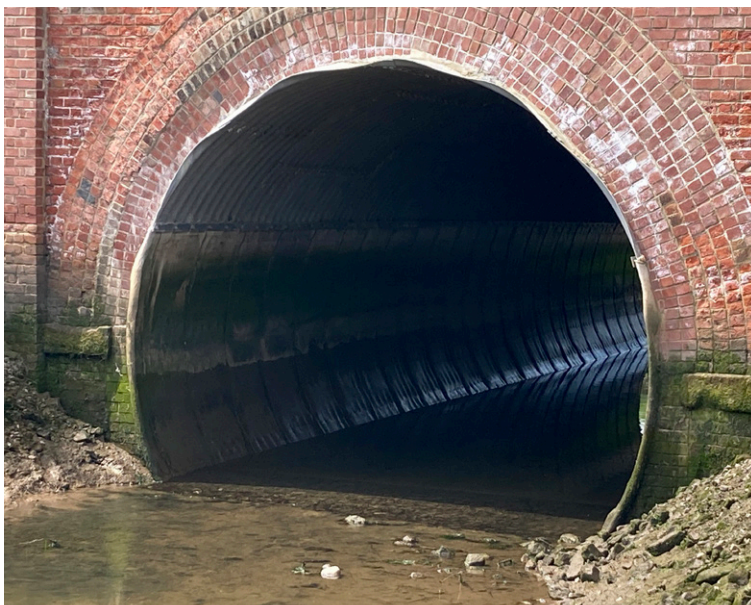
Return visit to Greatham Beck culvert site - CC is performing as intended and showing some signs of 'greening'

The site was re-visited in June 2021, over two-and-a-half years after the installation was completed. The CC GCCM was found to be performing as expected despite signs of very high tides. The GCCM is also beginning to 'green' due to algae growth on its fibrous top-surface. The culvert and CC material will continue to be monitored periodically.
