CONCRETE CANVAS

SLOPE PROTECTION

In April 2018, Concrete Canvas[®] GCCM^{*} (CC) was used to protect two sections of slope, four drainage headwalls and a drainage channel near a residential area in Panama.

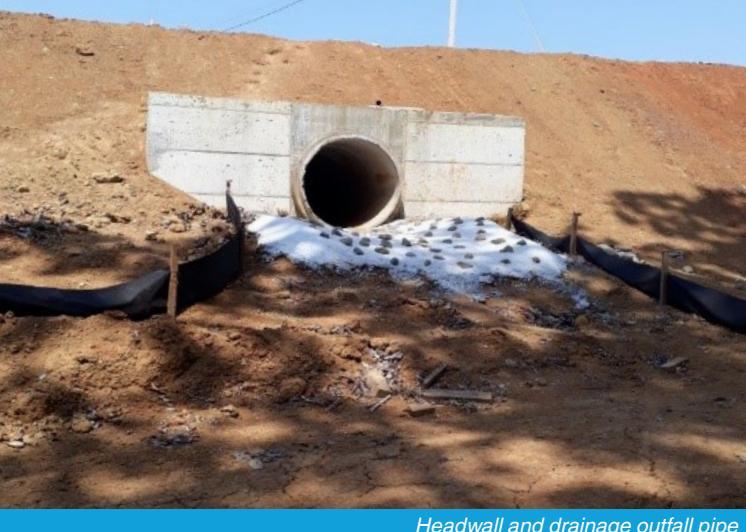
CC installed within drainage channel leading to rive

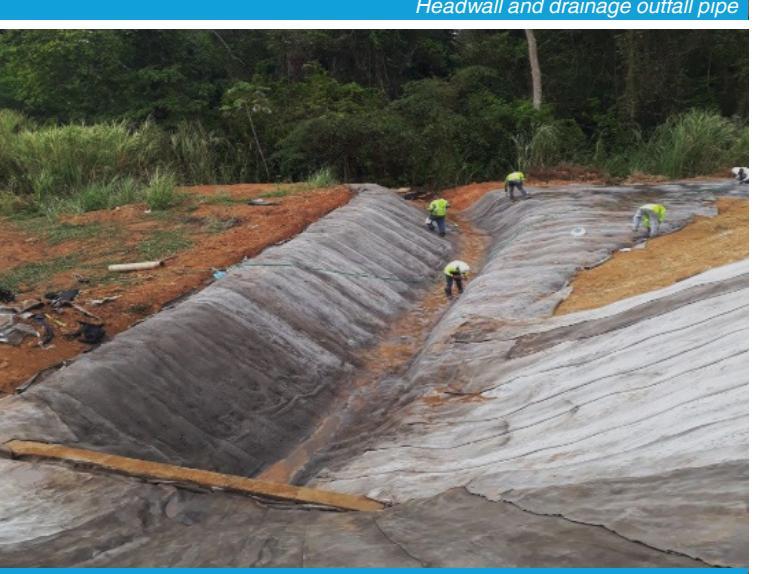
CC was laid down slope faces and overlaps iointed using screw

The pre-cut lengths of CC5[™] were transported to the site and laid in place by hand, with 100mm overlaps at each joint. The edges of the material were secured within the anchor trenches using ground pegs or metal bars and screws where required, depending on the state of the compacted surface. The CC below overlaps was then hydrated and the joints sealed using an adhesive sealant and jointed with screws at 150mm intervals. The CC was then hydrated fully. Once installation was completed, the anchor trench at the crest of the slope was backfilled and the substrate compacted, while the trench at the toe was fixed with U-shaped metal staples and backfilled using mortar. Where the slope connected with a lower drainage channel, the material was laid continuously from the crest, down the slope and along the channel, before terminating in an anchor trench on the far shoulder of the channel. For this section, the anchor trenches were backfilled and the installation completed in the same way.
