British Gypsum Marblaegis Mine Vent Wall

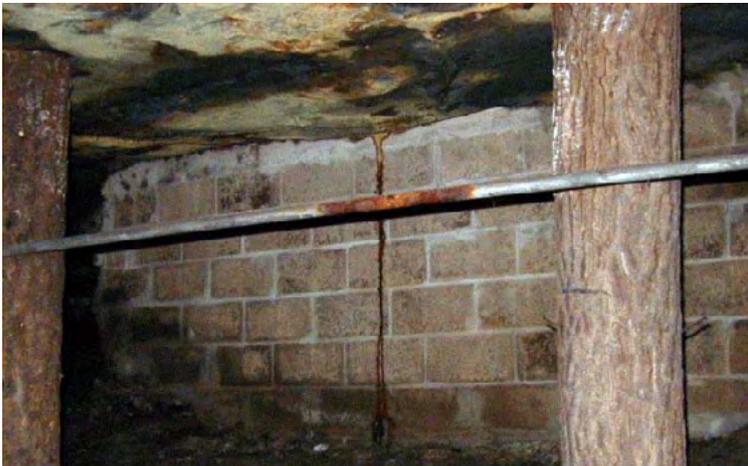
Concrete block vent walls had proved expensive and difficult to install

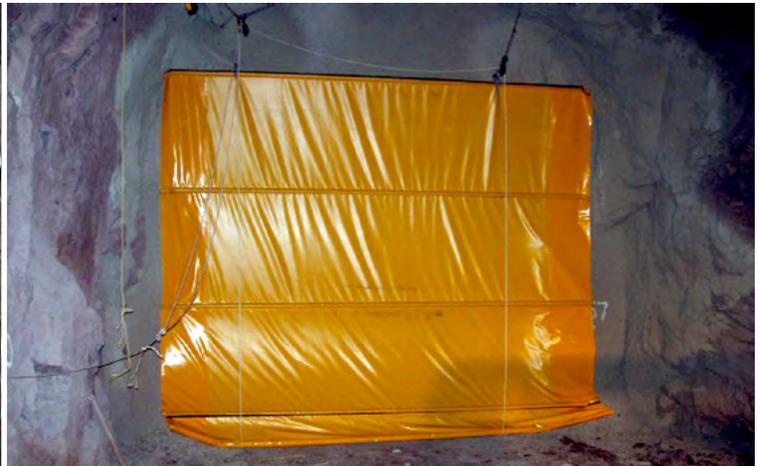
Brattice cloth had also been used but only as a temporary measure

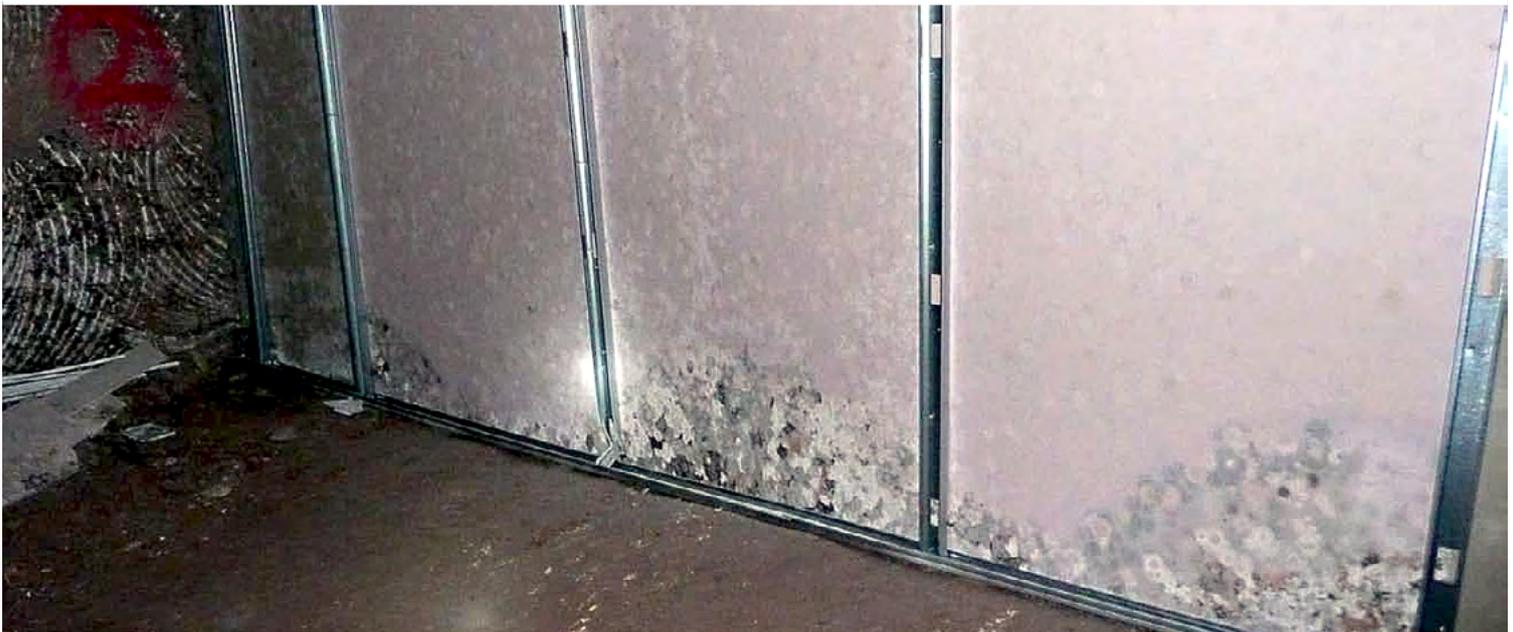
Vent walls had also been constructed out of the gypsum board the mine produced, but these were prone to rotting

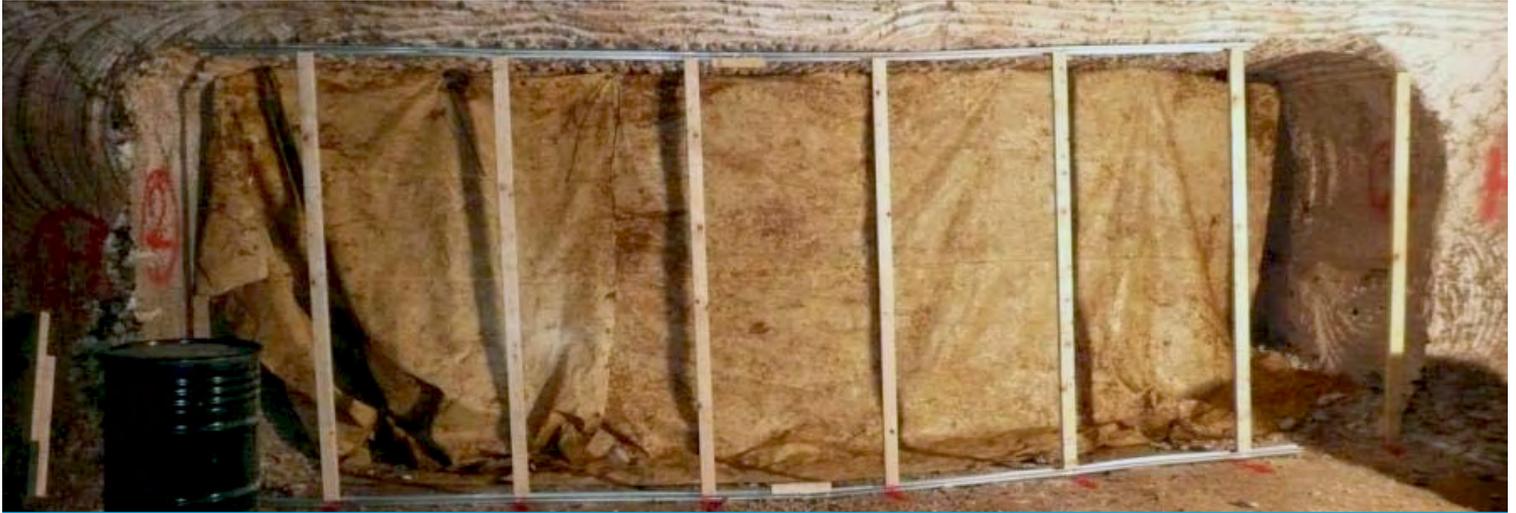
Frame created using British Gypsum branded aluminium stud wall system

Using batched rolls of CC5 meant that the 3-man installation team were able to carry the material to site without any plant or specialist equipment. After being cut to length on site using hand tools the CC5 was hung, shaped and fixed to a British Gypsum branded aluminium stud wall system and securely fastened using wooden battens, 200mm steel strips and screws. The whole structure was then hydrated using a portable water supply.

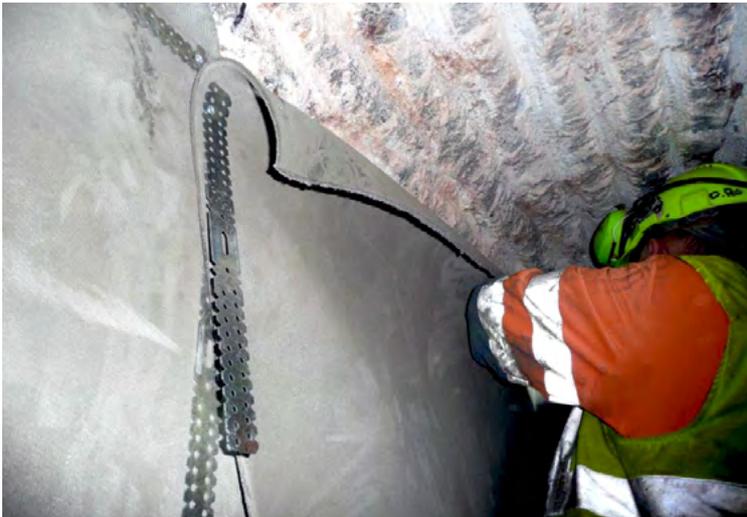
Concrete Canvas cut to size, held in place and screwed to frame

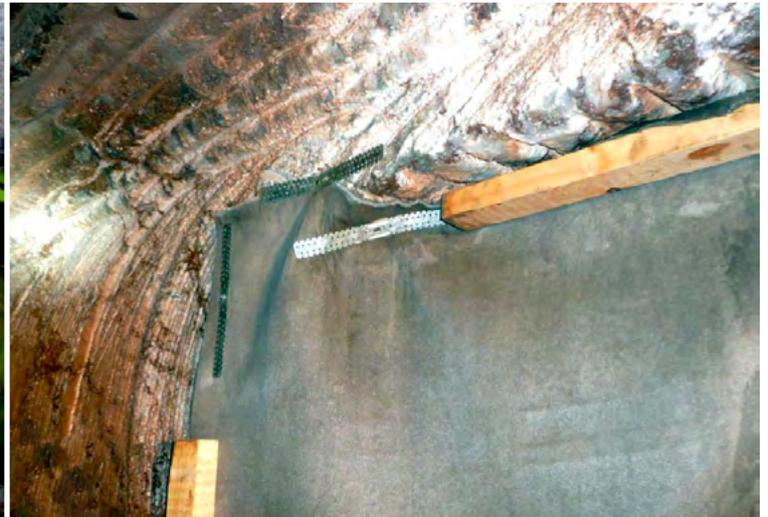
Battens, 200mm steel and screws used to provide strong fixing to rock

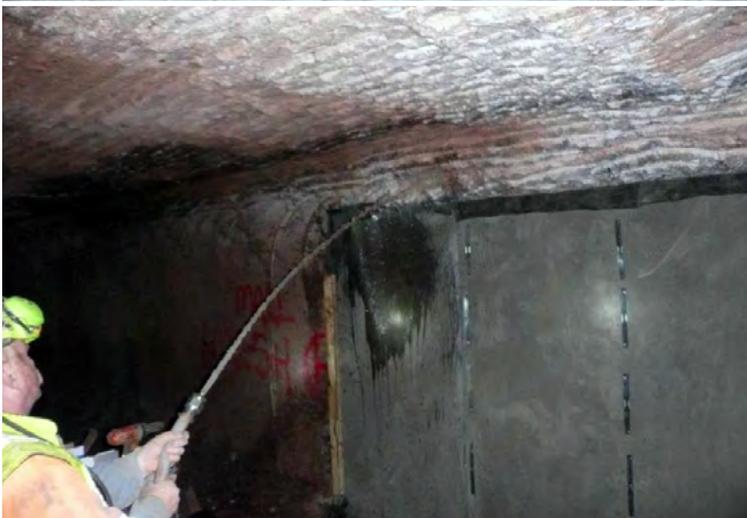
CC hydrated using on-site equipment

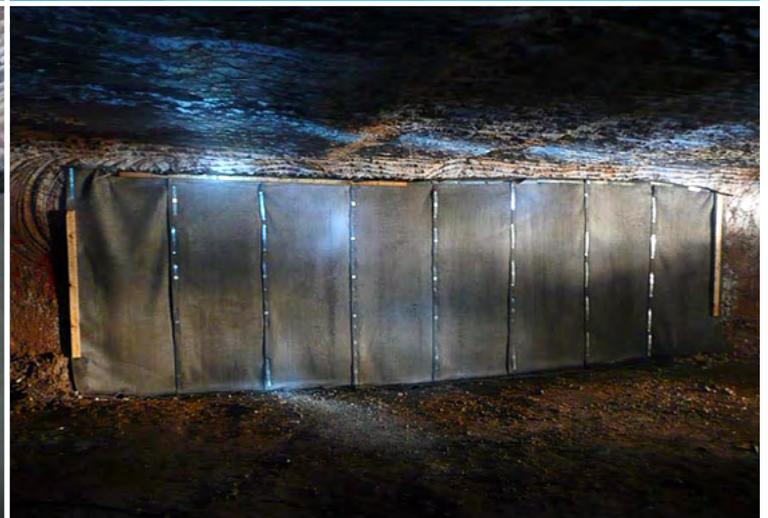
Completed vent wall closure using Concrete Canvas

British Gypsum were very impressed with the end result, stating that CC was installed as quickly as gypsum board but without the issues with rotting. They also noted that CC seems far more durable than brattice cloth and cheaper and easier to mobilise and install than concrete block walls.
