## Project Info

CC5™ Bulk Rolls

La Serena, IV region, Chile.

To improve the water management system of La Serena

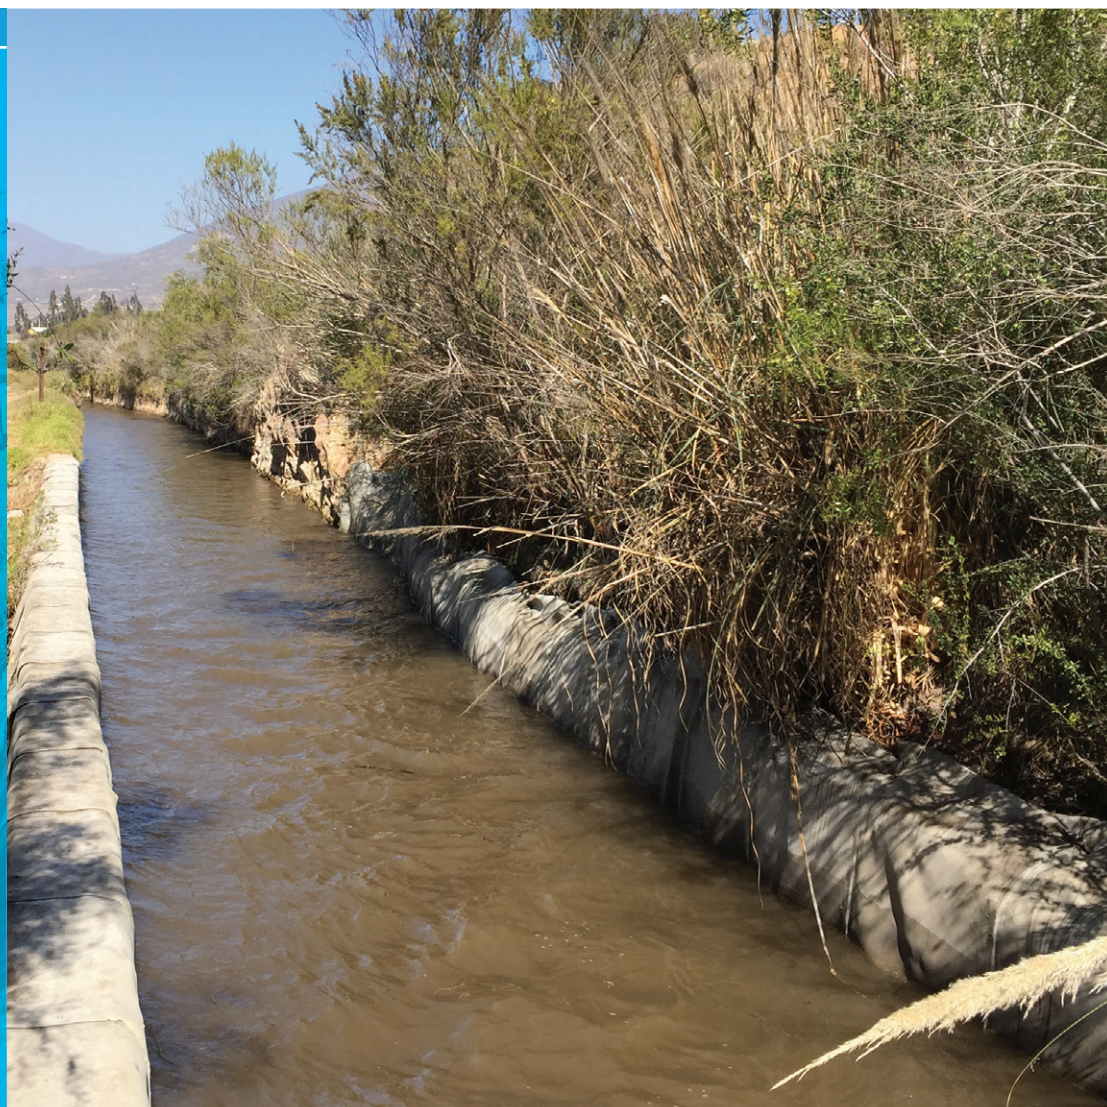
*The completed drainage channel installation*

In July 2016, Concrete Canvas® GCCM\* (CC) was used to line a drainage channel at La Serena, IV region, Chile. The objective was to stop water infiltration in an irrigation channel at 5 specific points and to improve the water management system of the local area. One of the main reasons that Concrete Canvas® was specified for the install is the fact that the channel dries out for around 5 days a year, so there were no other options to compare in terms of installation speed.

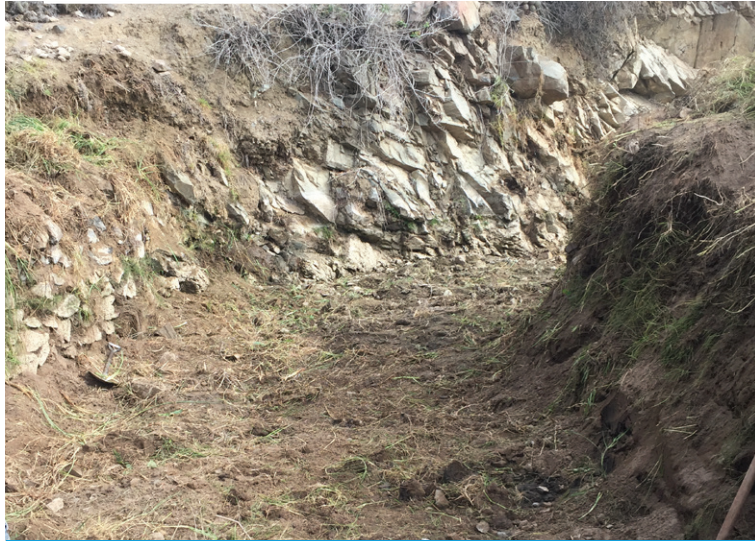
*A Skidsteer was used to excavate the area*

The works were carried out by Agrotek Spa for the Bellavista irrigation community. The weather was fine during installation, with average high temperatures during the daytime being around 15°C. Some rocks were removed, with the area being excavated, levelled and compacted with a Skidsteer. Any vegetation was cleared by hand using a Backhoe and Shovel etc.

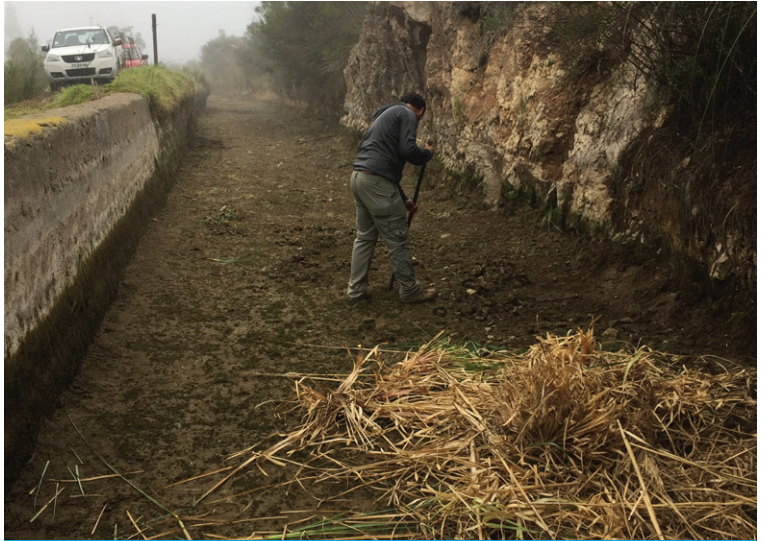
*Vegetation removal was carried out by hand*

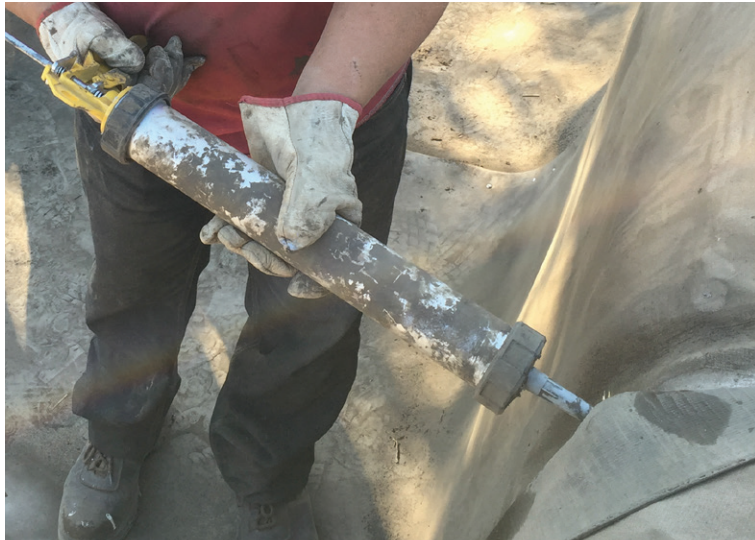
*SIKAFLEX - 11 FC was used on each 100mm overlap*

Hydration was completed via a roadside 1000ltr water tank and motor pumps. Each joint was then sealed with Sikadur® 31, Hi-Mod Gel, to ensure a perfect seal. 600m<sup>2</sup> of CC5™ were installed in 5, 8hr days by 6 people,

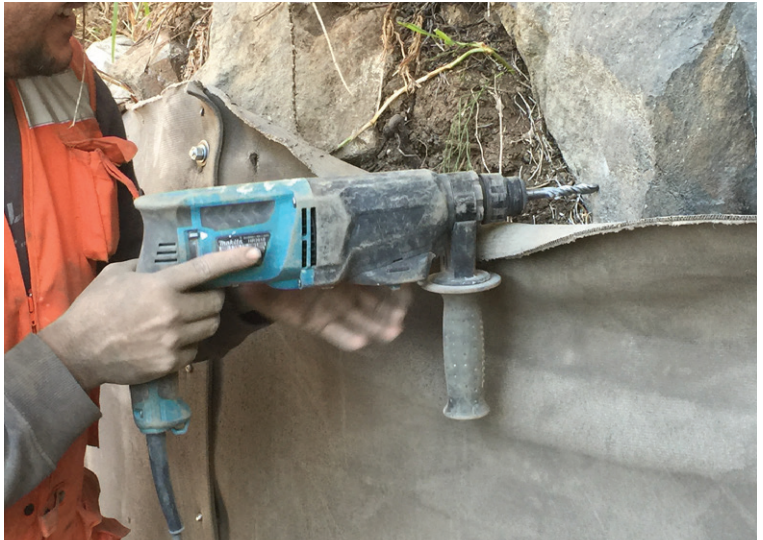
*The CC was fixed to the natural rock surface with expansion bolts*

The Concrete Canvas was supplied on bulk rolls. The spooled CC was mounted onto a spreader beam and cut to the exact length required using knives, eliminating waste and accommodating any variations in the channel profile. CC's main advantages over conventional concrete are speed and ease of install, cost savings, durability and environmental friendliness. Overlapped in the direction of water flow by 100mm, adjacent layers were underpinned with Sikaflex 11 FC and screwed together using SS screws at 200mm centres. The outside edges of the Canvas layers were captured in a backfilled anchor trench after being pinned to the ground using 250mm steel ground pegs where possible and fixed to the rock surface with expansion bolts in other areas.

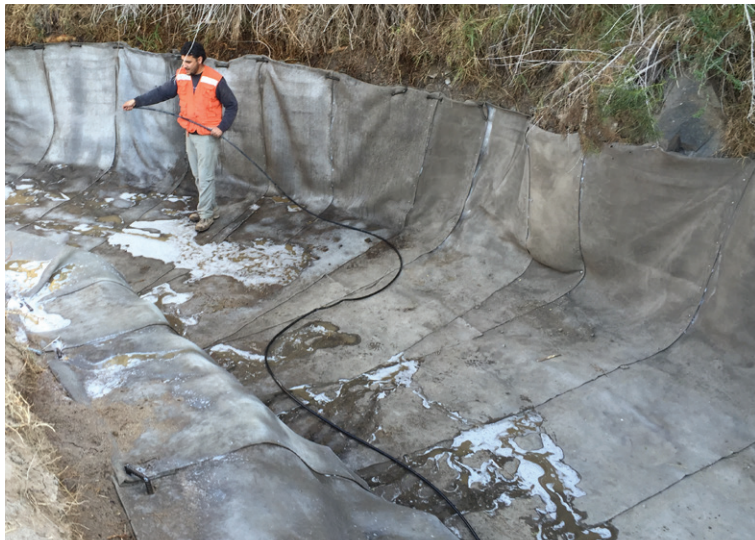
*Hydration taking place*

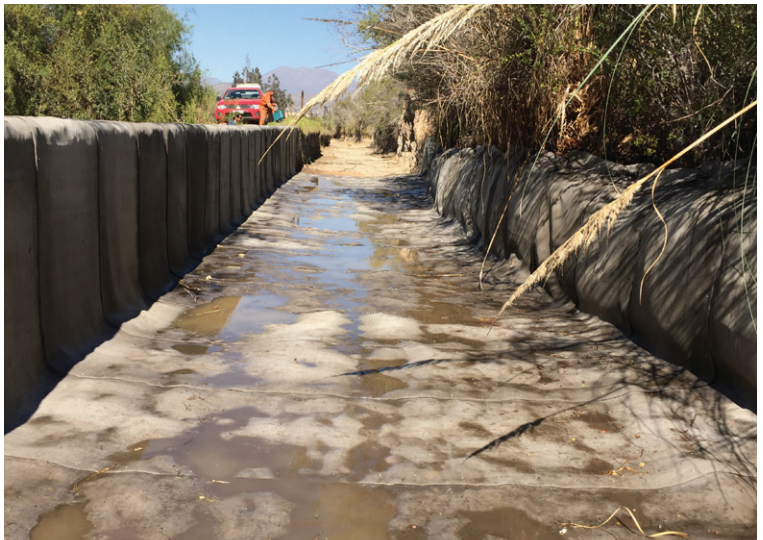
*The completed installation*

The project was very successful, the CC was able to stop the water infiltration at all 5 points in the extremely restricted timeframe. Two larger engineering projects are currently in development at the same channel, measuring 16000m<sup>2</sup>; 1km in length, each to be constructed in 2017 and a further two in 2018.

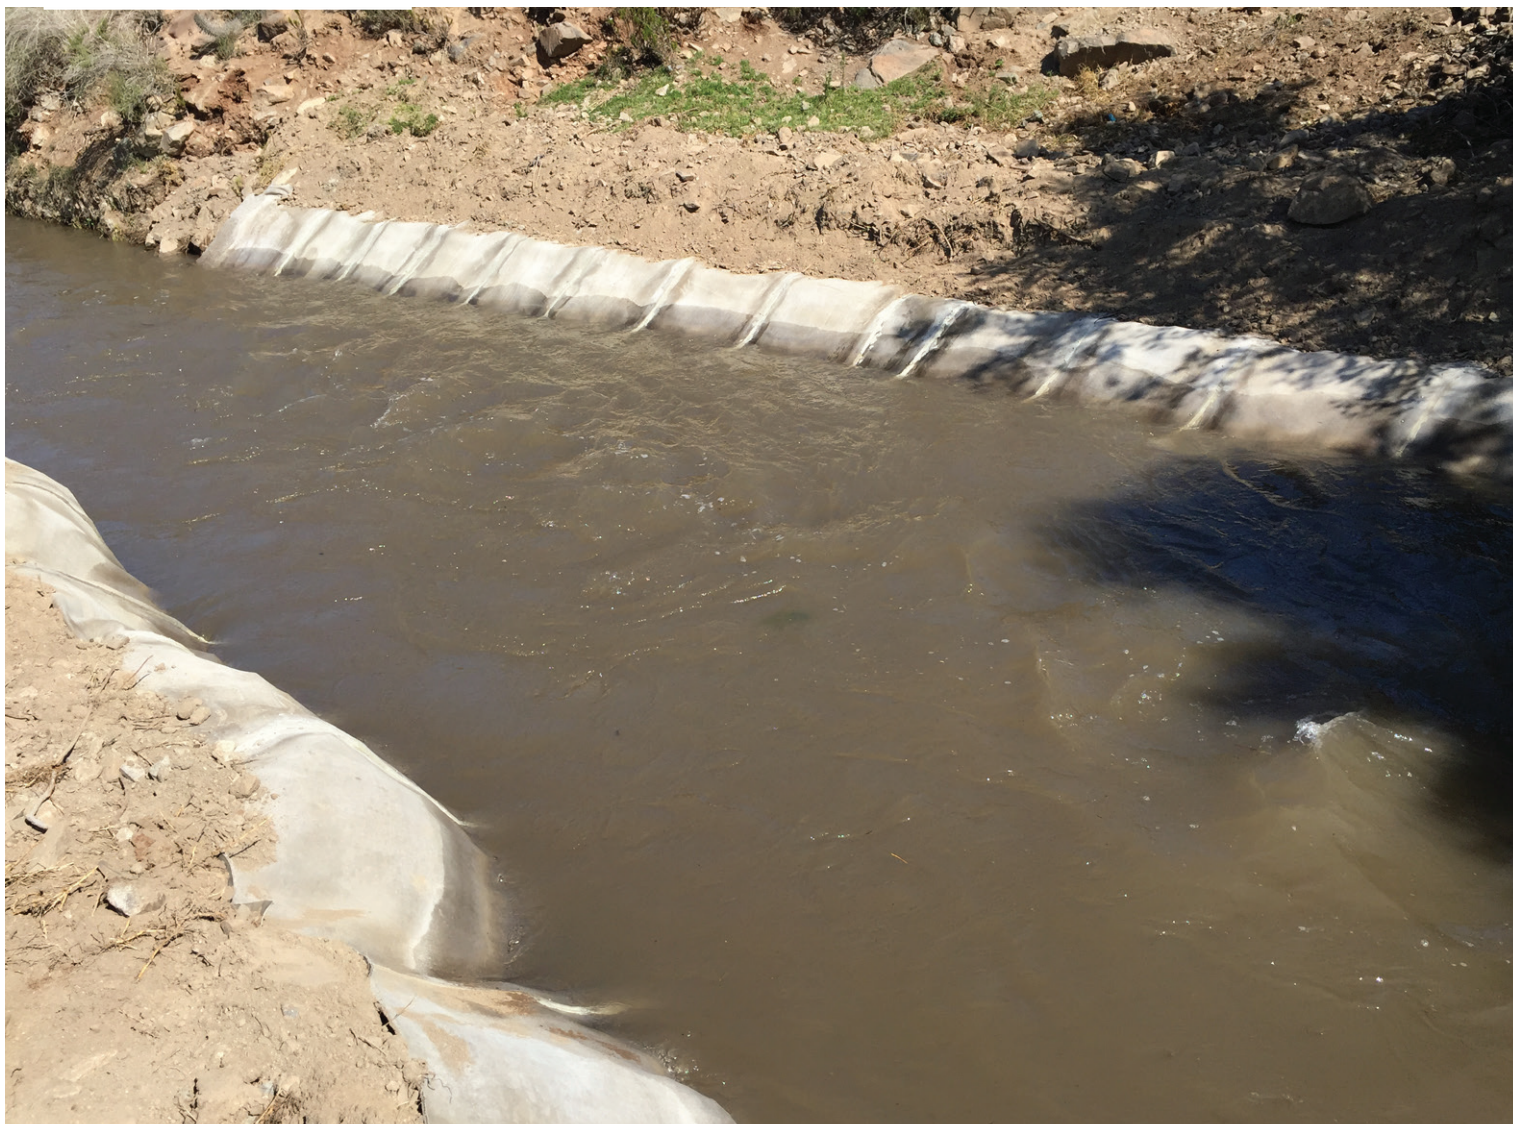
*When in flow, there was a flow rate of 5.7m<sup>3</sup> per second within the channel*
