In May 2017, 900m<sup>2</sup> of CC Hydro<sup>™</sup> GCCM\* (CCH5<sup>™</sup>) was used to provide a retrofit below tank liner for a tank overhaul project at a refinery in the UK. CCH5™ was specified by IKM Consulting, a multidisciplinary consulting engineering company, with 20 years of Oil & Gas and Petrochemical experience. Work was carried out by Sean Carr Lining Technology (SCLT) on behalf of the client.

# Concrete Impregnated Containment

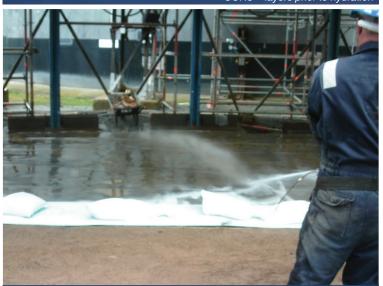
Hydration taking place

Following the welding and testing of the joints, CC Hydro<sup>™</sup> was hydrated at the end of each day via the local onsite water mains. The material cannot be overhydrated so an excess of water was used to ensure full saturation.
