CC8™ Bulk Rolls

Crindau, Newport,
Wales, UK

CC8™ used to prevent deep slip and tidal and weathering erosion of a clay core, grassed flood berm on the banks of a tidal estuary on the River Neath in Newport, Wales.

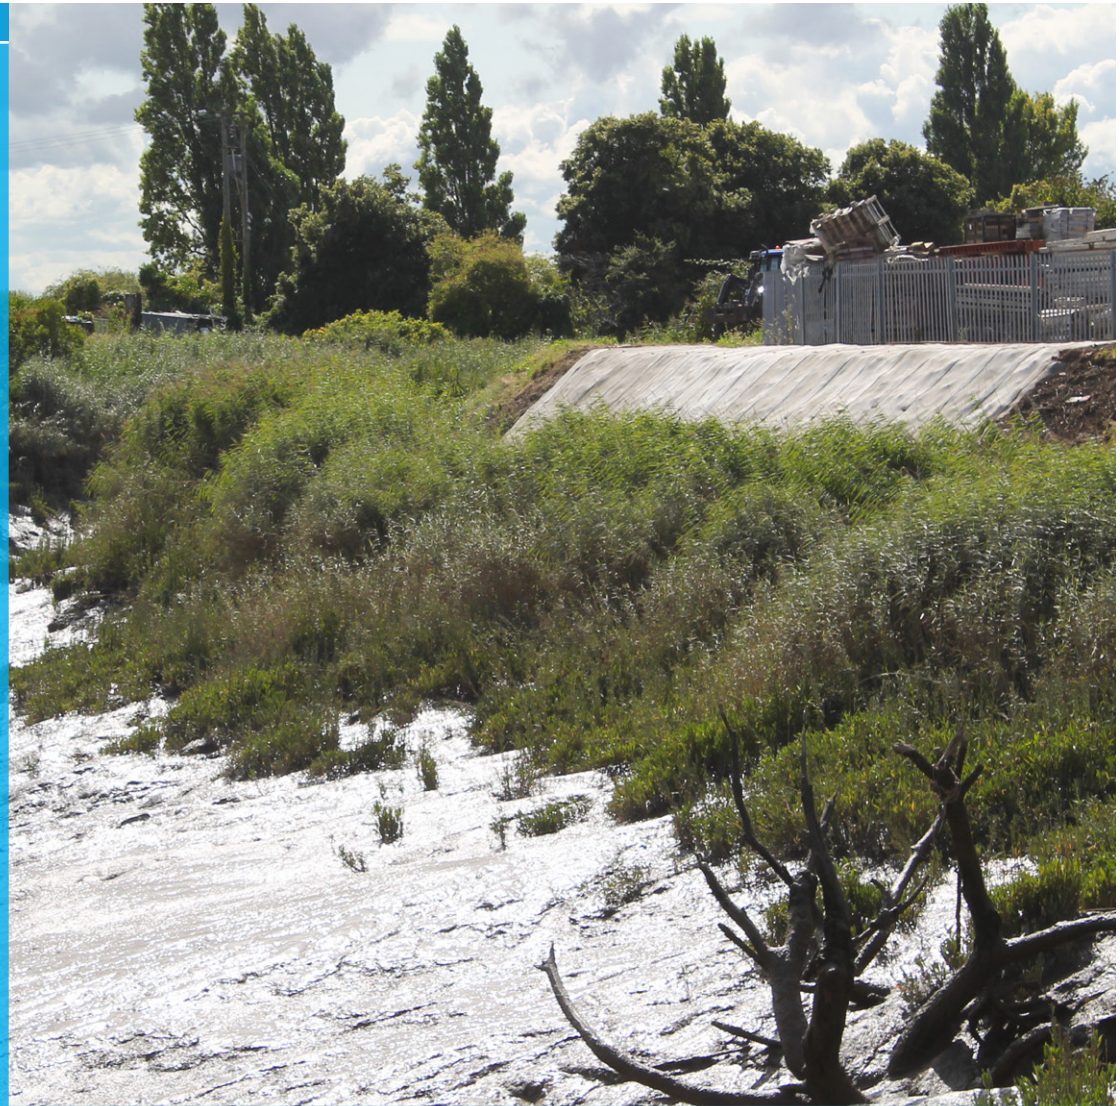
Completed first section of lined berm

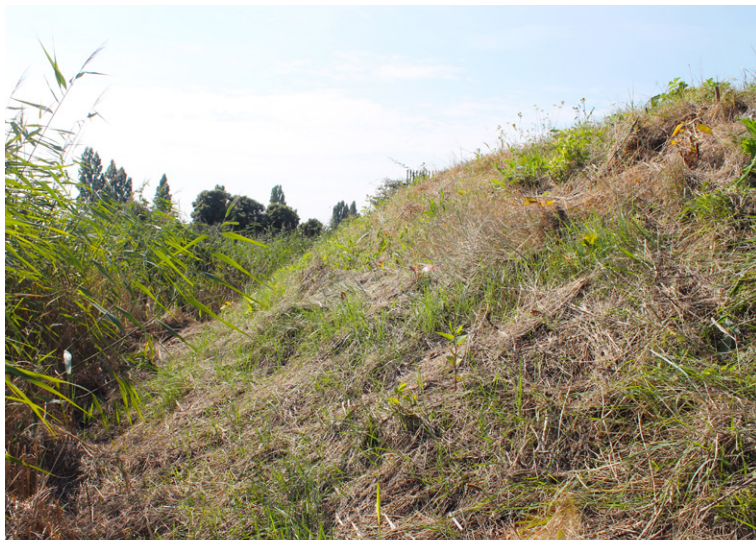
Berm prior to vegetation removal and grading

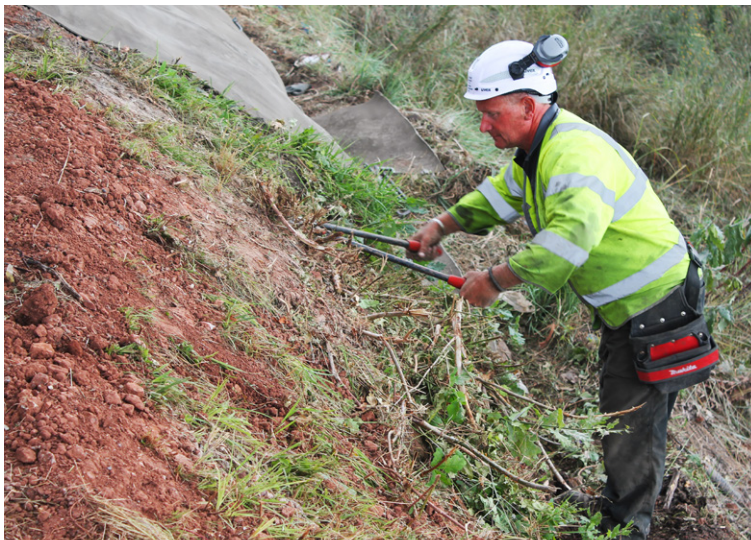
Vegetation removal from bank

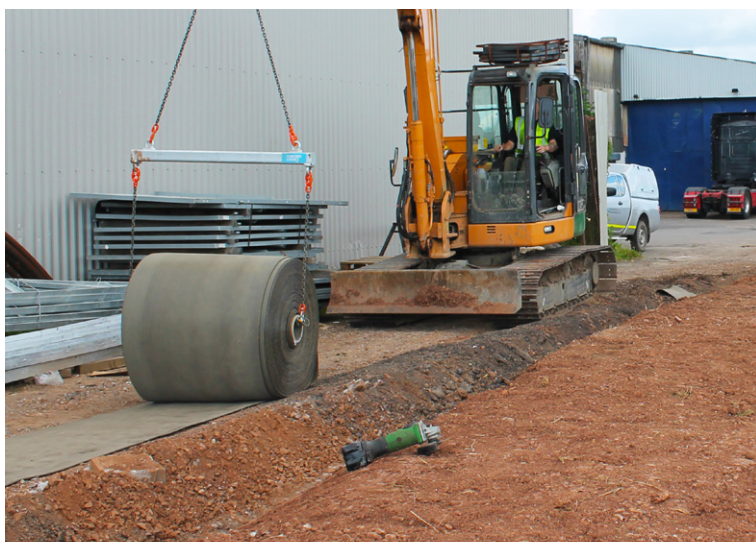
Batching lengths of CC from spreader beam suspended bulk roll

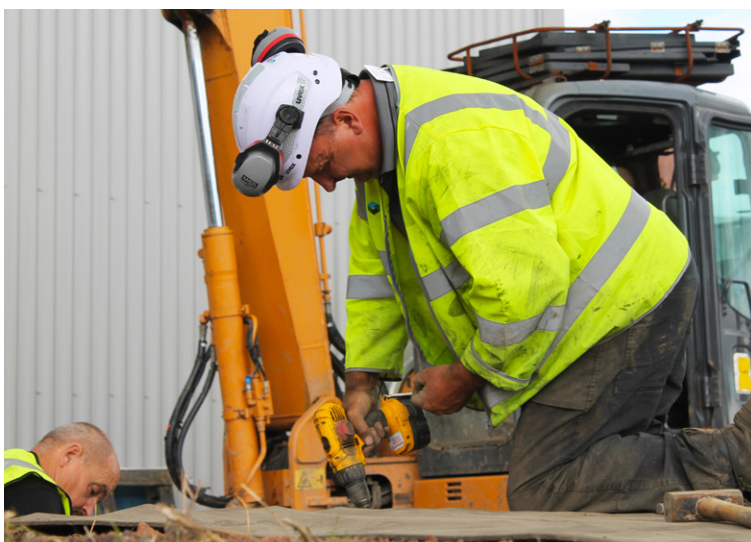
Fixing of the CC overlaps with stainless screws at 150mm centres

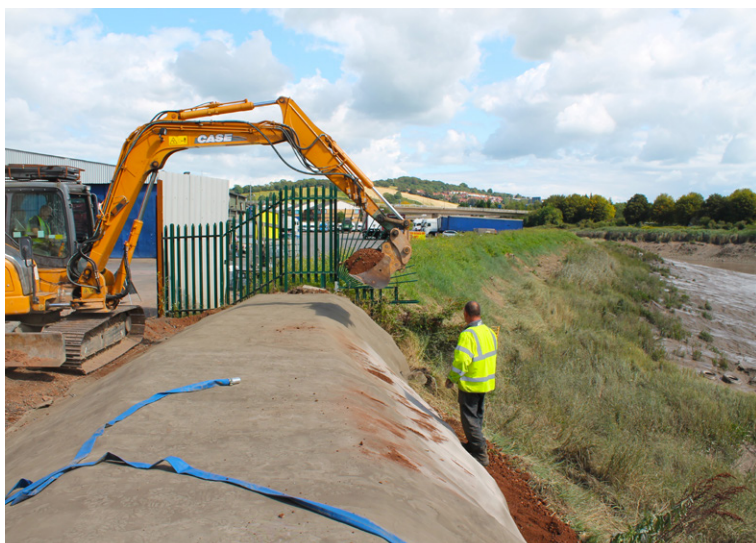
Backfilling anchor trench at toe of second section berm

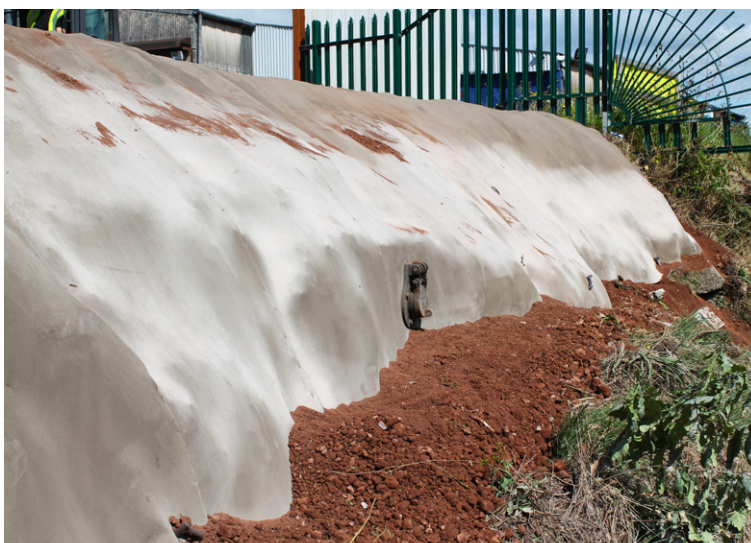
Backfilled anchor trench post hydration

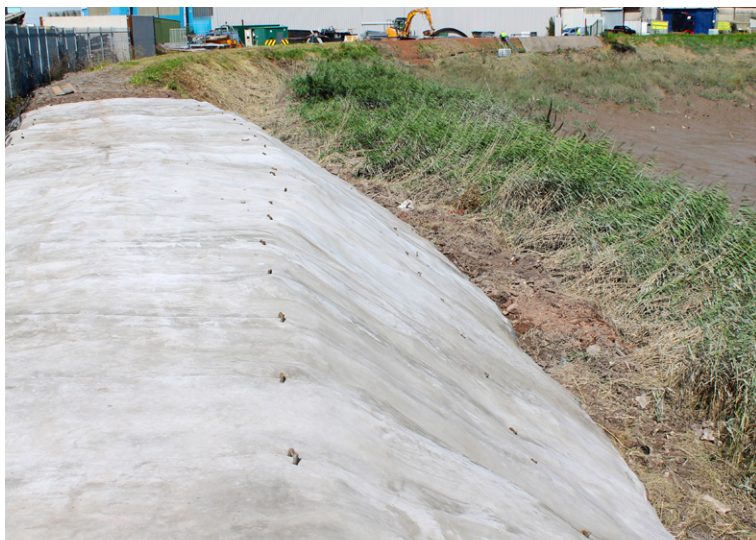
Completed first section, showing ground pegs at 3m intervals

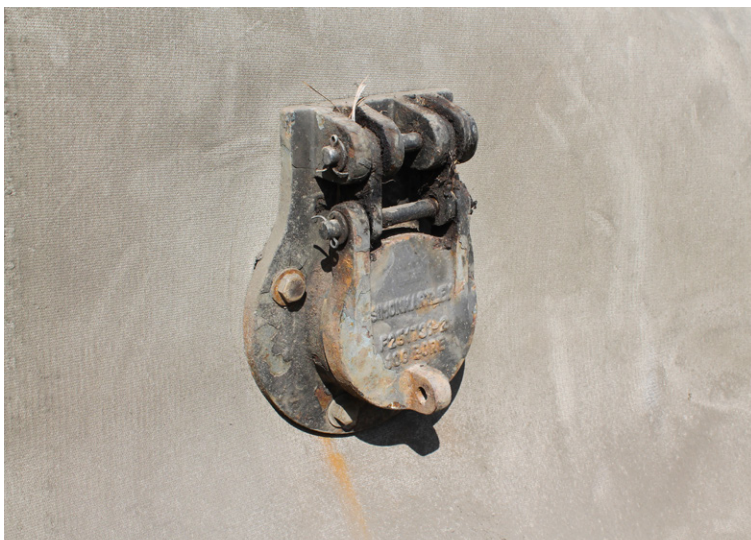
Drain pipe cover access through CC

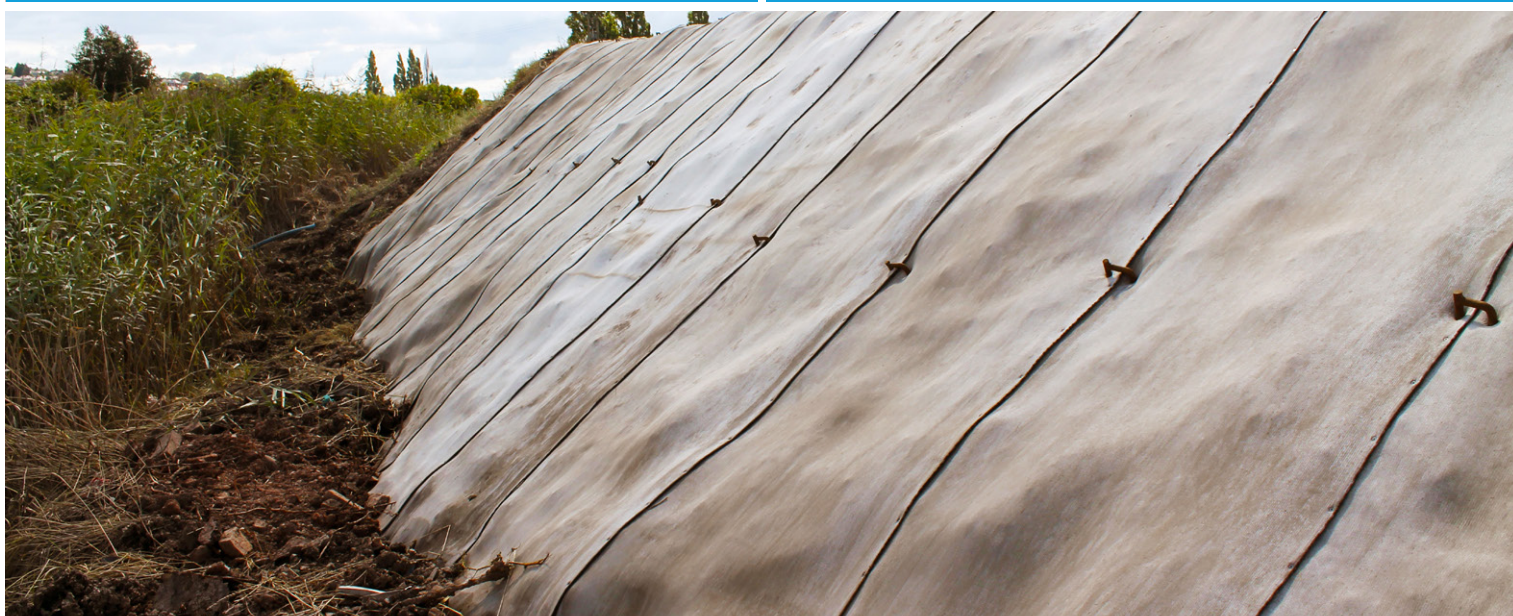
Completed first section showing toe anchor trenching, screw fixings and ground peg placement
