In June 2018, Concrete Canvas® (CC) GCCM* material CC8™ (an 8mm thick variant) was specified to provide erosion control and reduce permeability of open drainage channels as part of the A14 Cambridge to Huntingdon improvement scheme, situated at Section 1 along the southbound side of the A1.

The purpose of the project was to collect highway runoff water from adjacent slipform drainage, providing additional storage capacity if required during storm events. The channels measured approximately 2.7m wide, with varying lengths totalling 2km in total on the Southbound side.

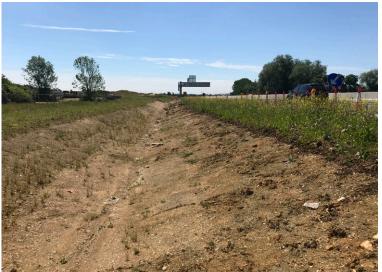
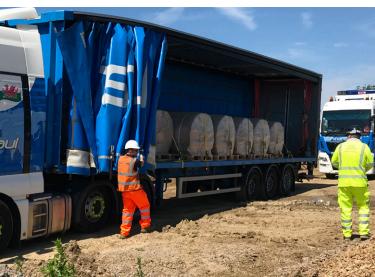
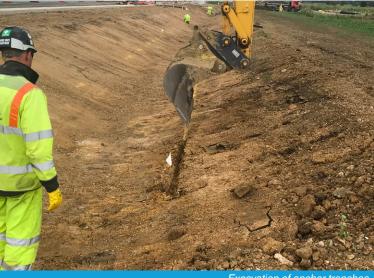
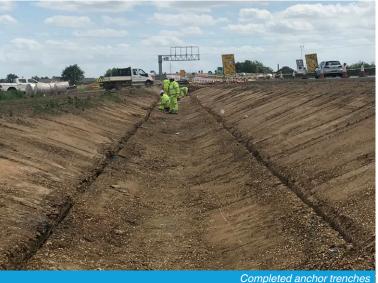
In preparation for the installation, the channel profiles were excavated, then an excavator created a 'notch' one-third of the way up the side slopes to enable the edges of the CC to be buried.

Depending on the construction sequence, CC was either laid before the slipform was installed, or returned up the slipform before a grout filet was applied to captured the edge. On the other side of the channel, the CC was extended up to full slope height to create a 'splashback' and prevent possible erosion from water flowing into the channel.

The CC layers were screwed and sealed at the joints, while grout was applied against the slipform channels and sandbag headwalls. Following installation, the CC was hydrated using a bowser at the end of each day.

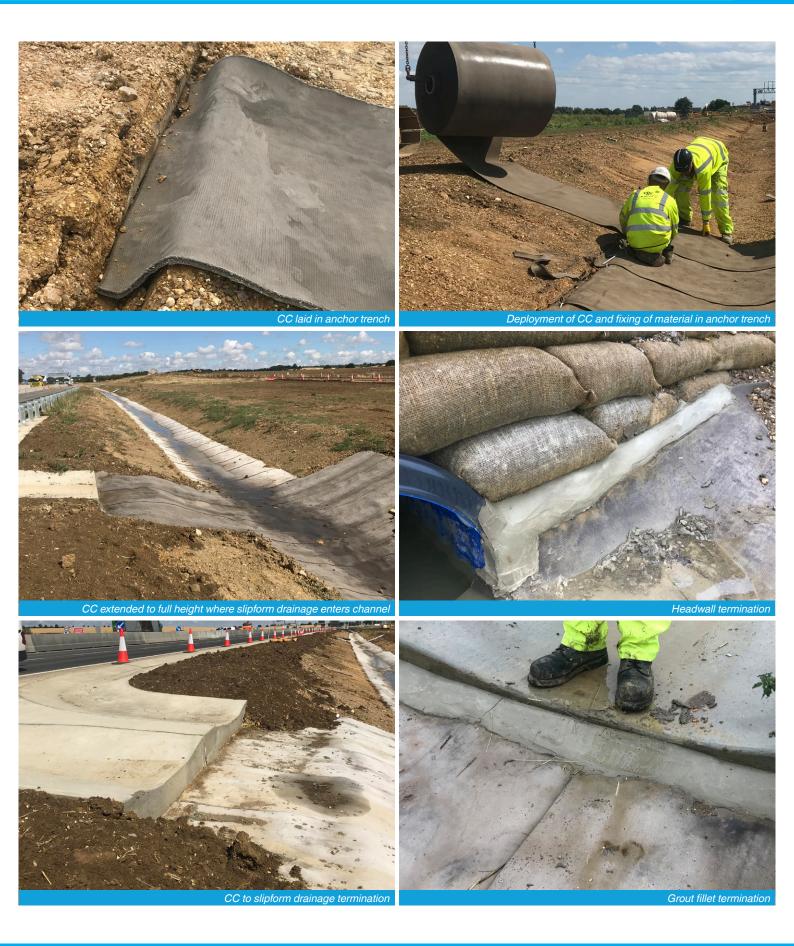
It is unusual for CC to be used only part way up side slopes, but it was specified as the full height of the channel would be needed for major flood events only, but one-third height was only necessary to contain typical rainwater runoff from the highway.

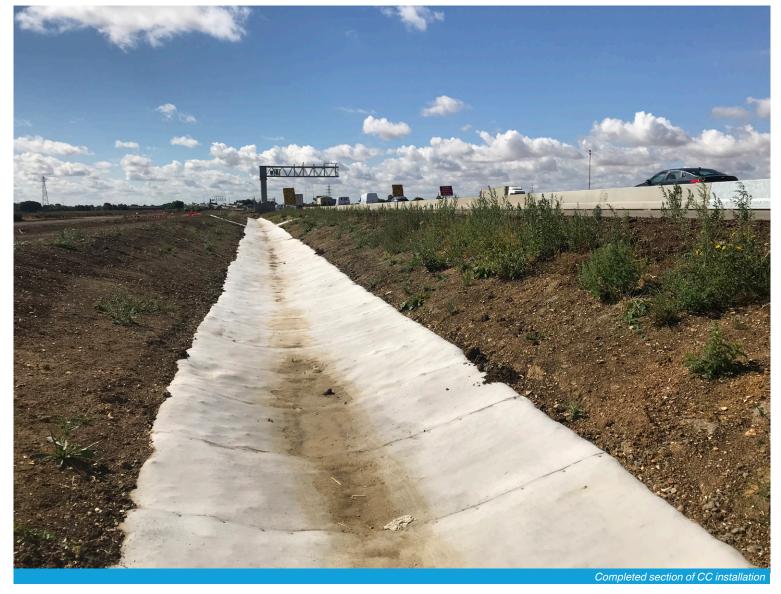
The Southbound installation was completed with over 100m of channel lined on some days, including the work required to excavate anchor trenches.

A total of 7500m² has been installed on the scheme so far, with a further 675m of channel to be lined on the Northbound side in the coming months, when weather permits works to resume with minimal disruption. The client and contractor are happy with the results of the scheme to date, and have also installed another 450m² of CC to line a subsequent channel for Section 2.
