CC8™ Bulk Rolls

A465 (Brynmaur),  
Wales, UK

CC8™ used to line  
drainage channels  
as part of a Highways  
Agency road widening  
scheme

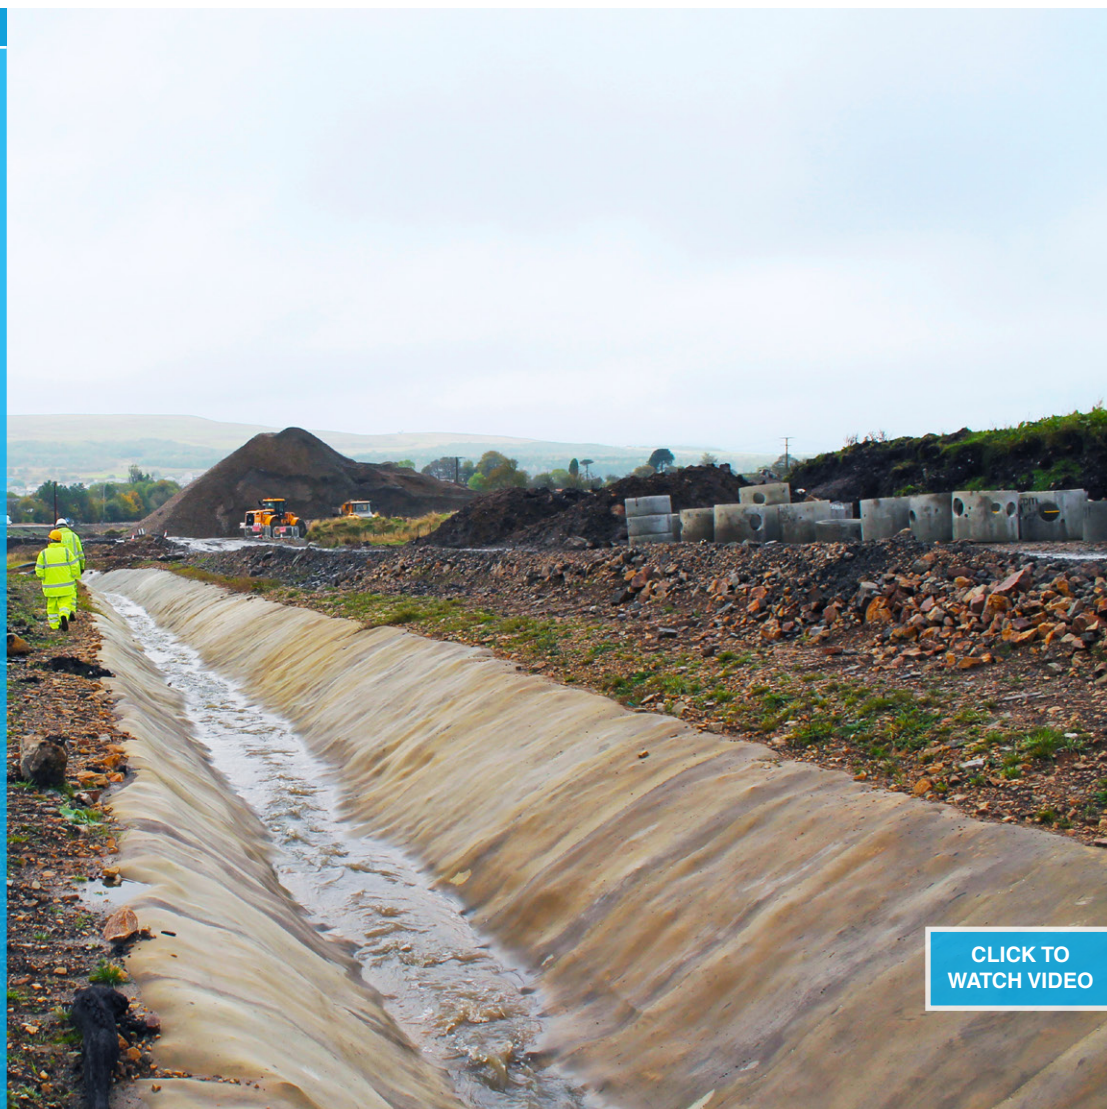
*A completed section of ditch*

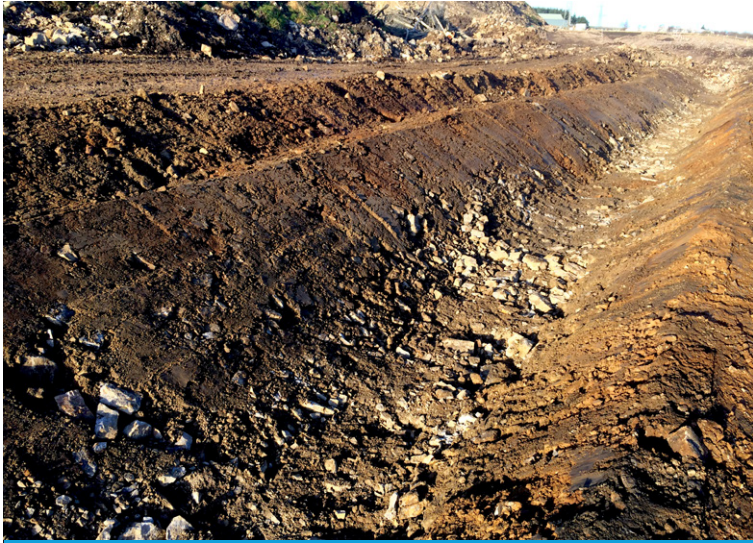
*The ditch was excavated and graded to profile*

CC8™ was used to line one main ditch and various smaller ditches on site. The main ditch is approximately 250m in length, 7m in width at the crest, and 3m wide at the base. Bulk rolls were deployed using an excavator and spreader beam before being batched to length using hand tools. Subsequent layers were overlapped by 100mm in the direction of the water flow and screwed in place at 150mm intervals. The CC was installed at a rate of approximately 50m<sup>2</sup> per day with a 3 man team (two of the crew laying the material and a third fixing it in place), with a total of 4,250m<sup>2</sup> installed.

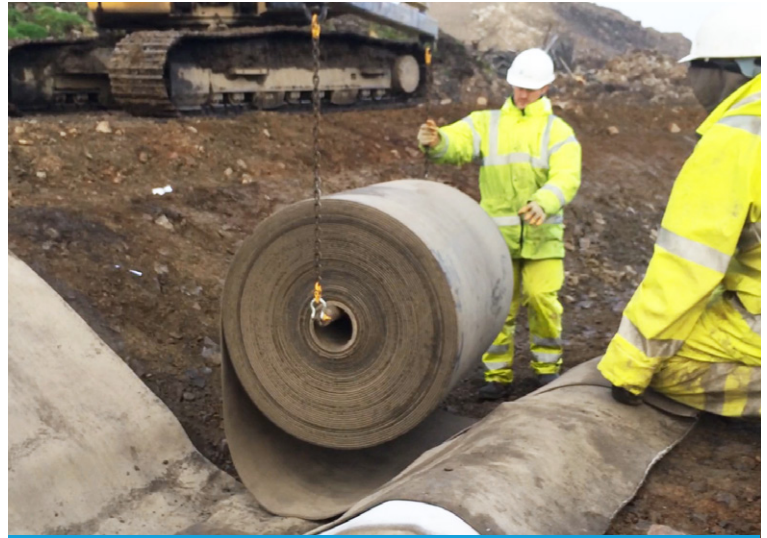
*Plant was used to unroll and place the material*

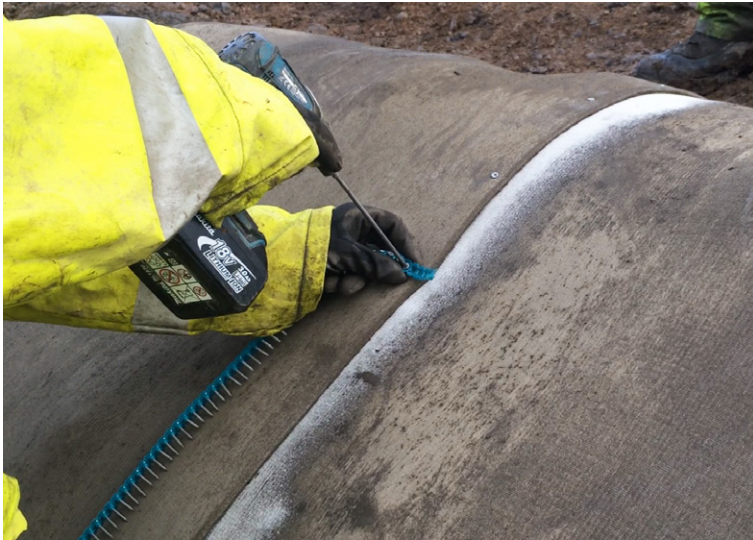
*Transverse layers with a 100mm overlap were screwed in place*

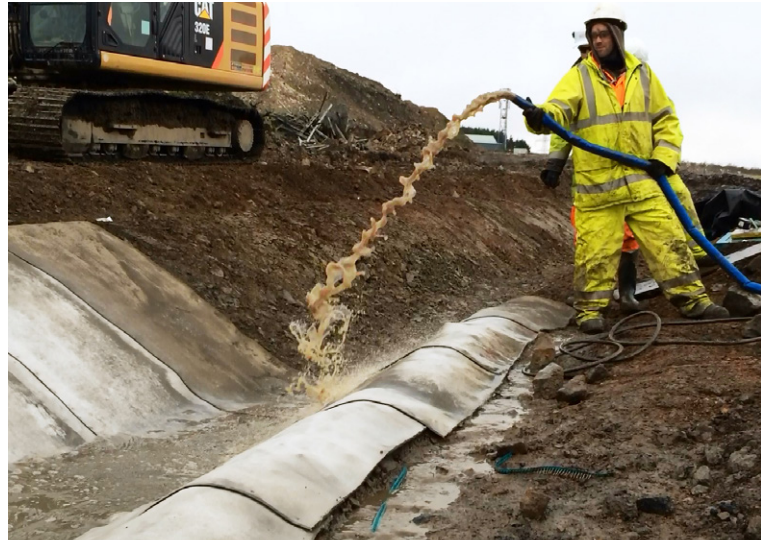
*Hydration of CC8 via bowser and petrol pump*

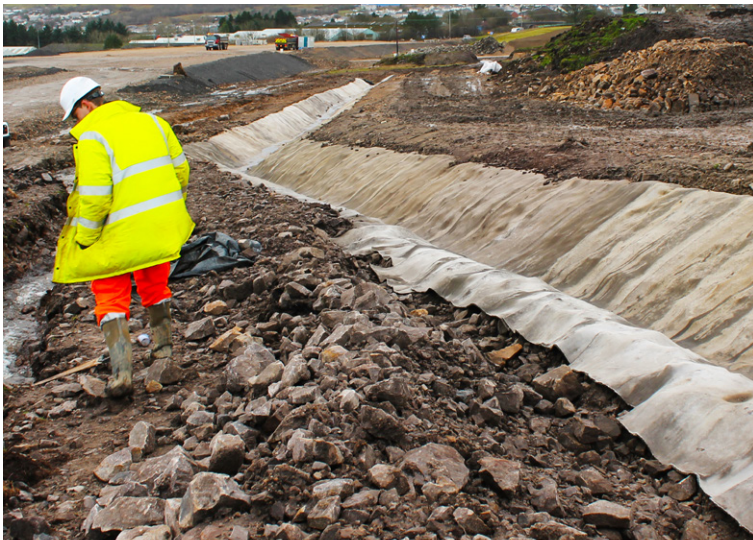
*Transverse layers backfilled into the anchor trench along crest*

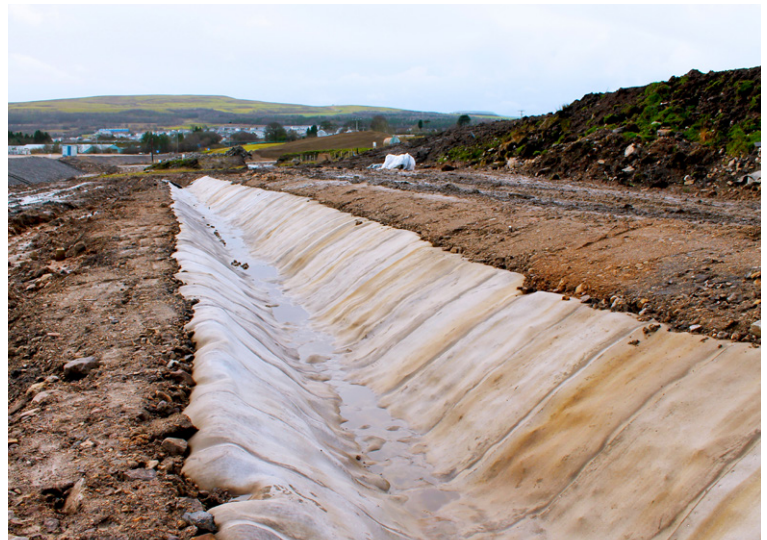
*The finished ditch*

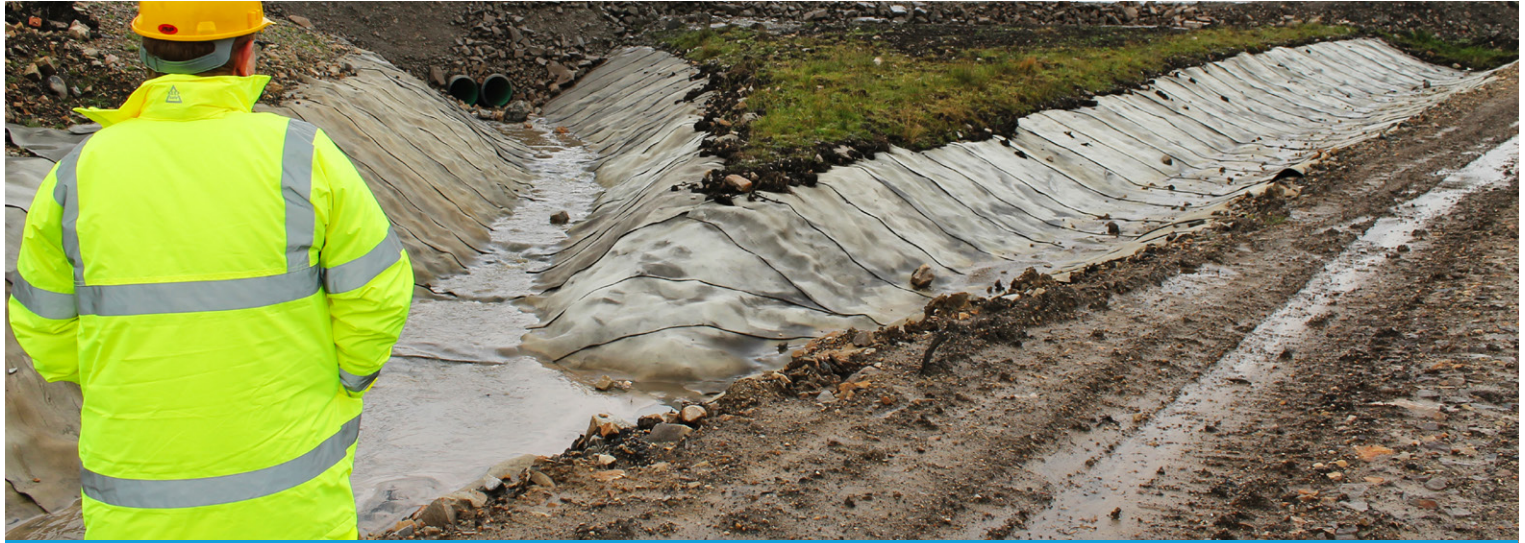
*CC junction*

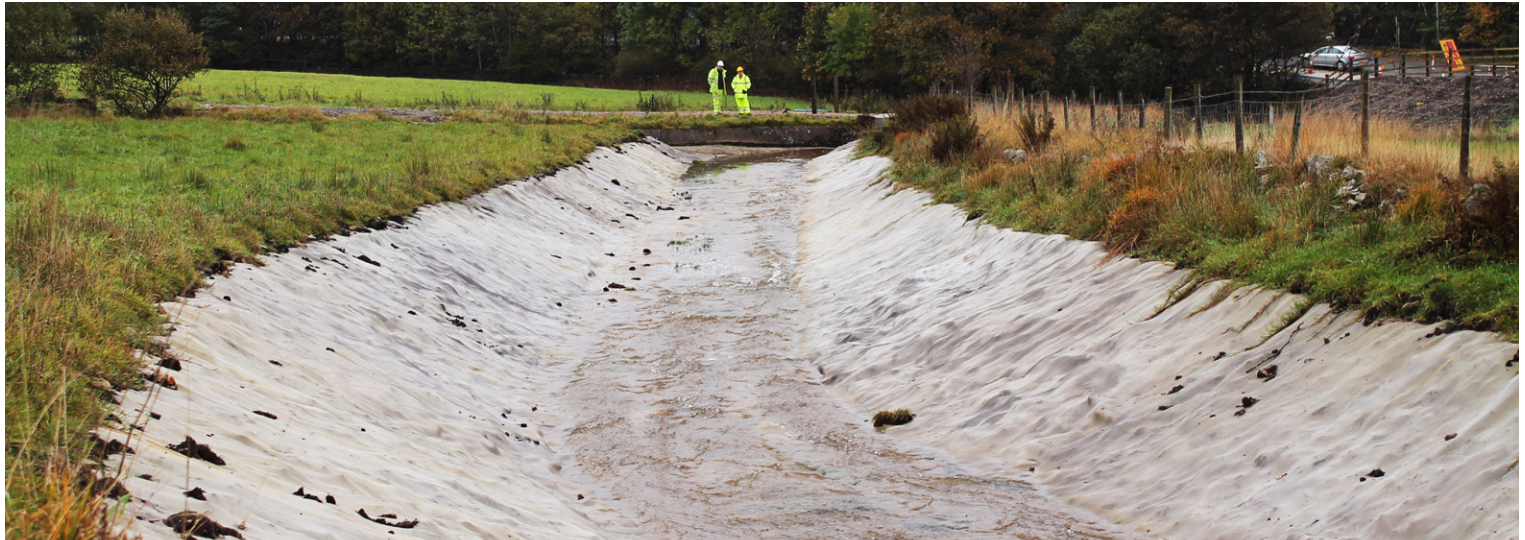
*A completed section of ditch*

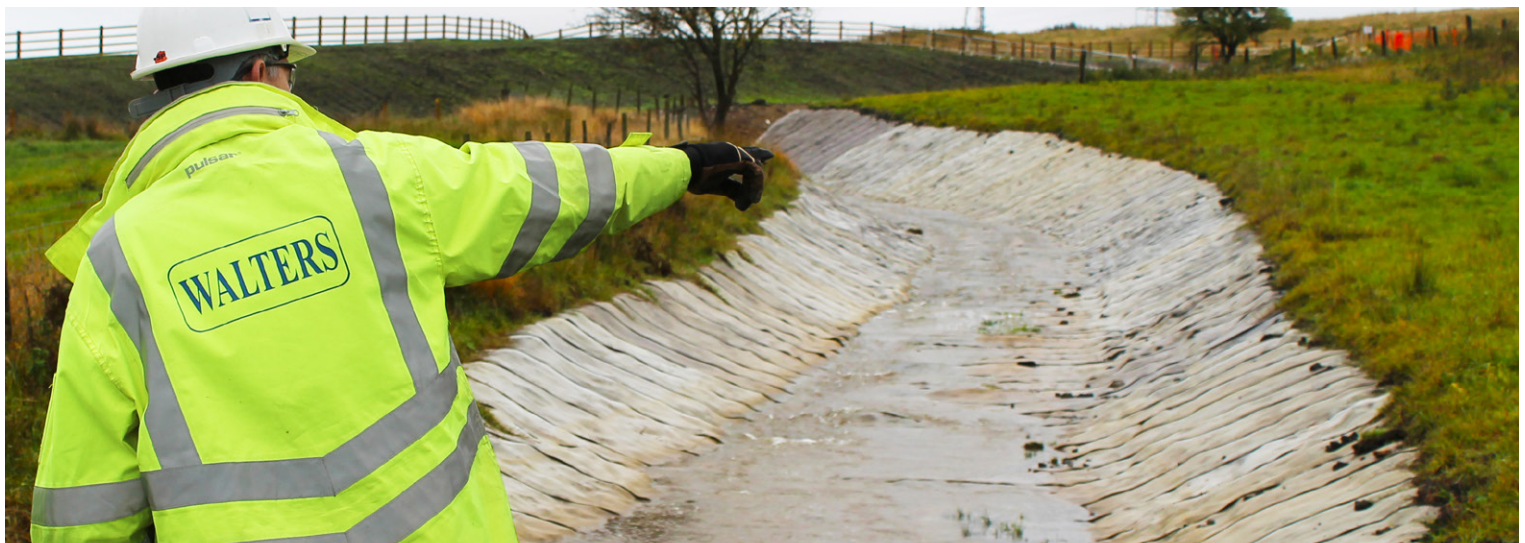
*CC accommodating a turn*

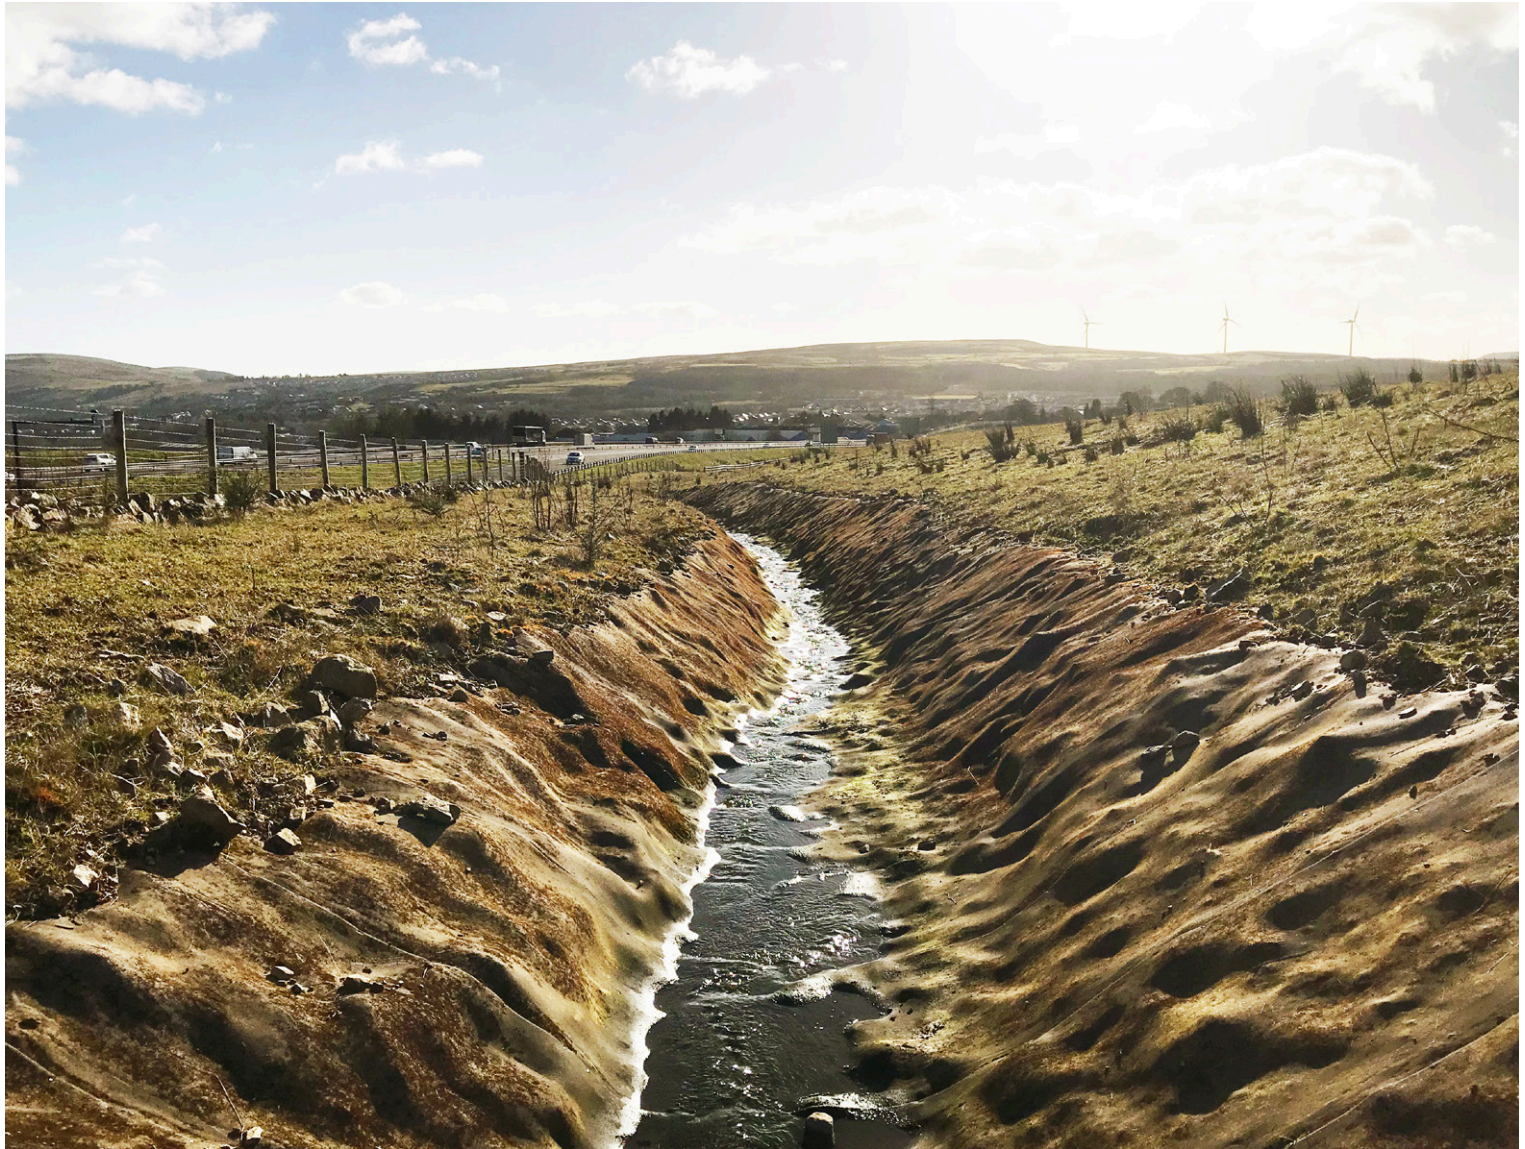
*CC lined channel shown five years after installation, having required zero maintenance over that period.*

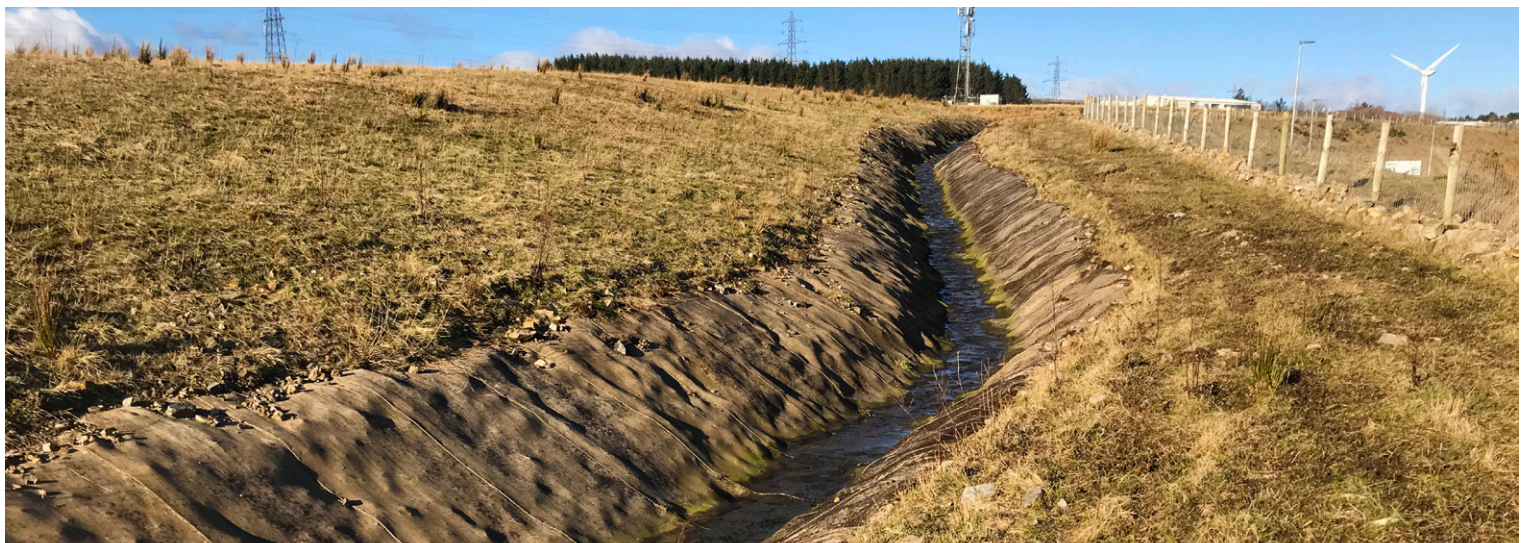
*The CC material has blended in with the surrounding environment, whilst the channel is performing hydraulically, exactly as originally designed.*
