CC5™ Bulk Rolls
-

A'ali, Bahrain
-

CC5™ was used to provide erosion protection to a channel and slope section at a roadside in Bahrain

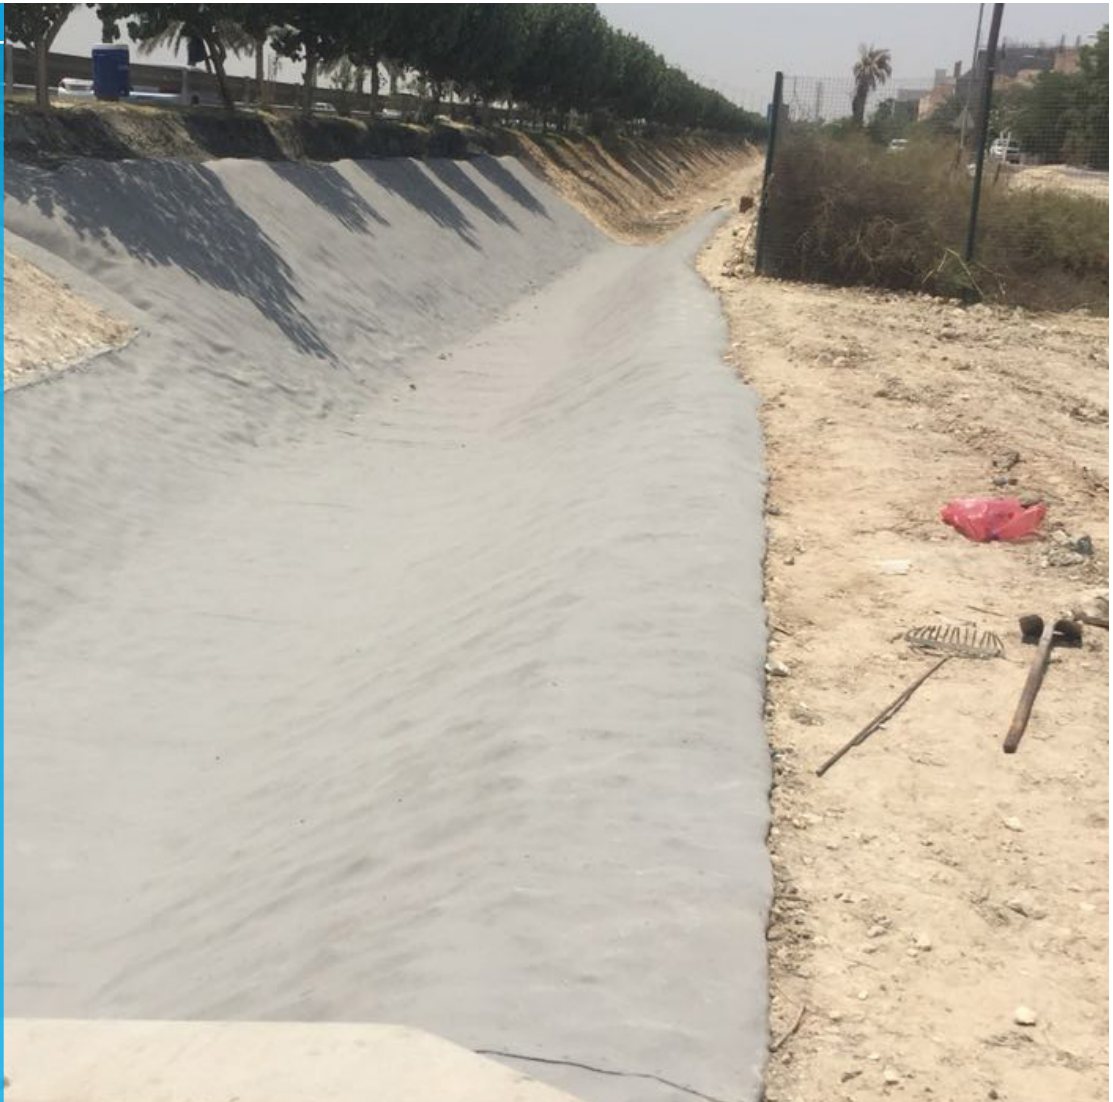
Completed channel and slope installation

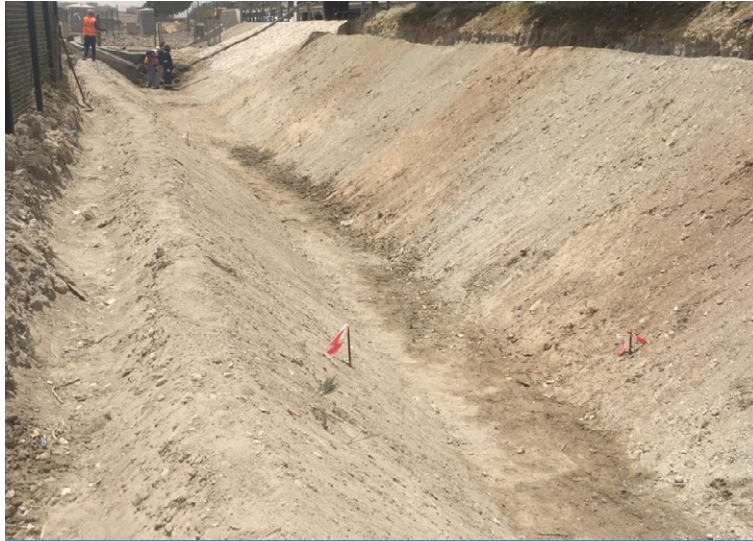
Channel following preparatory works

Prior to installation, vegetation and sharp rocks were cleared by hand using a backhoe and shovel. The channel was then levelled and compacted to ensure an even substrate. The CC5™ material specified for the project was then delivered in bulk rolls, cut to required lengths on site to reduce wastage, and unrolled down the slope. The edges of the material were buried within pre-dug anchor trenches and secured with ground pegs. CC was then laid transversely along the inverts of the basin and across the channel. Stainless steel bolts were used to joint the overlapped layers of CC through the existing rip-rap and headwalls while stainless steel screws were used within the channel. Cement mortar was then used to seal the CC edges where they met the rip-rap slope. The anchor trenches were then back-filled with concrete to provide a neat termination and prevent water ingress. Following installation, the CC was hydrated and then painted when set.

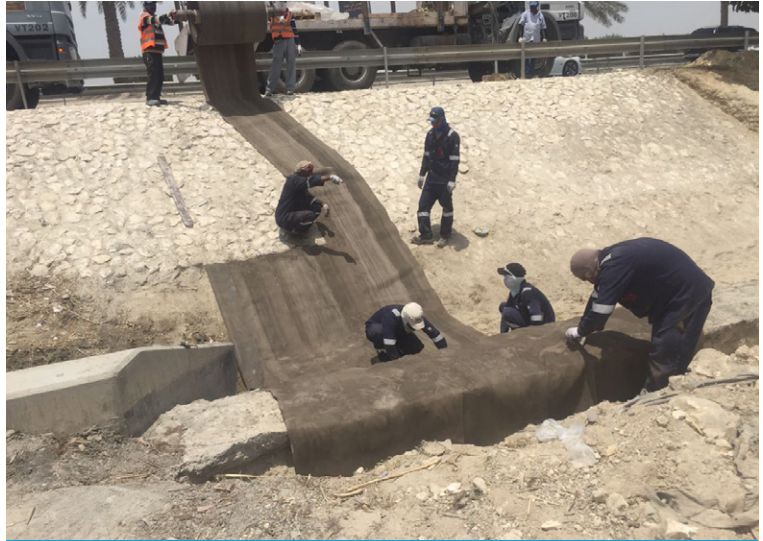
Deployment of CC material

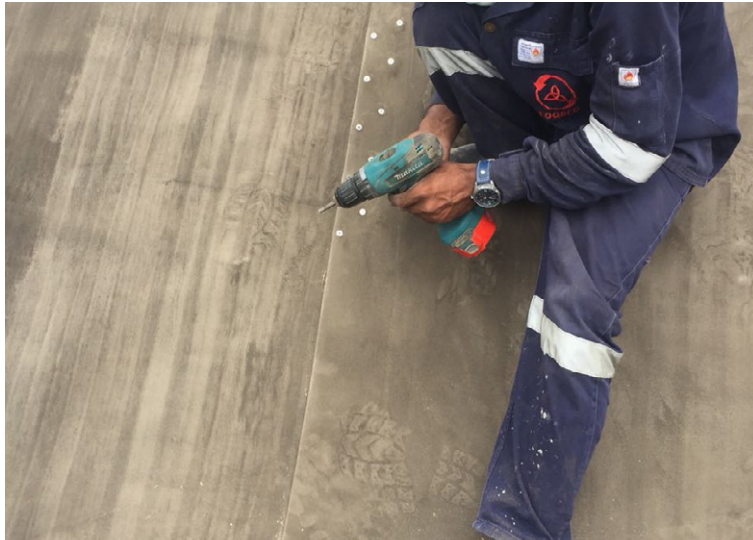
Joining overlaps using stainless steel screws

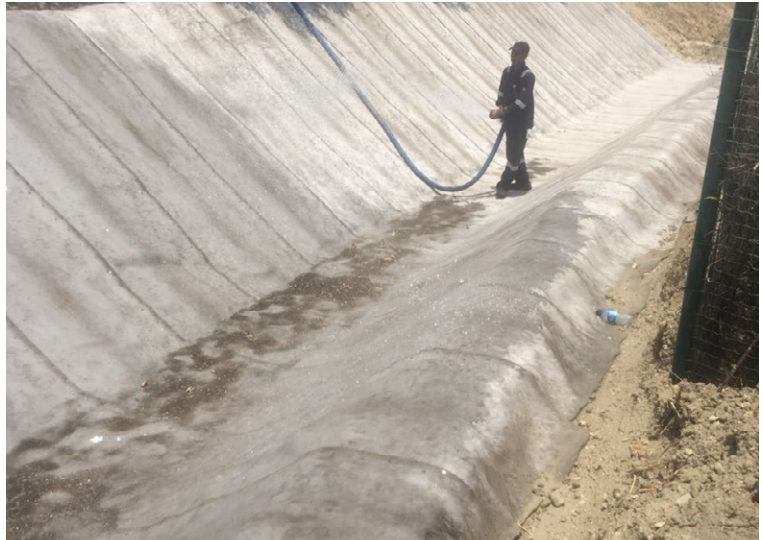
Hydration of the CC

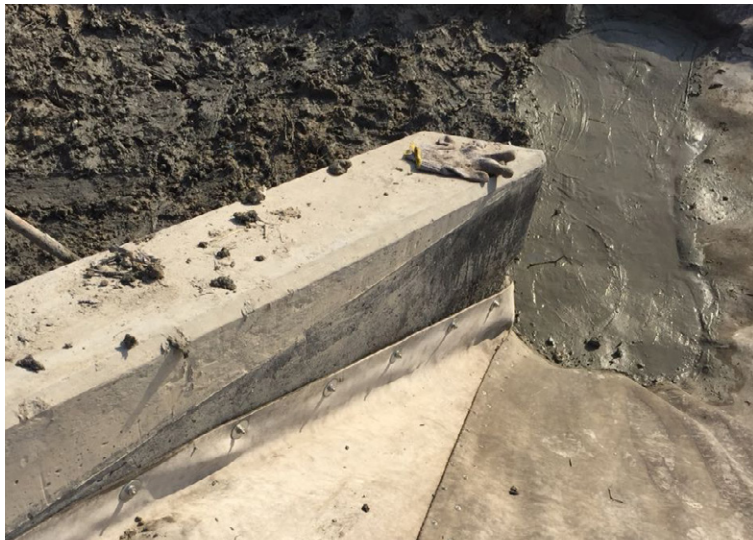
Filling anchor trenches with cement

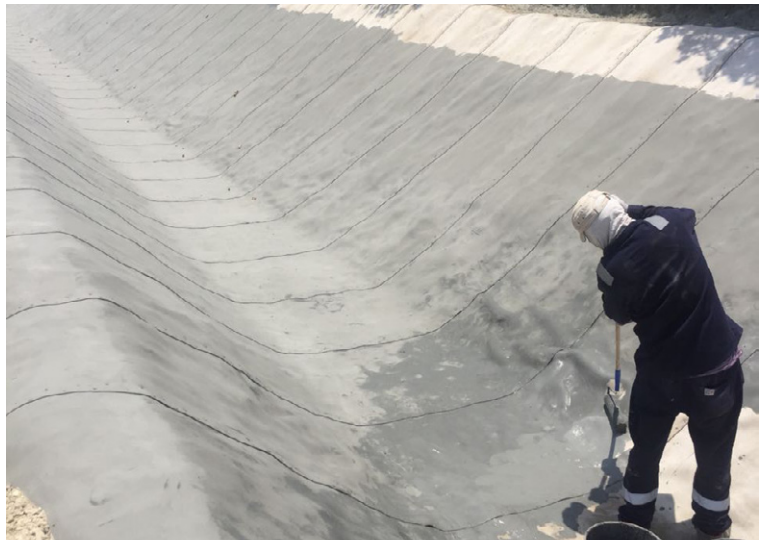
Painting completed installation

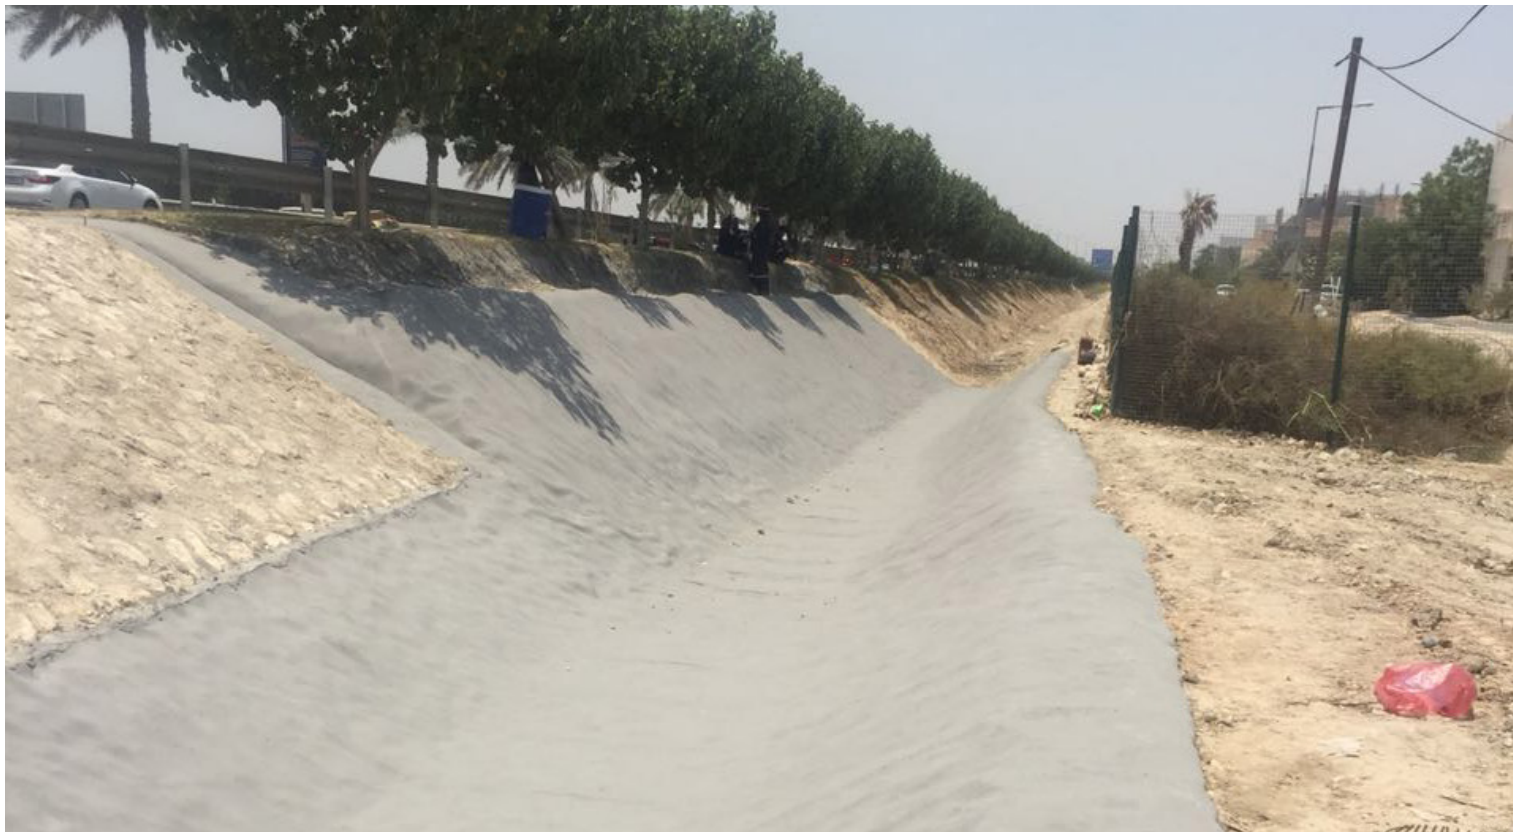
*Completed installation*

The installation took a total of 10 days to complete, in very hot and dry conditions and an average of 10 hours worked each day. This included preparatory works, installation, setting and painting. A total of 620m<sup>2</sup> were installed for this project.
