CC8™ Bulk Rolls

Accra, Ghana

CC8™ was used to line  
an irrigation channel as  
part of the Ashaiman  
Irrigation Scheme in  
Ghana

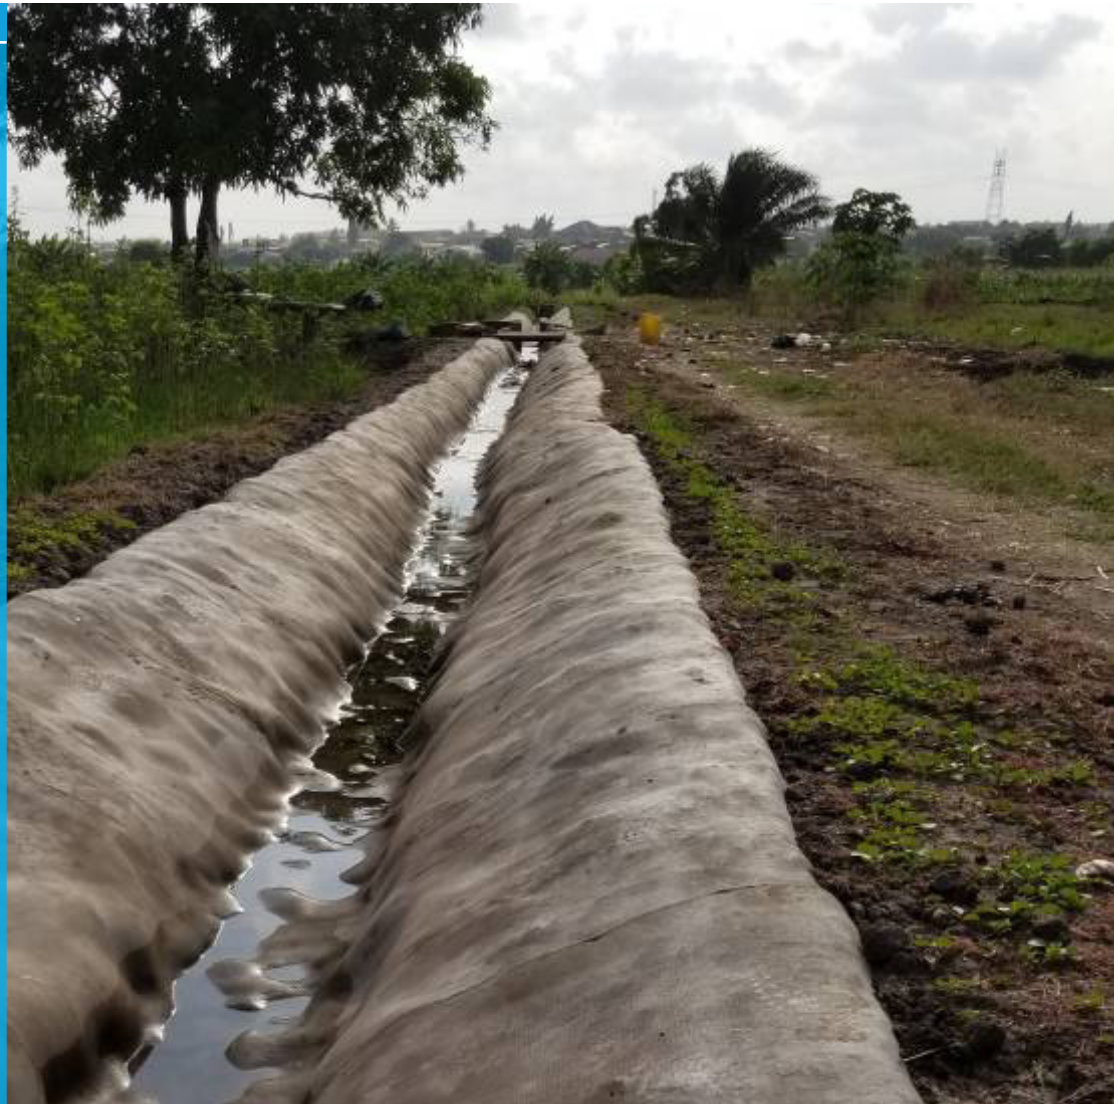
*Completed irrigation channel in Accra, Ghana*

A total of 125m<sup>2</sup> of CC8™ were installed in just 2 hours, by a team of 7. Due to the use of CC rather than conventional methods, there was a significant reduction in closure time of the canal during installation, and the supply gate from the dam was able to be re-opened shortly after its completion.

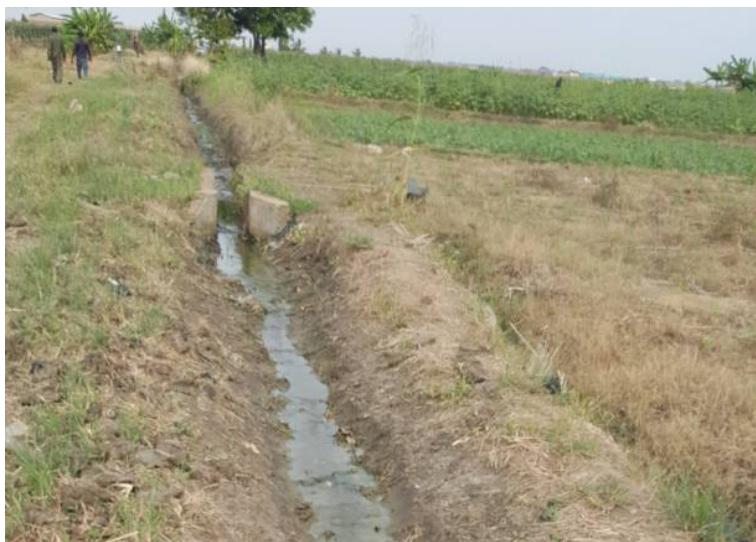
*The original channel*

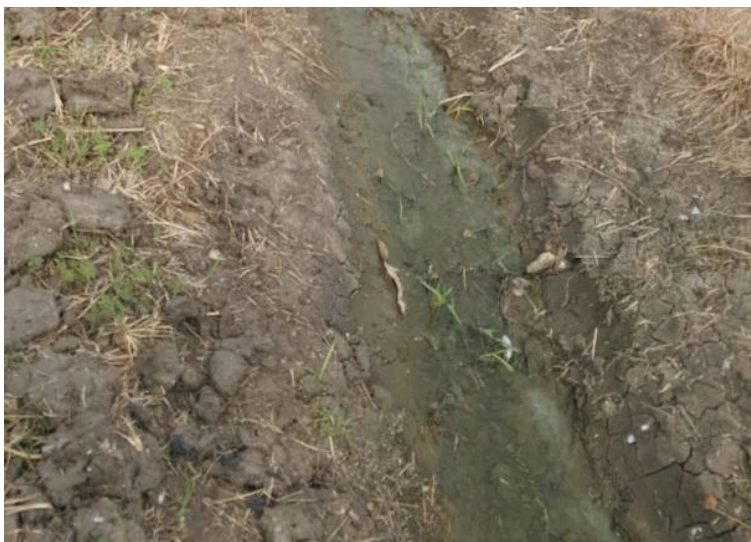
*Prior to works the channel was overgrown and heavy with sediment*

Prior to installation, any vegetation was removed from the ground within the channel and its profile was re-graded and shaped. Anchor trenches were then dug on each shoulder and a bulk roll of CC8 was delivered to site. The CC was then mounted onto a spreader beam, unrolled and cut to specific profile length. These pieces of material were then moved by hand to the channel and laid transversely, with additional layers laid with overlaps of 100mm. CT1 Sealant was then used for jointing the CC layers, along with 20mm stainless steel screws at intervals of 200mm. The edges of the CC8 were anchored with 375mm ground pegs at 1m intervals where a transverse layup was used, and where a longitudinal layup was used instead, 2m intervals were implemented. Once the installation was completed, a 650-litre water bowser was used to hydrate the CC, and the process was repeated after one hour to ensure sufficient saturation.

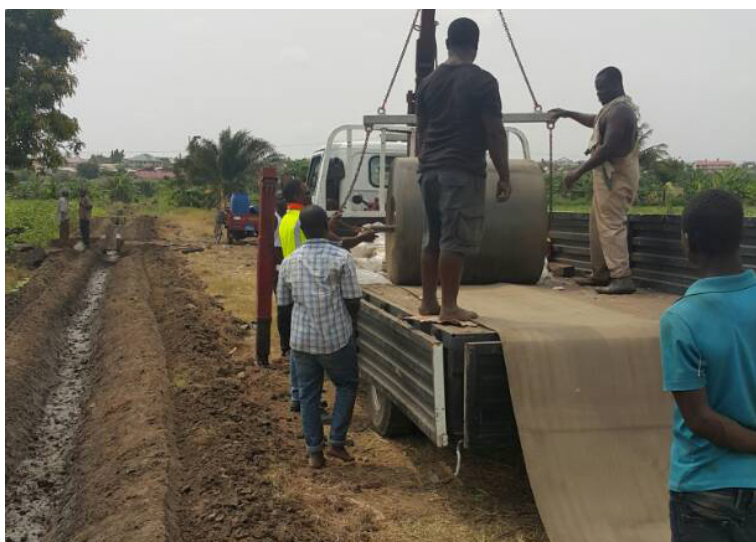
*The CC was delivered on a bulk roll, unrolled and cut to length*

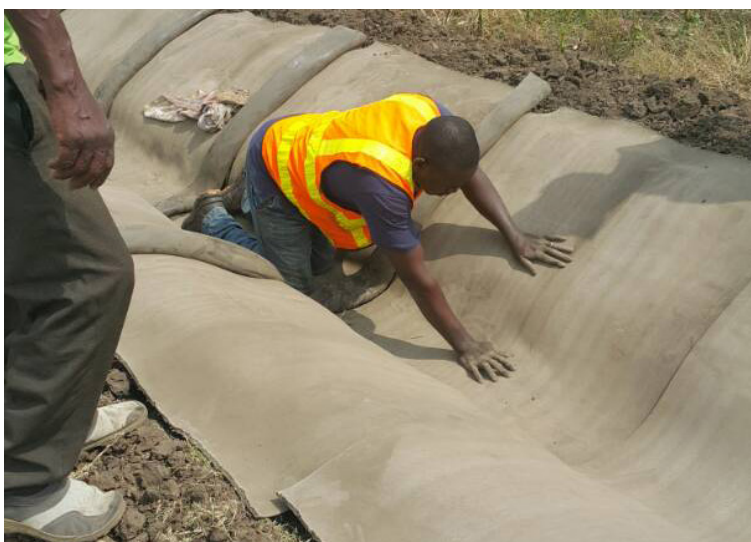
*The CC was laid transversely*

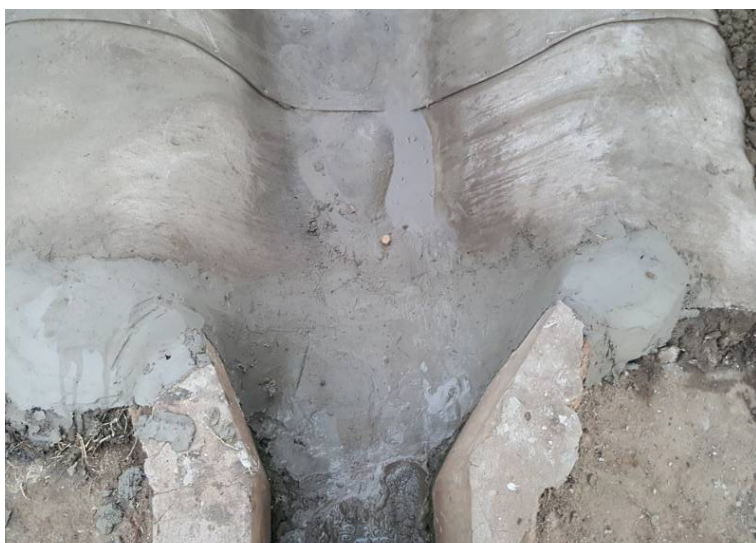
*Grout was used to seal the ends of the CC at gates transitions*

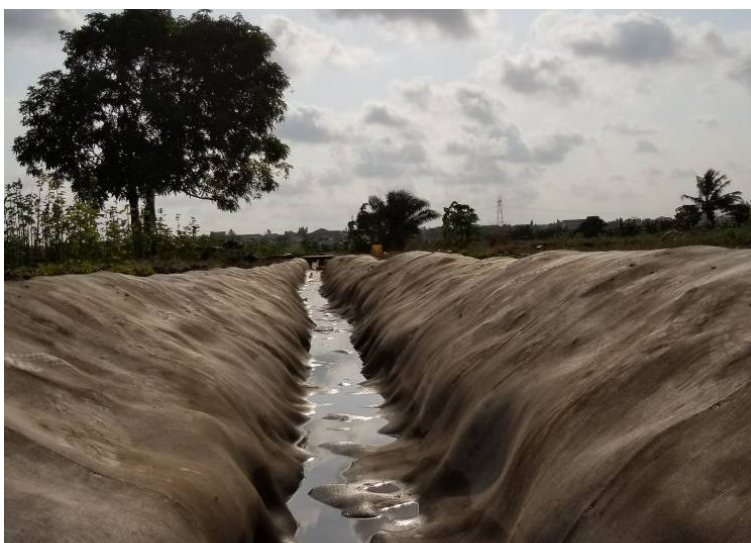
*Completed transverse section post-hydration*

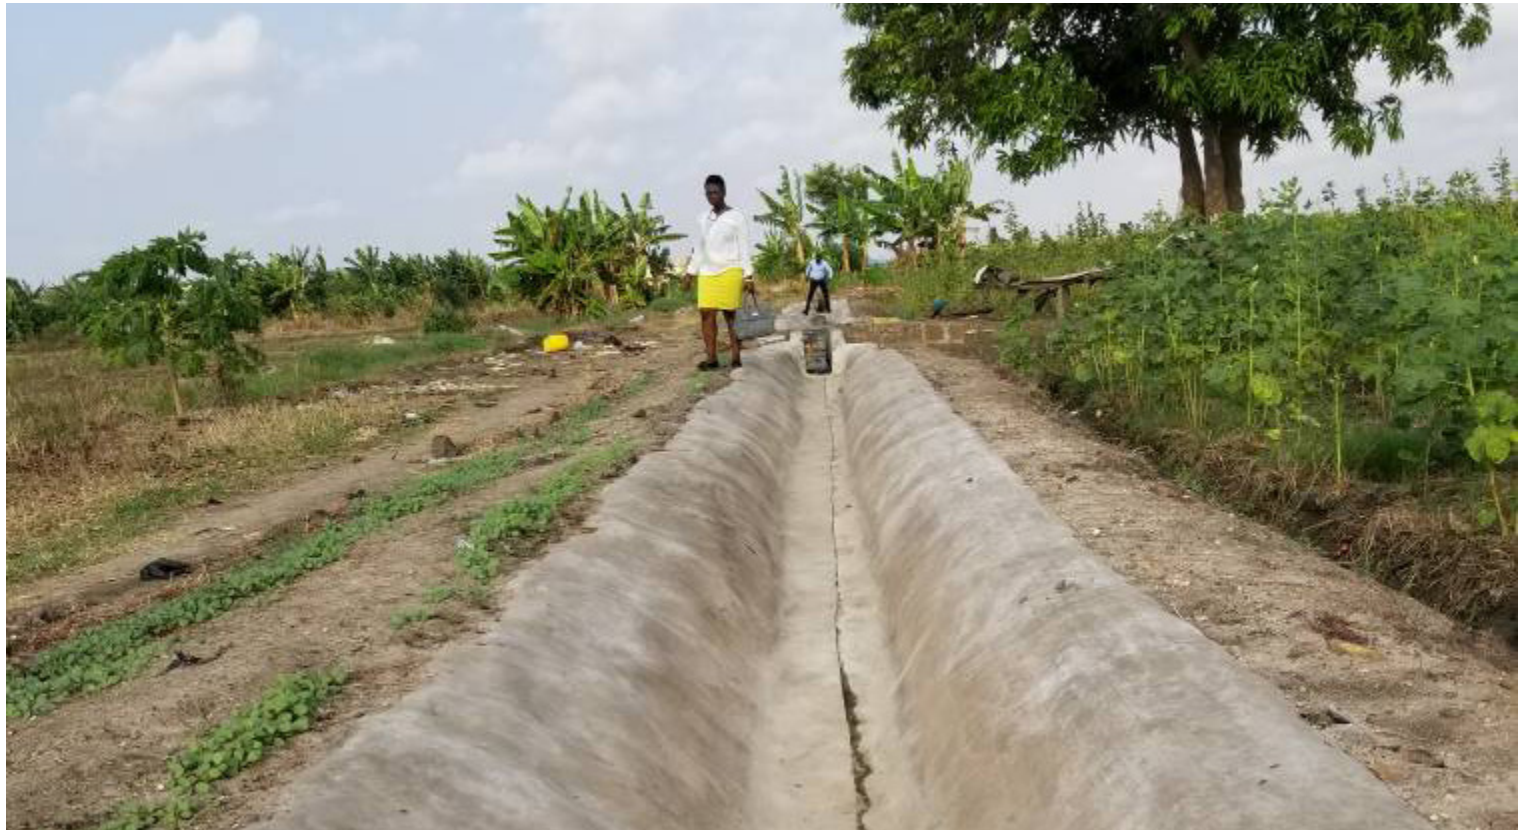
*Completed longitudinal section of channel*
