In June 2017, Concrete Canvas® GCCM* (CC) was used to line a series of drainage channels to divert surface water around a remediated contaminated spoil site at the Avoca Mines in Wicklow, Ireland.

CHANNEL LINING

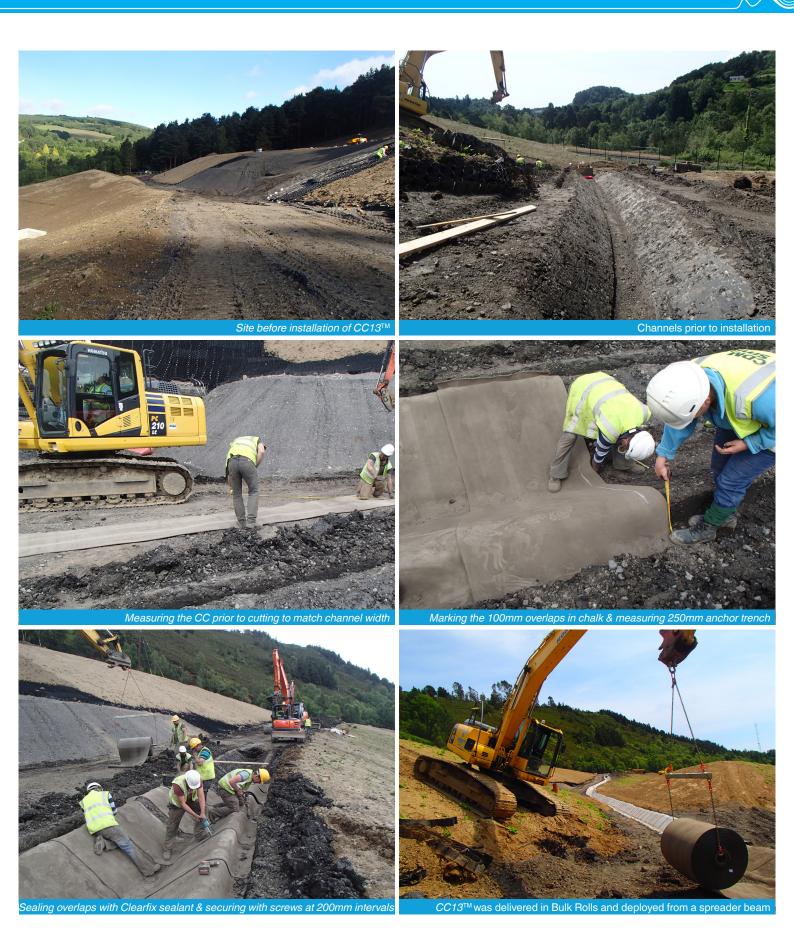
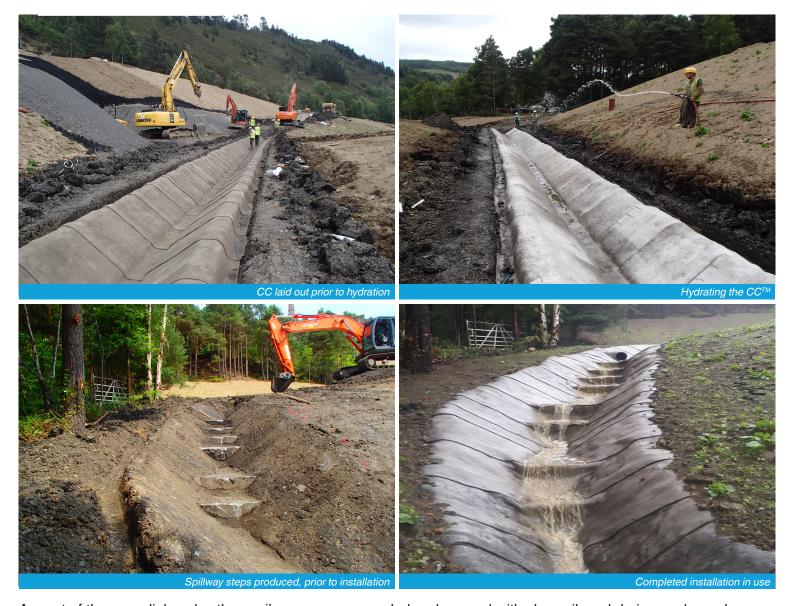
As part of the remedial works, the spoil areas were regraded and capped with clay soil, and drainage channels were installed at the boundaries around the site to redirect upstream drainage around the capped area on site instead of through it.

The original design used a combination of precast concrete channels and a HDPE liner/rip rap channel. In order to reduce long lead in times for the precast concrete and construction risk associated with steep slopes, Priority Construction Ltd. proposed CC as an alternative.

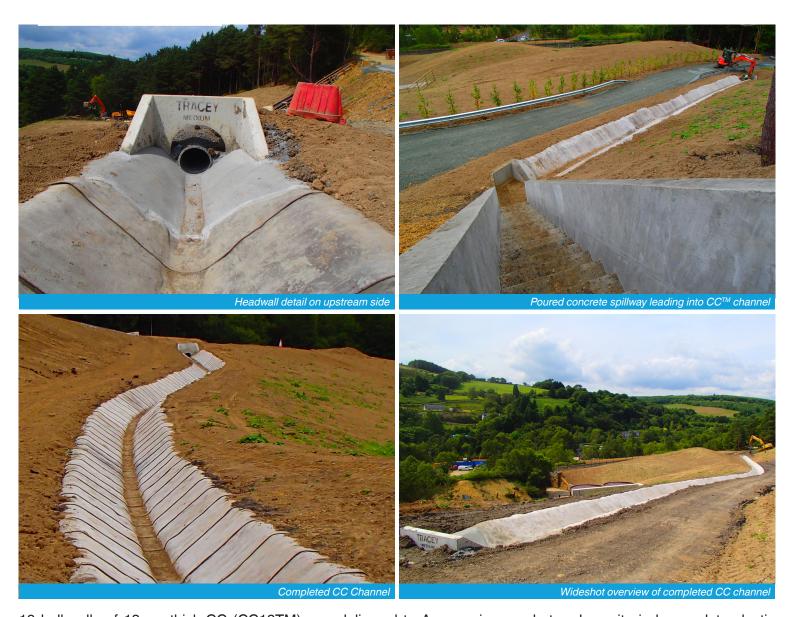
19 bulk rolls of 13mm thick CC (CC13TM) was delivered to Avoca mines and stored on site in heavy duty plastic sheeting. Prior to installation, the channel was excavated and compacted to profile using a 20T excavator and V bucket. A 250mm x 250mm anchor trench was created on either side of the channel to allow the leading edge of the CC to be buried so as to prevent any undermining. The CC was mounted onto a spreader beam and hung from an excavator, and was then unrolled before being cut to specific profile length with a utility knife and dragged into place, minimising material wastage.

Priority Construction Ltd. laid the CC transversely to accommodate changes in profile, overlapping layers by 100mm in the direction of water flow. The overlaps were sealed using a bead of Everbuild Clearfix adhesive sealant and screwed together at 200mm intervals with 30mm stainless steel screws. 250mm steel ground pegs were inserted through each overlap in the anchor trenches on either side of the channel and the anchor trench was then backfilled with material as an extra precaution against undermining.

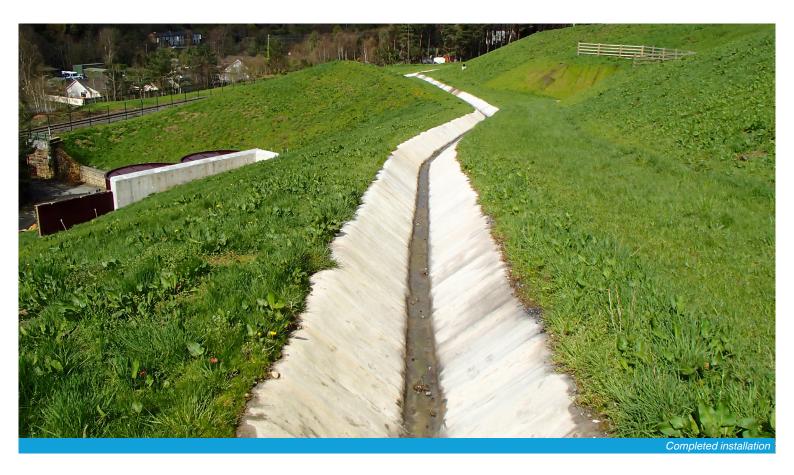
In total, 1,520m2 of CC13[™] was installed within 2 weeks and will provide long-term scour protection and erosion control for the network of drainage channels on the site.

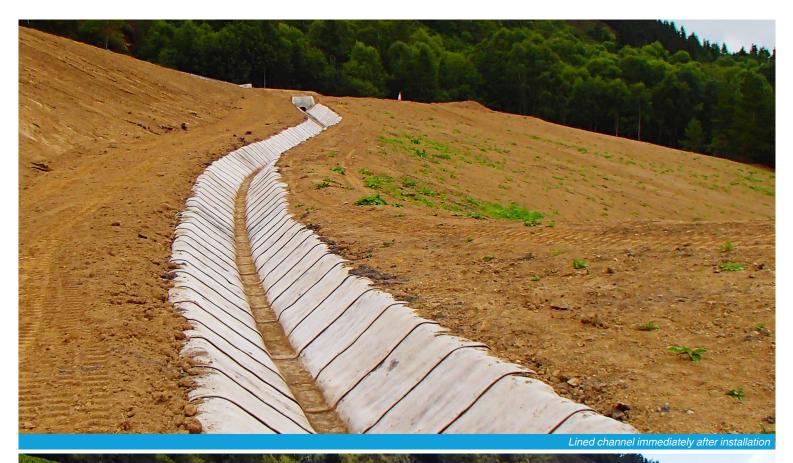
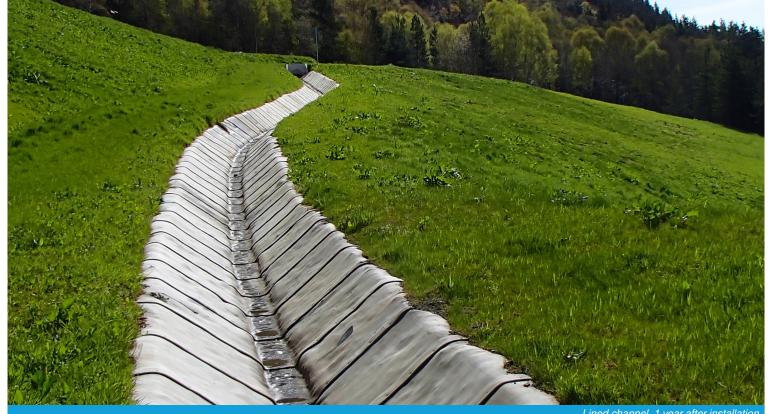
Despite the steep and varying slopes and difficult to access areas on site, the contractor achieved installation rates of over 200m2 per day. Following the success of this installation, Concrete Canvas (CC) is now being considered for multiple projects in the same region in both the public and private sectors.
