CC5™ Bulk Rolls

La Serena, 4th Region,
Chile

CC5™ was used to line
an irrigation channel to
eliminate water loss

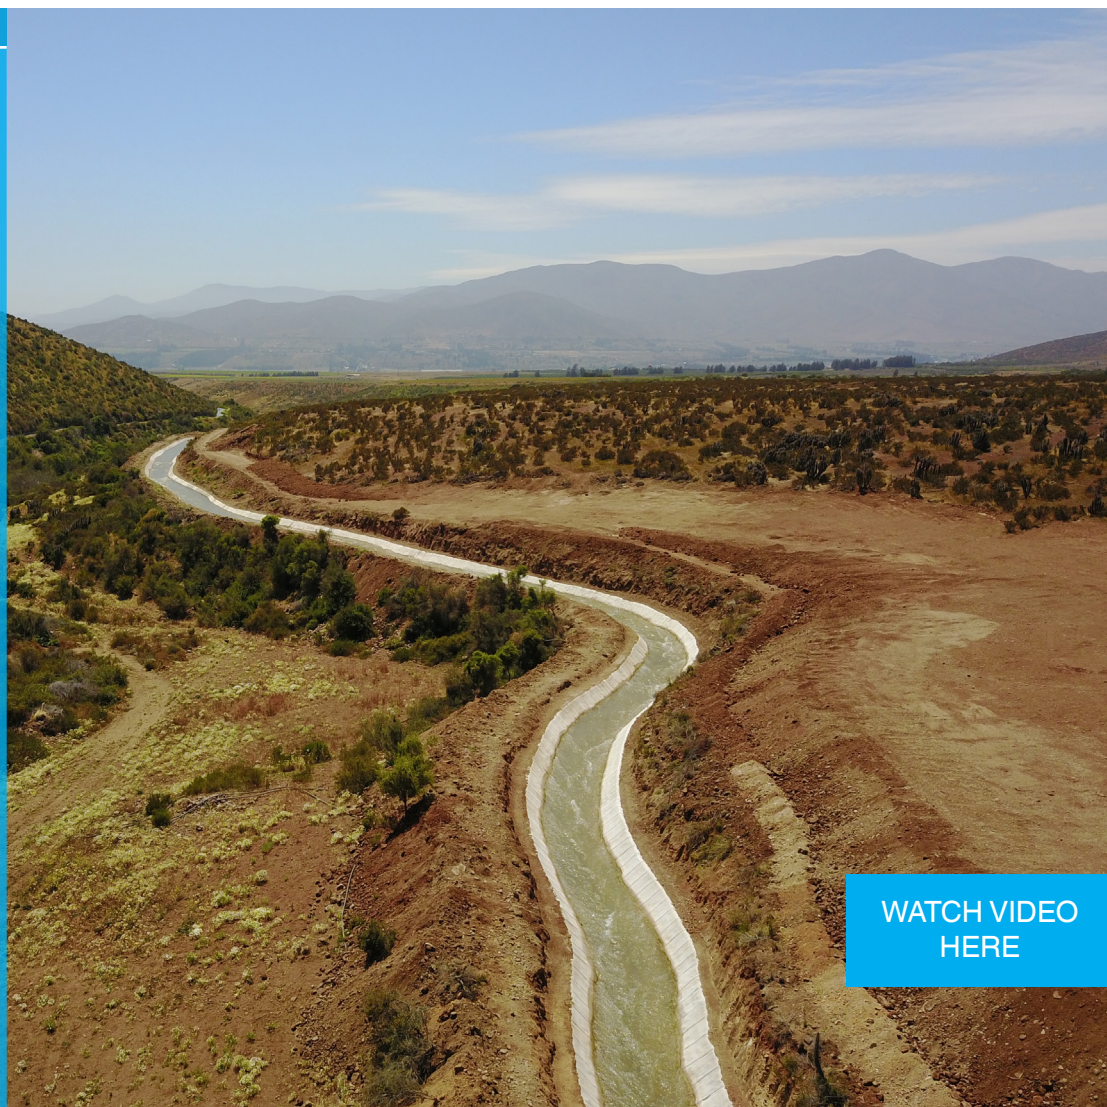
Section of completed channel

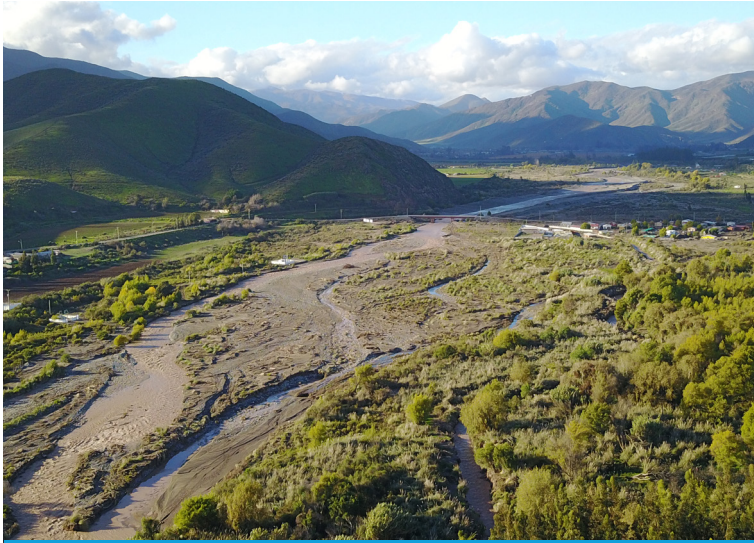
Site prior to works

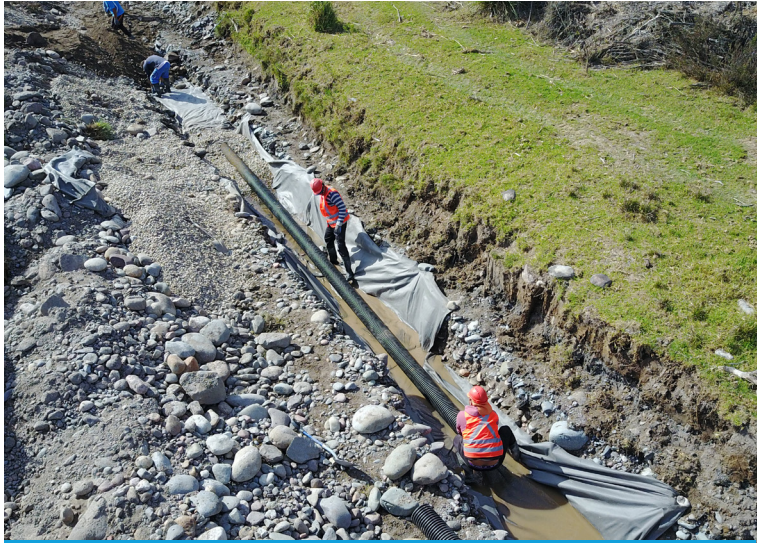
Water pumped from existing channel prior to works

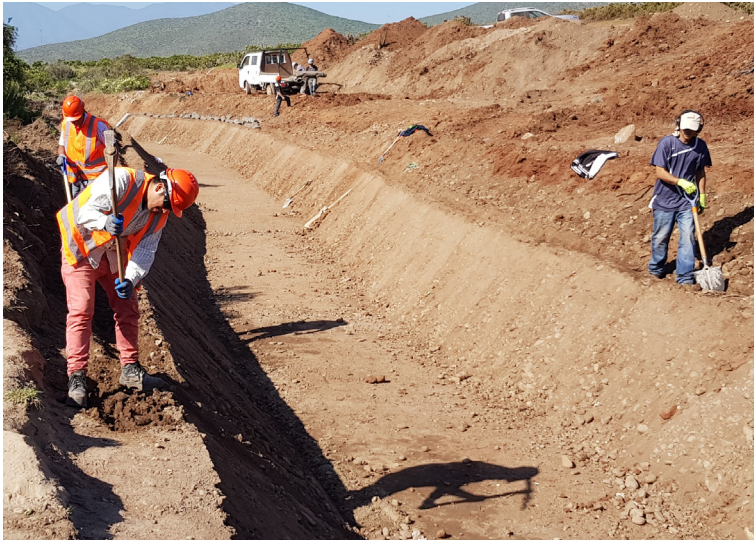
Removal of rocks and debris following excavation of channel

In preparation for the installation, the soil was replaced with a stabilised material, compacted and graded using channel forms to give an accurate shape according to the engineering design. The CC5 was delivered to site in bulk rolls which were loaded onto spreader beams and excavators. The material was unrolled transversely across the width of the channel, the edges fixed in anchor trenches using ground pegs and subsequent layers overlapped by 100mm and jointed using screws and polyurethane sealant to prevent ingress. Where the CC met existing concrete infrastructure, concrete screws were used to secure the material, and sealant was then used along the edge of the material, and over the screws to prevent ingress and eliminate any protrusions.

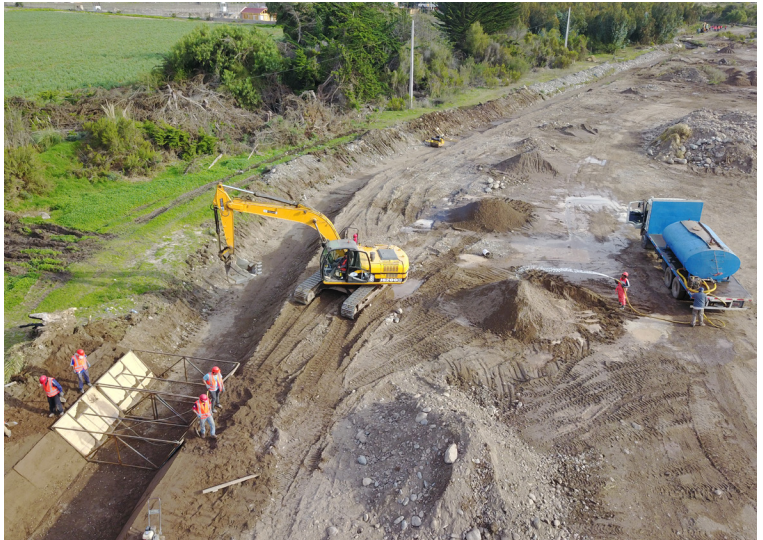
Excavation and formwork grading carried out in tandem

A team of anywhere up to 70 installers worked on the project at any one time, working on the 2.4km channel in sections, with 3 ground works forms, 11 backhoes, three 20T excavators and spreader beams available on site. While one team worked on re-grading and preparing the substrate, another team was laying material on a section of channel that the preparation team had just completed, and another team worked behind them hydrating the completed installation sections, and so on. This allowed the installation to progress at a much quicker rate than it otherwise would.

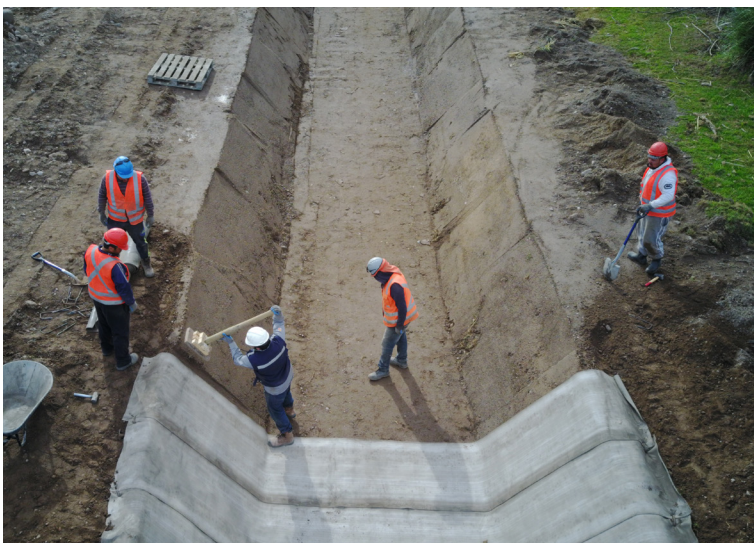
Laying of CC following completion of channel grading

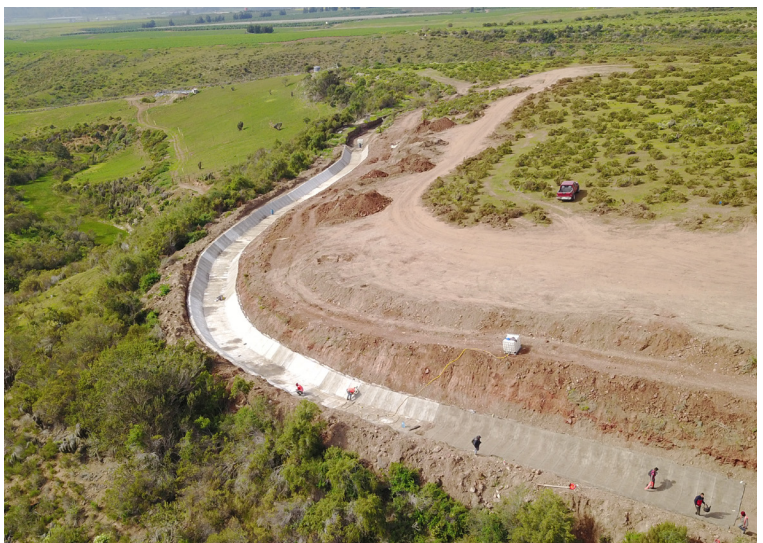
A section of CC being laid behind a section of hydrated CC

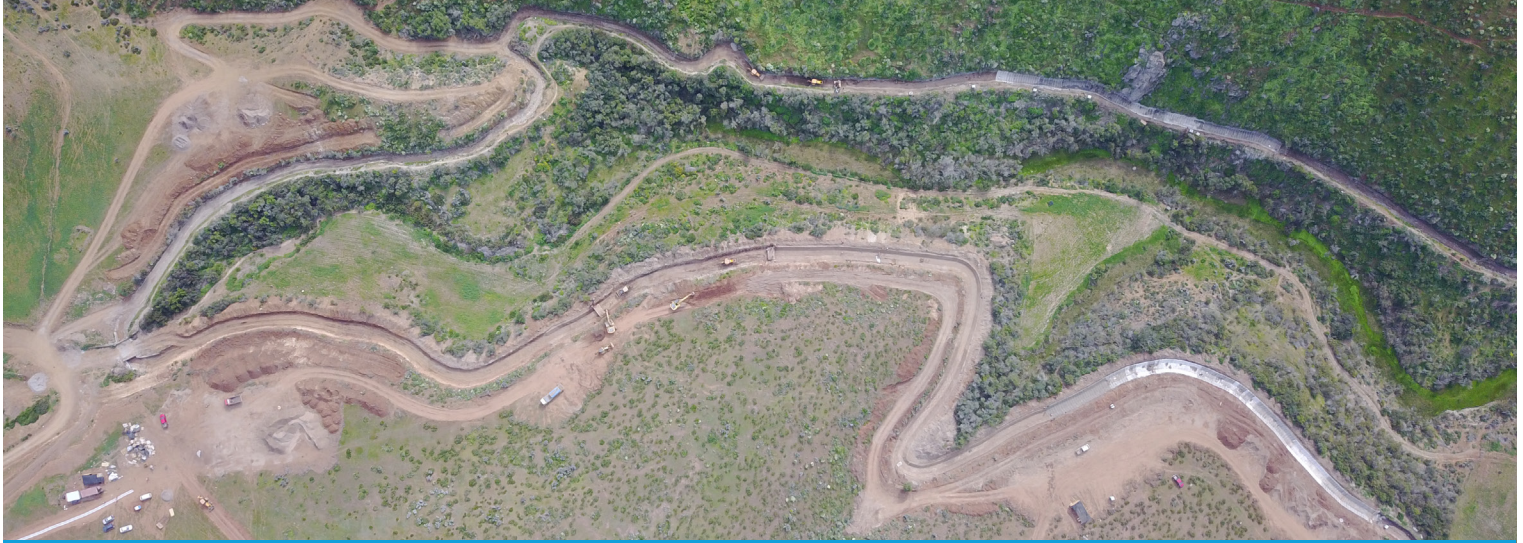
Aerial view of ongoing works shows various teams working on different sections of channel in stages

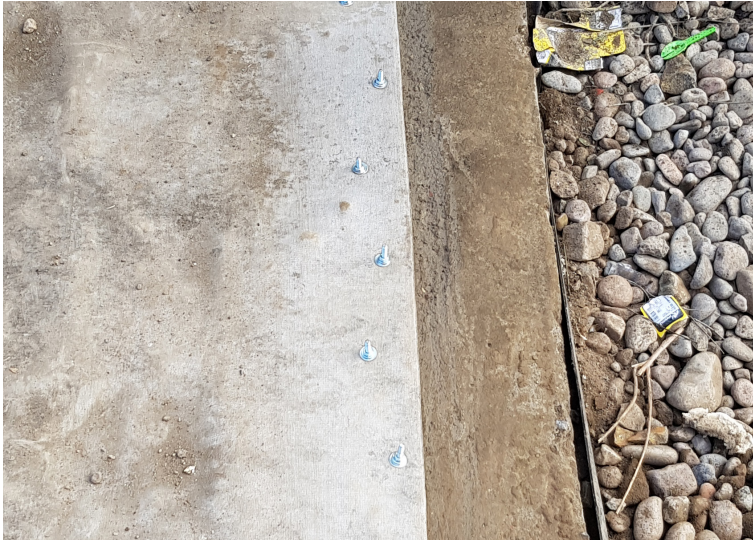
CC secured to concrete infrastructure using concrete screws

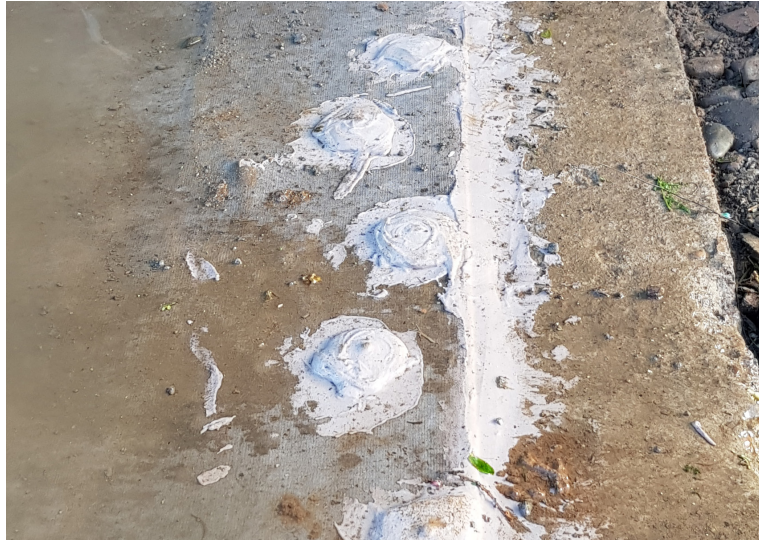
Sealant used to cover screws and prevent ingress at edges

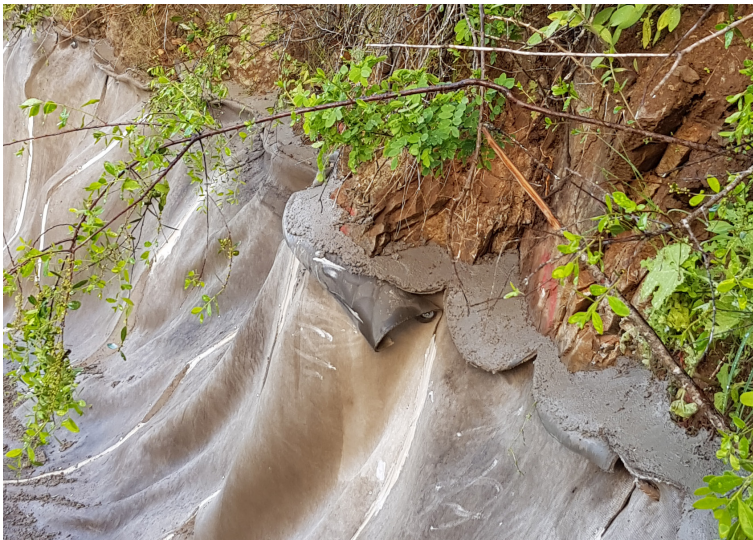
Polyurethane sealant used to fill the CC edges

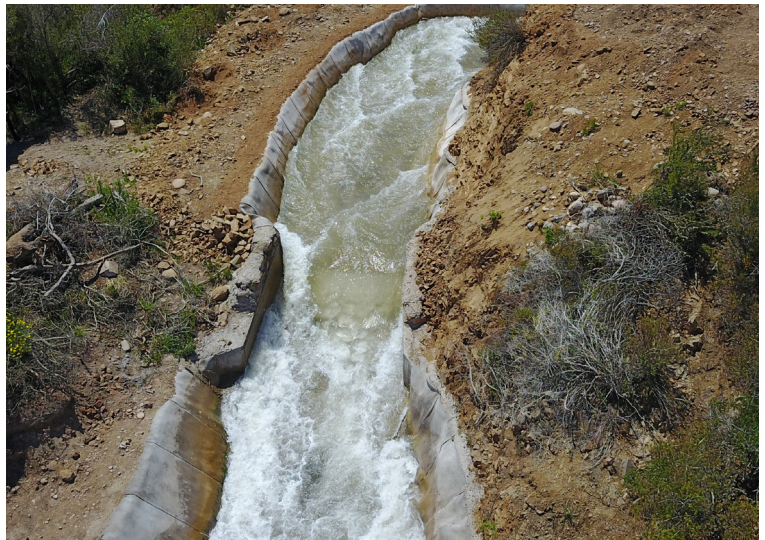
CC easily conformed to changes in channel profile

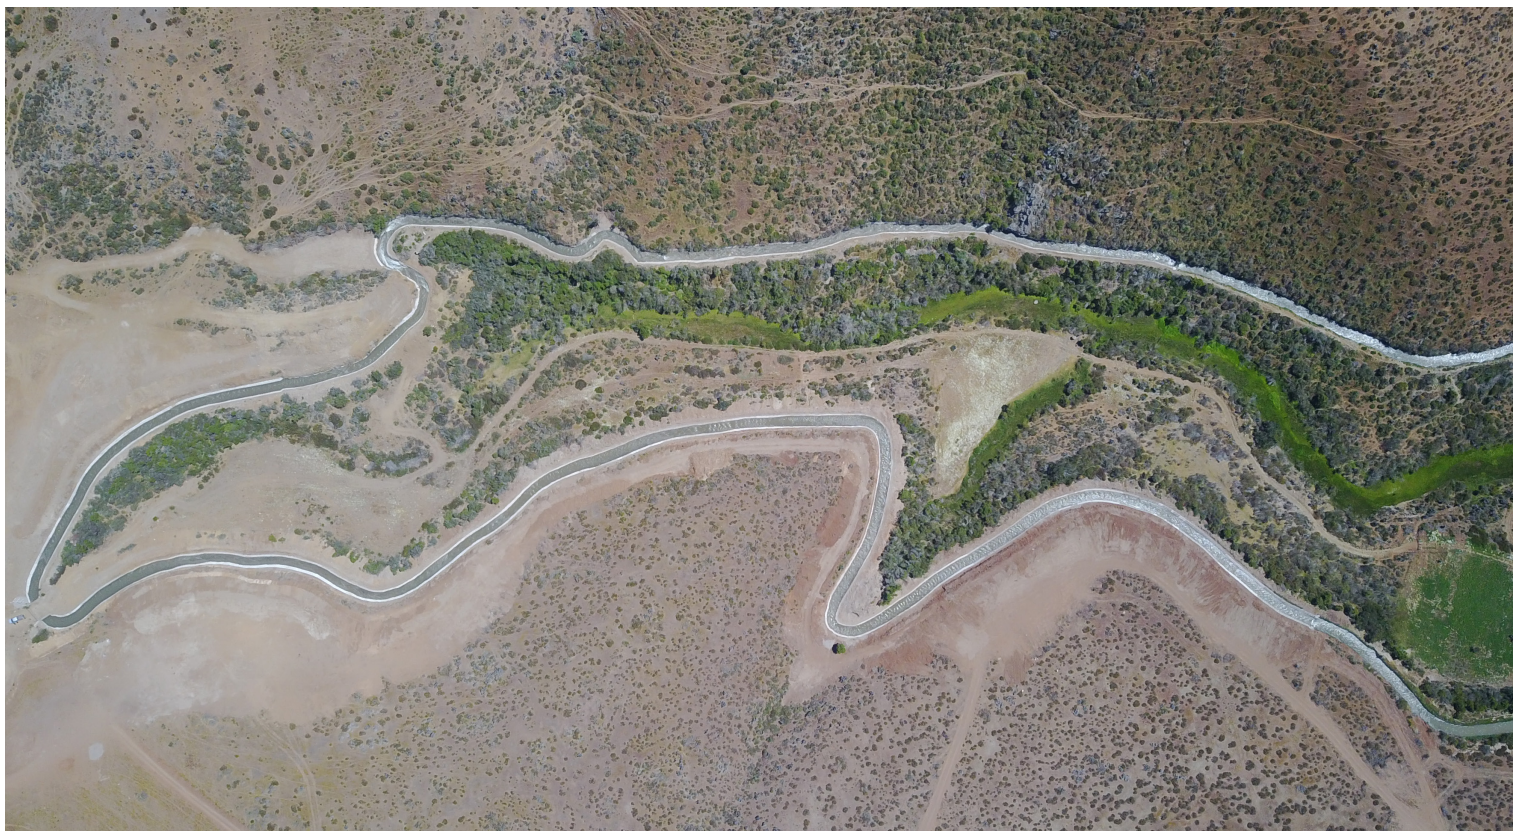
Aerial view of completed channel

A total of 18,000m² of CC5™ was installed in 40 days, with the team working around 9 hours each day. Due to the way this project was carried out, with multiple smaller teams working at once in stations along the channel, the project was finished on time. As a result of the project's success, the client has specified CC for another project, and more similar projects with other clients have been specified as a direct result of the Bellavista Channel.
