CC8™ Bulk & Batched Rolls

Coalcleugh, Hexham, Northumberland, UK

CC8™ was installed as an erosion control solution for a newly formalised channel on a mine adit site

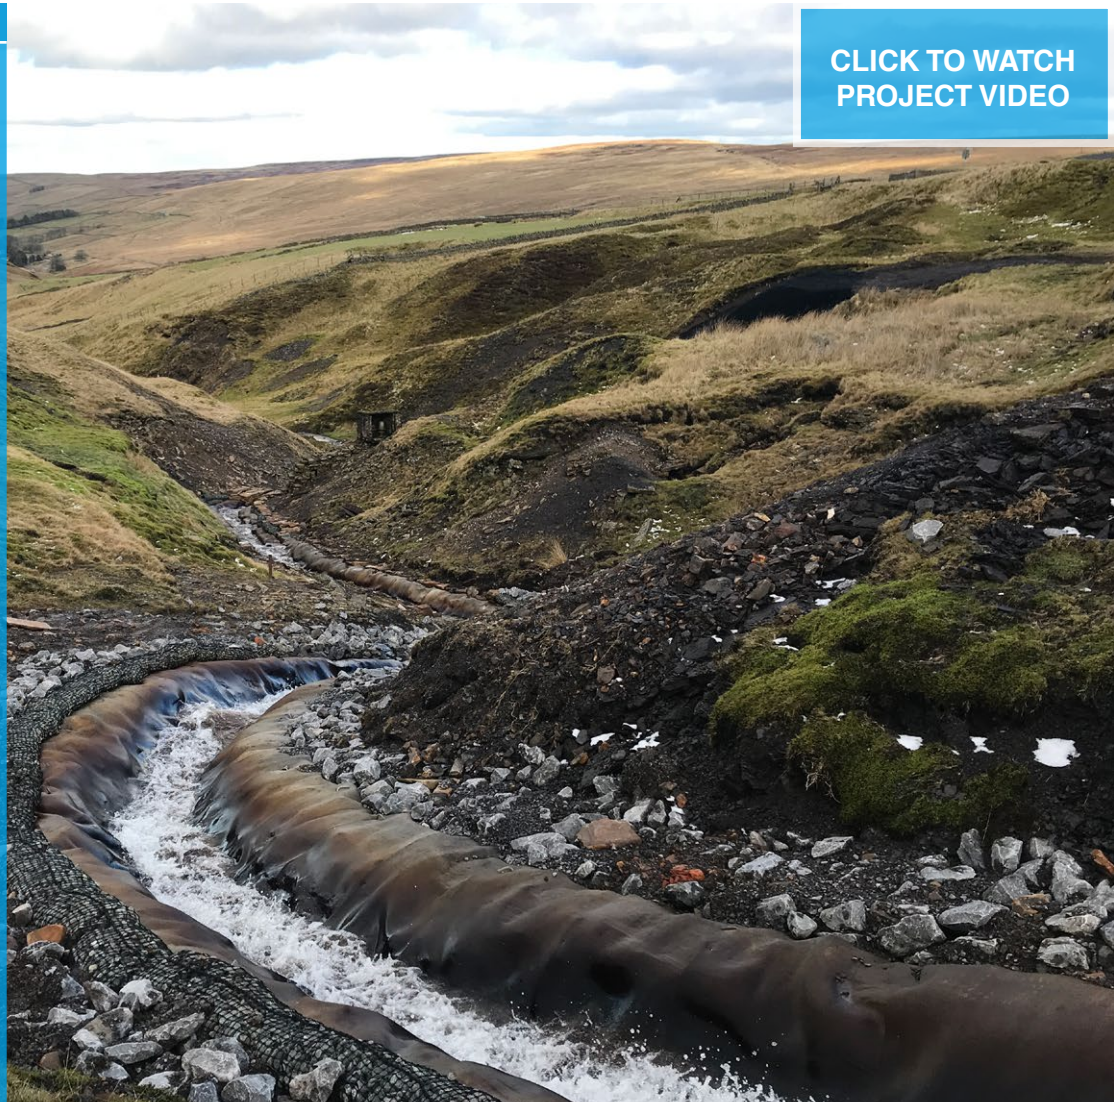
*Upstream view of the completed CC lined channel*

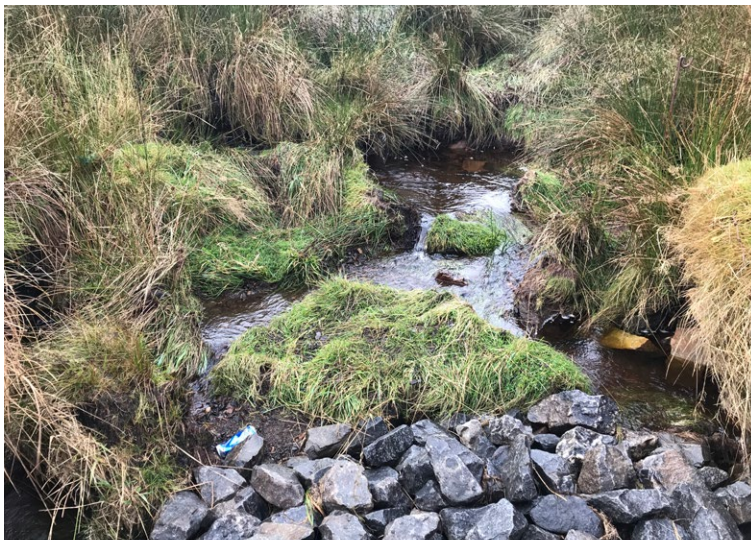
*Channel prior to formisation*

The ground conditions on the project site were very difficult as the channel had been eroded away over time. A small excavator was used to create the profile of the channel as per the designs, while rock rolls were then used to create the exact shape of the channel where the excavator was unable to reach to profile the channel to the correct dimensions.

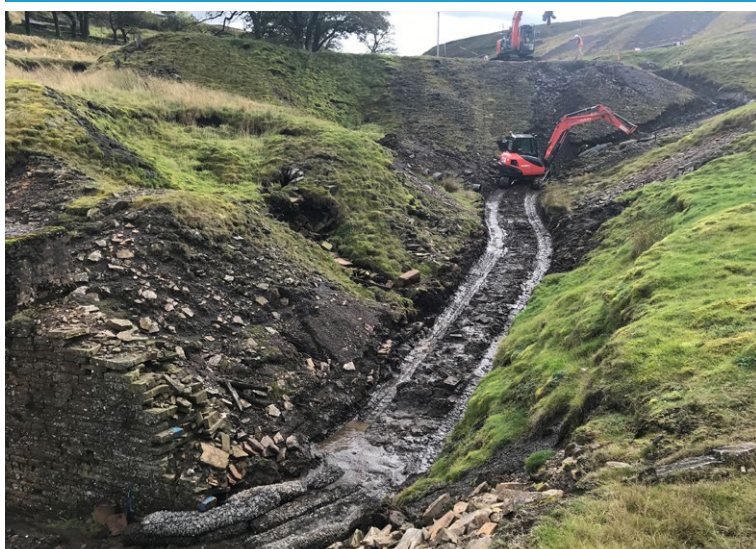
*Small excavator used to create the channel profile*

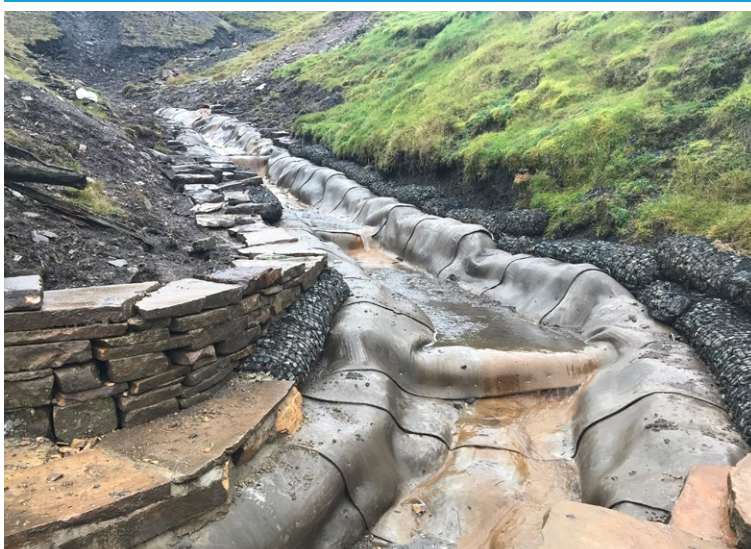
*Installation began downstream, working up the channel*

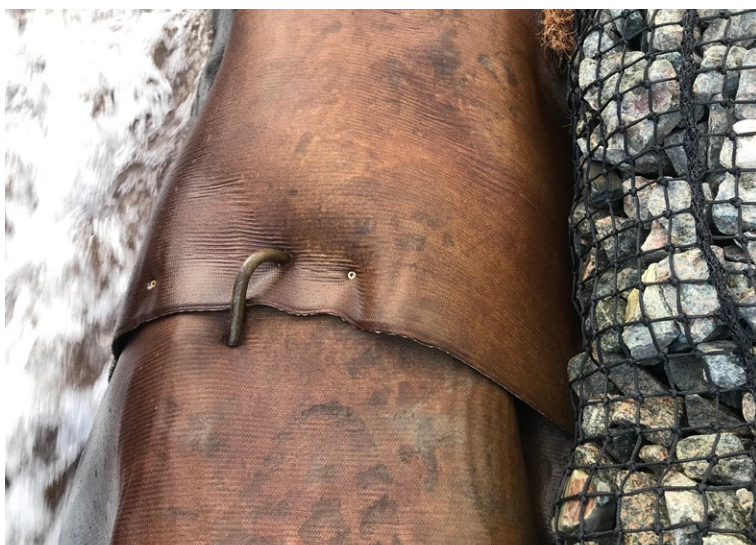
*Ground pegs secured CC to substrate and screws used to joint overlaps*

The material was laid transversely with stainless steel screws used to joint the overlaps at 200mm centres. At the end of the channel, the material was terminated into a drystone wall and at the top of the channel, the material was terminated into a sandbag headwall. Where traditional anchor trenches could not be formed, rock rolls were placed on top of the material and secured in place using metal stakes to secure the edge of the material. Where anchor trenches had been prepared, the CC edges were captured using ground pegs and then backfilled. Water was constantly flowing through the stream, which was diverted during the placement of CC but provided an easy solution for hydration of the material, removing the requirement for sending a bowser to site.

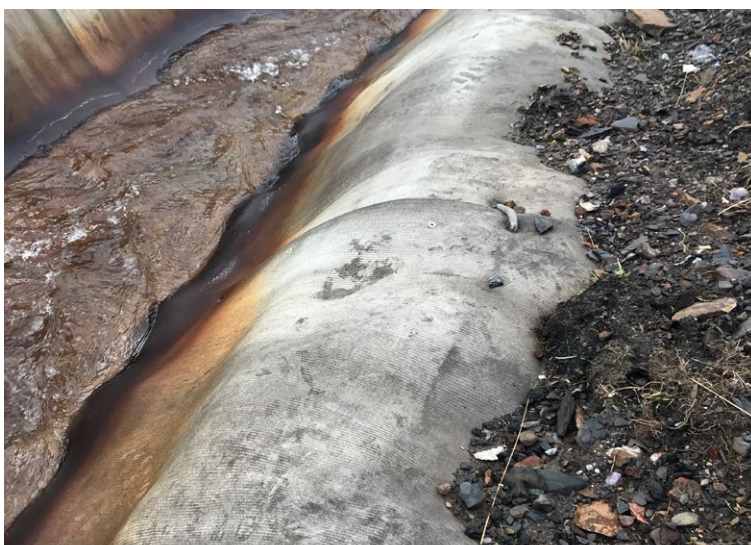
*Anchor trenches used to capture CC edges where possible*

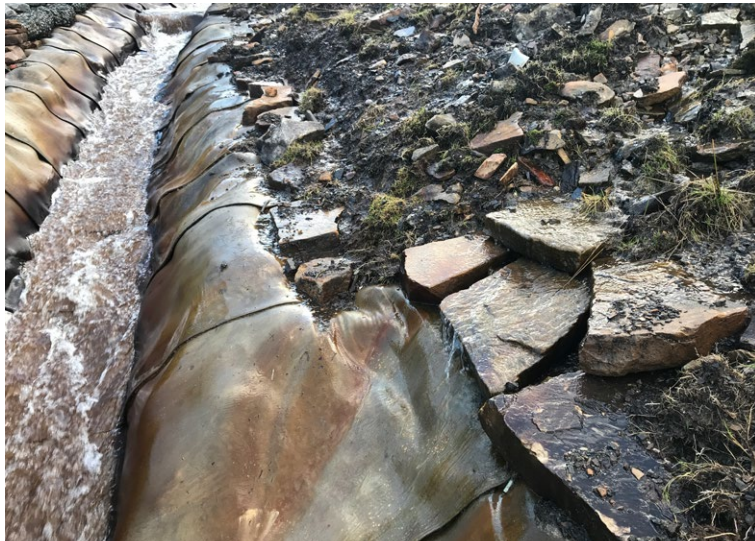
Where anchor trenches were not possible, rock rolls and stones were used

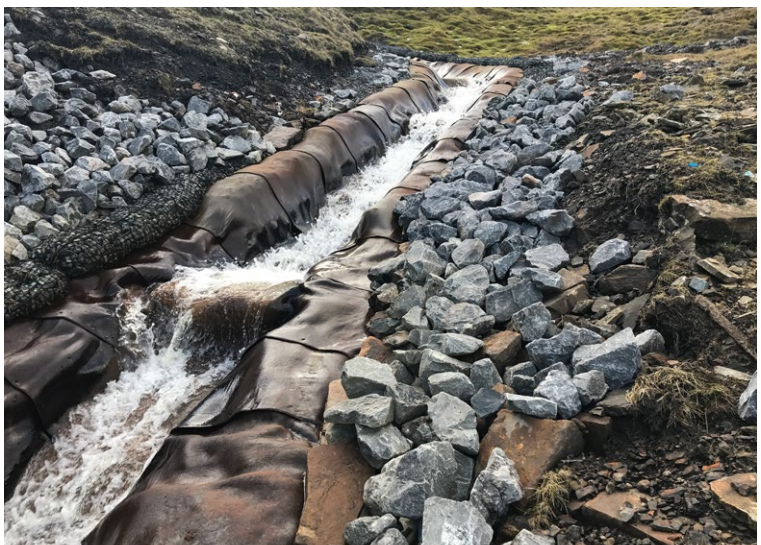
CC provides erosion control, particularly in high flow events

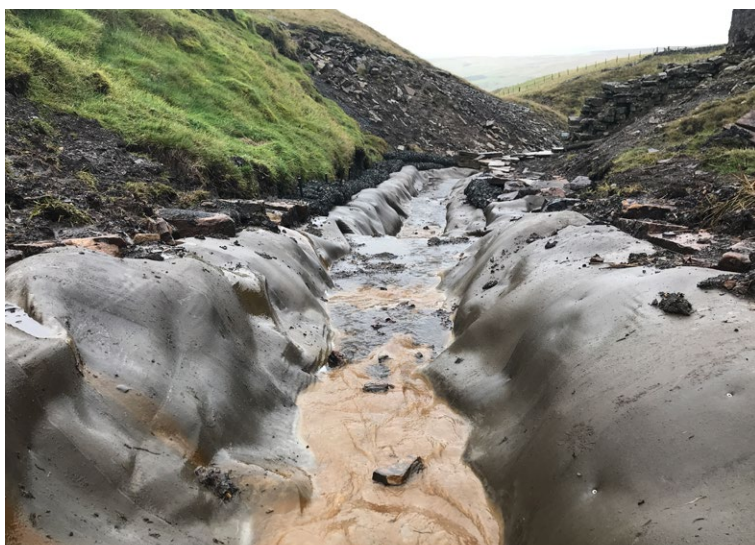
Upstream view of channel - CC able to conform to varying channel profile

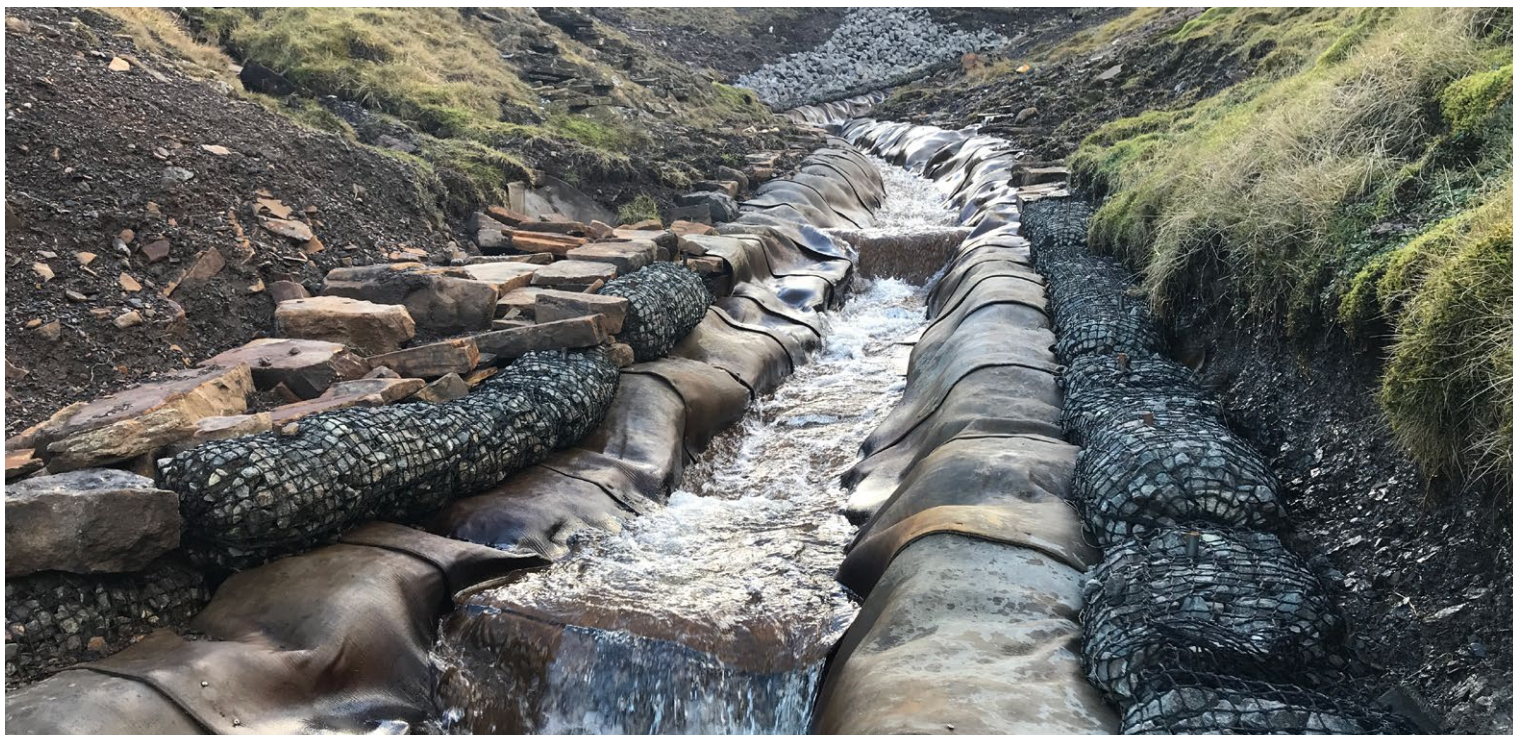
*The site was revisited five months after the installation - the CC had begun to blend in with its surroundings and was performing as expected*
