CC8™ (Type II) and
CC13™ (Type III)
Bulk Rolls

Eagle Gold Mine, Yukon,
Canada

CC8™ (Type II) and
CC13™ (Type III) were
used to provide erosion
control and channel lining
to two spillways

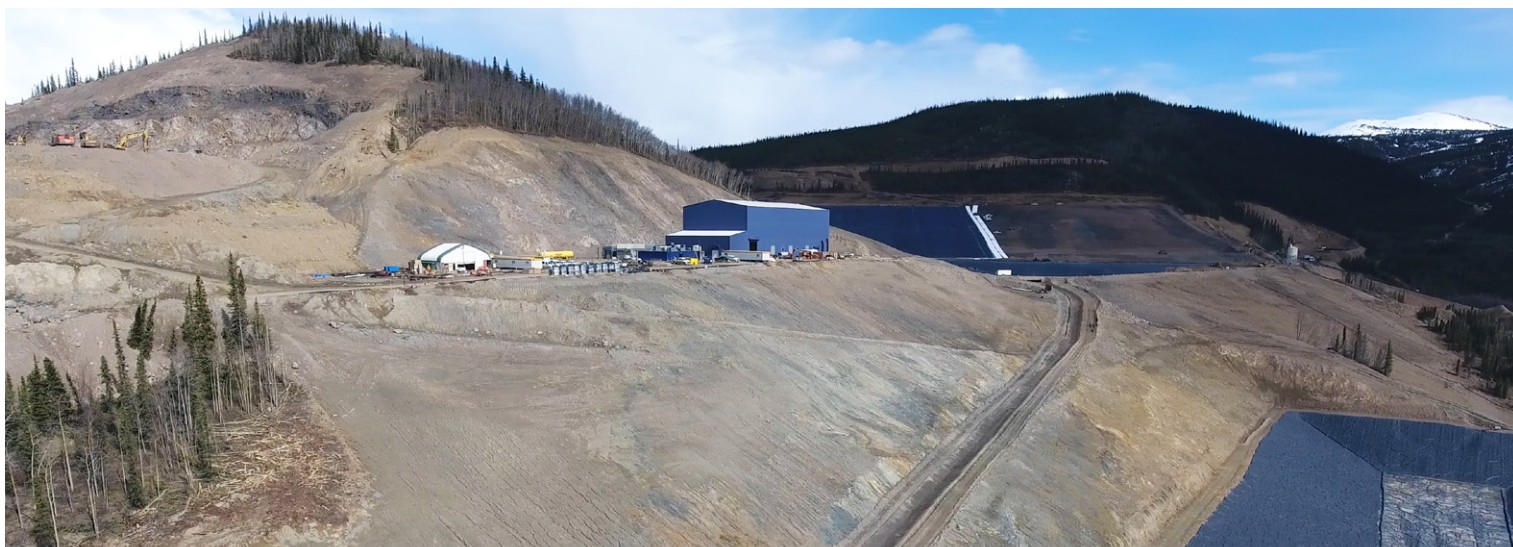
Main spillway

The main spillway is approximately 500m in length with profile sections of 5-8m at 7-15%. CC8™ (Type II) GCCM was used for fall sections of 7.5% and CC13™ (Type III) GCCM was used where the fall of the section increased to 15%.

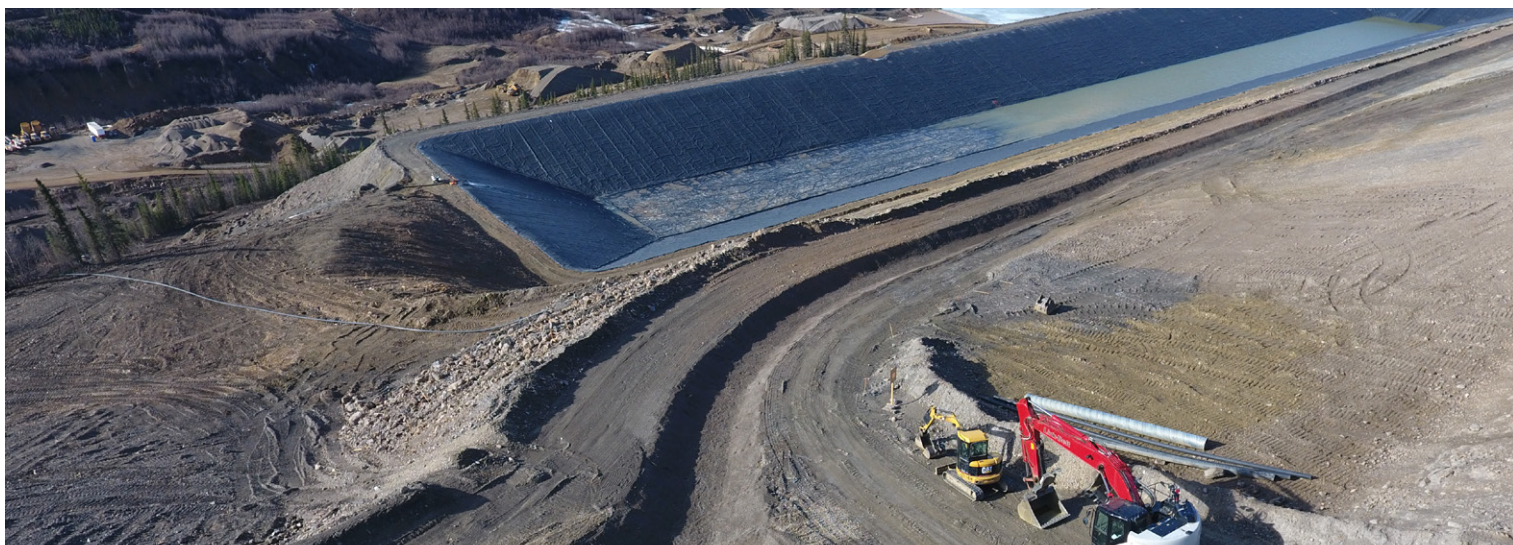
Main spillway channel to be lined with CC

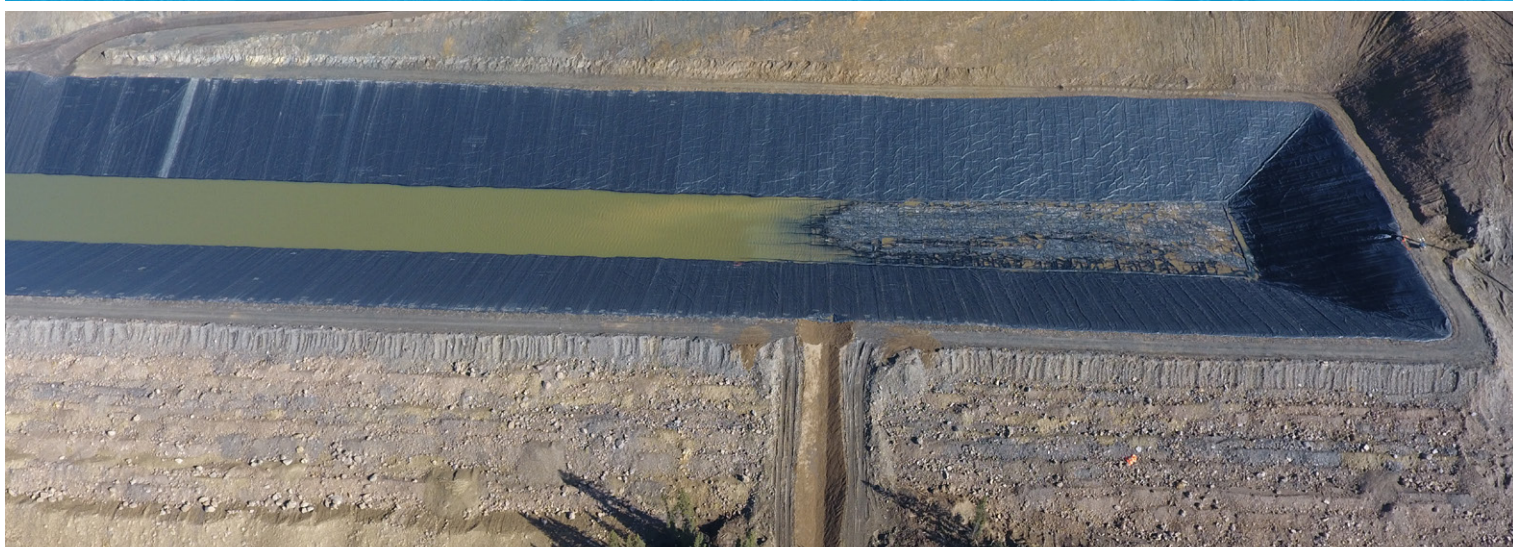
Emergency spillway channel to be lined with CC

The emergency spillway is approximately 140m in length of varying width at 50% gradient and lined exclusively with CC13™ as per the specification of the engineering consultant, BGC Engineering.

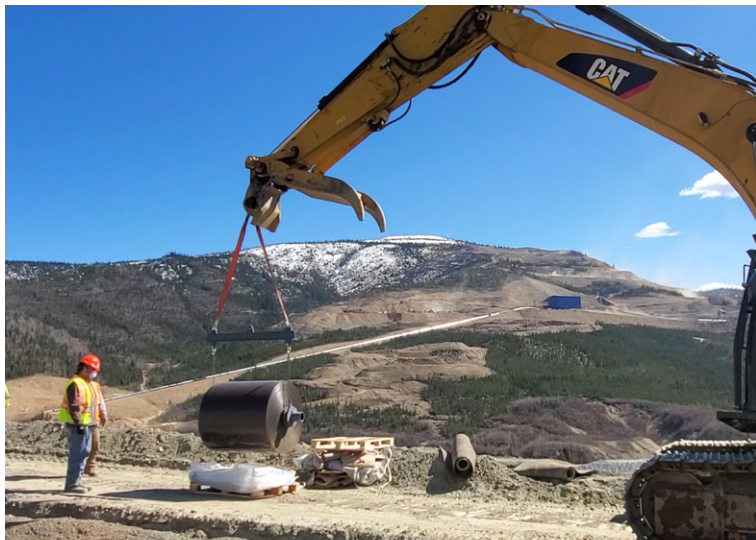
Bulk rolls of CC13 and CC8 deployed via spreader beam

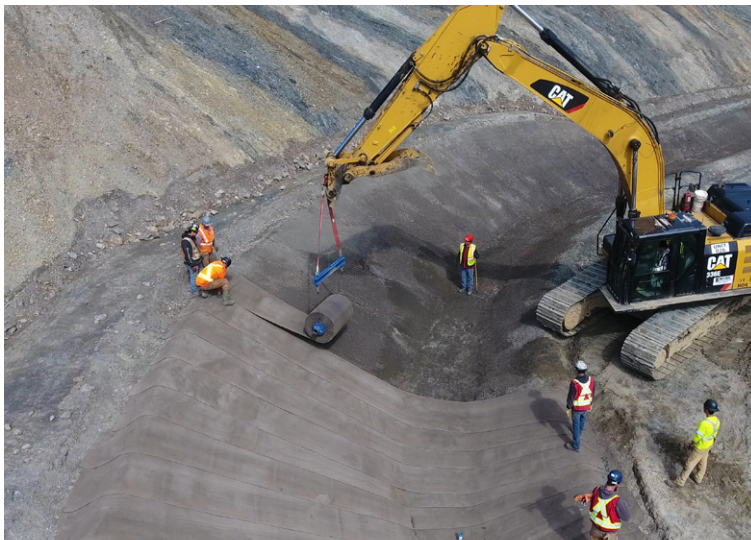
Installation starting downstream of main spillway.

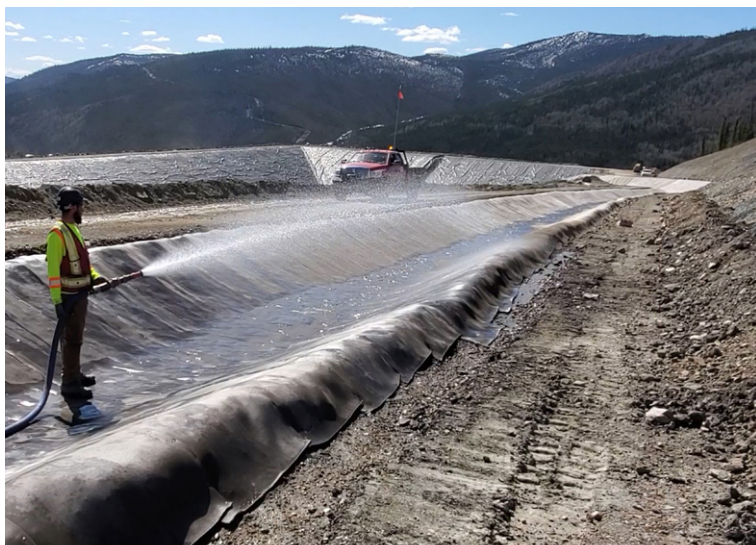
Hydration of the lined channel

The main spillway was installed using a standard CC screwed and sealed overlap joint; by hydrating the underlaps and applying an 8mm bead of Soudal 250XF adhesive sealant, then folding the overlap back into position and securing the material together using stainless steel screws at 200mm centres. The CC was secured in an anchor trench at the crest with ground pins before backfilling to prevent perimeter water ingress.

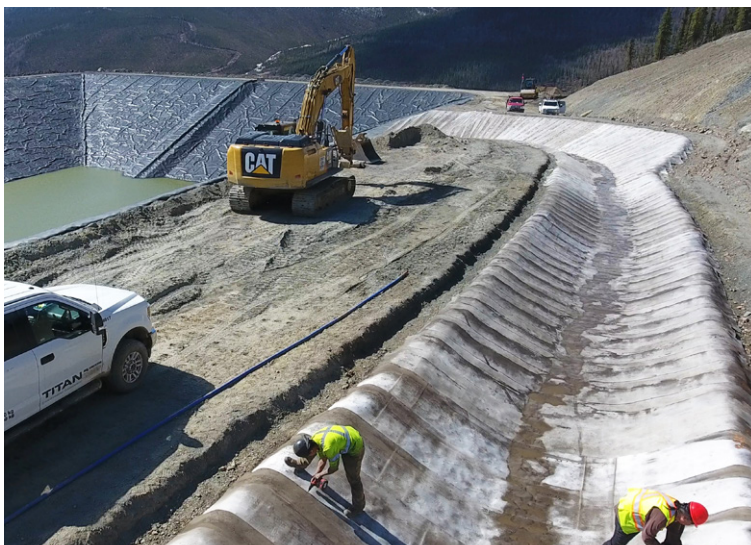
Joints were sealed and screwed for increased impermeability

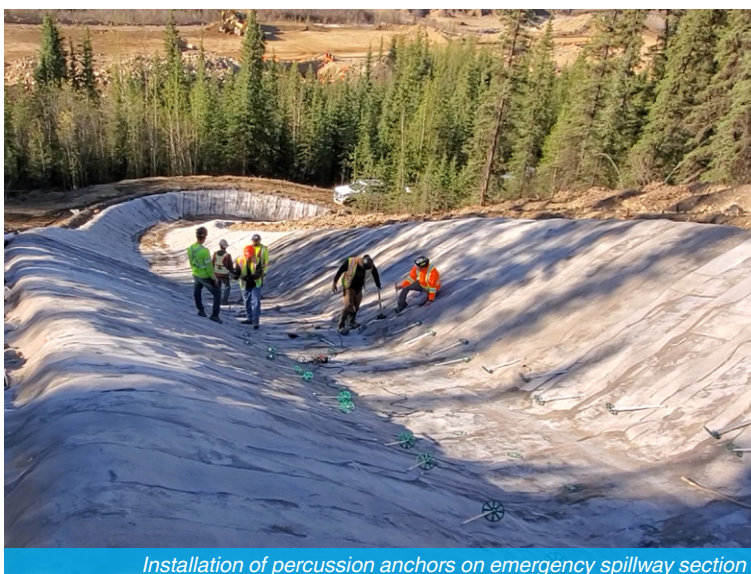
Installation of percussion anchors on emergency spillway section

BCG asked Concrete Canvas Ltd to review the hydraulic design of the spillways to advise on whether the CC material required intermediate fixings in order to resist the anticipated hydraulic shear forces. Concrete Canvas input site parameters into their hydraulic calculator. It was determined that the main spillway did not require intermediate fixings, but they were necessary for the emergency spillway due to the shear forces generated along the 50% channel gradient. Rock anchors were installed at 1.8m centres along each overlap joint for the main spillway section. At a 90° corner, anchor centres were no more than 0.5m apart.

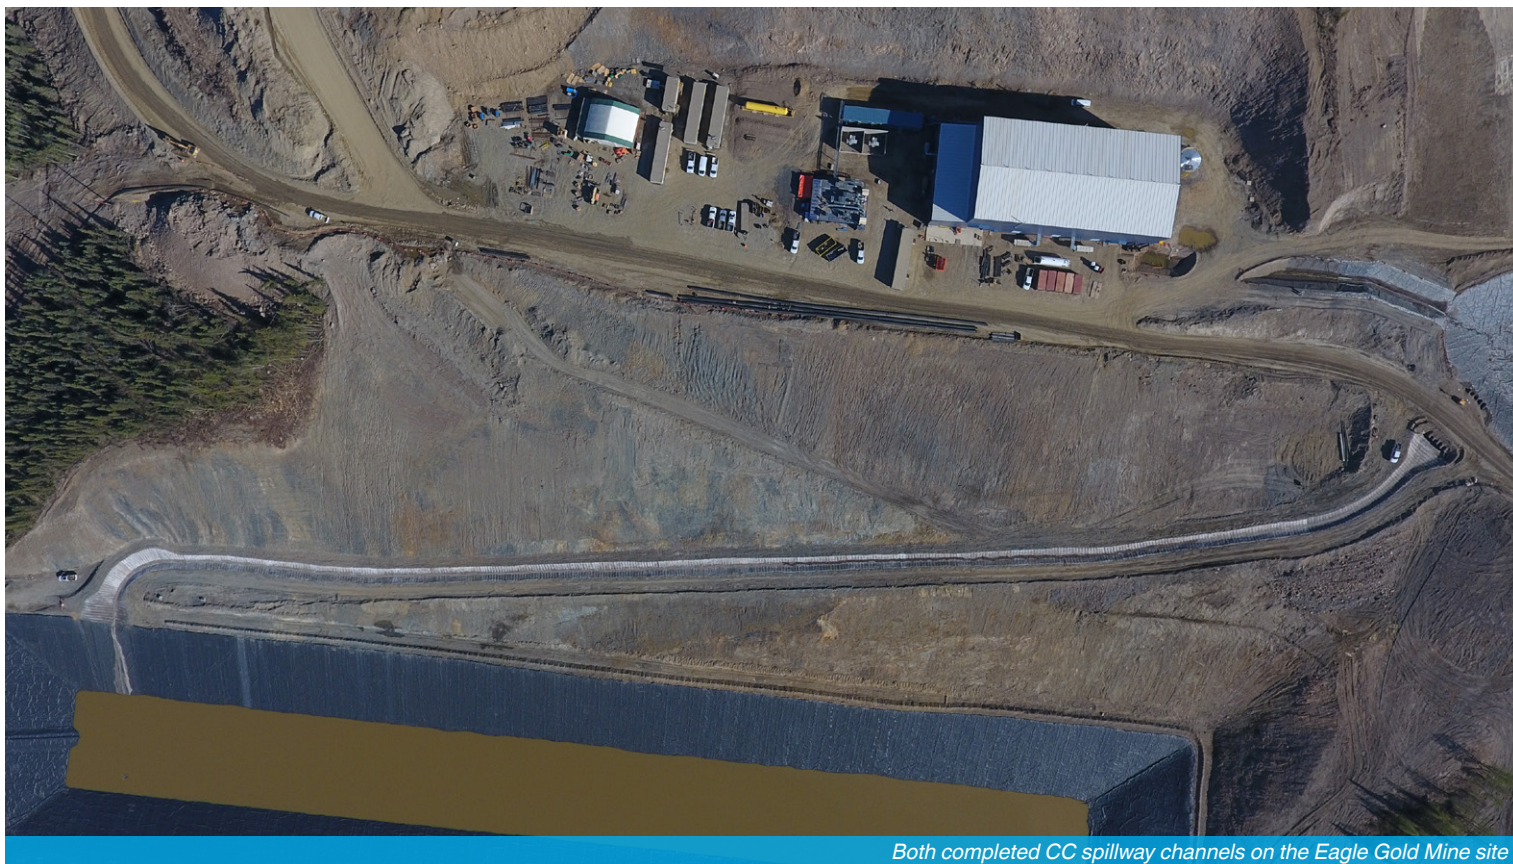
Both completed CC spillway channels on the Eagle Gold Mine site
