**Project Info**

CC8™ Bulk Rolls
-

64th Arrondissement, Buzy, France
-

CC8™ used to line an earth channel on a slope adjacent to a railway line.

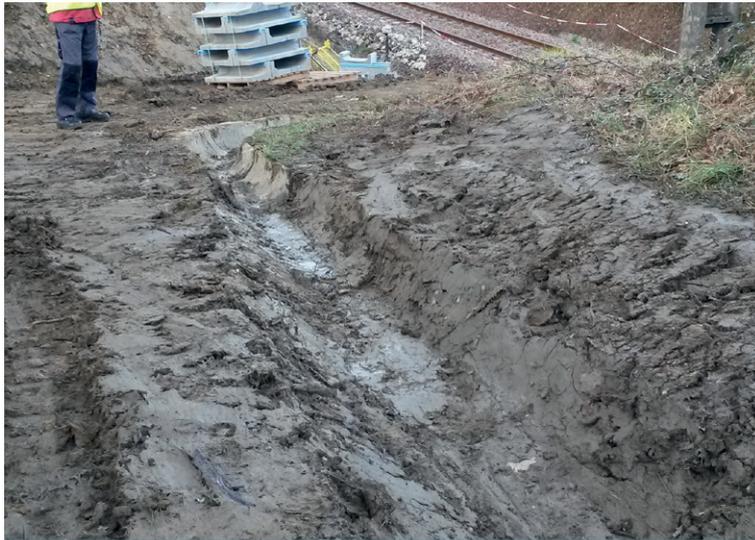
Graded channel prior to installation

Prior to installation, the channel was graded to profile. Heavy rains had caused the soil to become saturated which would have prevented the use of conventional concrete without damming and the use of a blinding layer. The properties of CC allow for installation even in difficult and damp conditions such as these. The material was mounted onto a spreader beam and unrolled down the length of the channel in two layers, with an overlap of 100mm created between them. The material under the overlap was hydrated with a 1000L bowser before it was sealed with Everbuild Clearfix Adhesive sealant and jointed with screws every 200mm. The rest of the material was then hydrated, with hydration repeated an hour later due to the high temperatures.

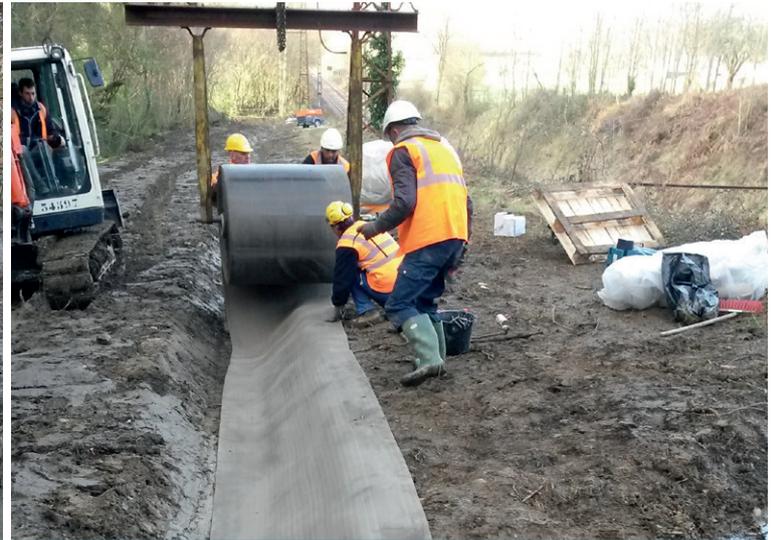
Unrolling first layer of CC

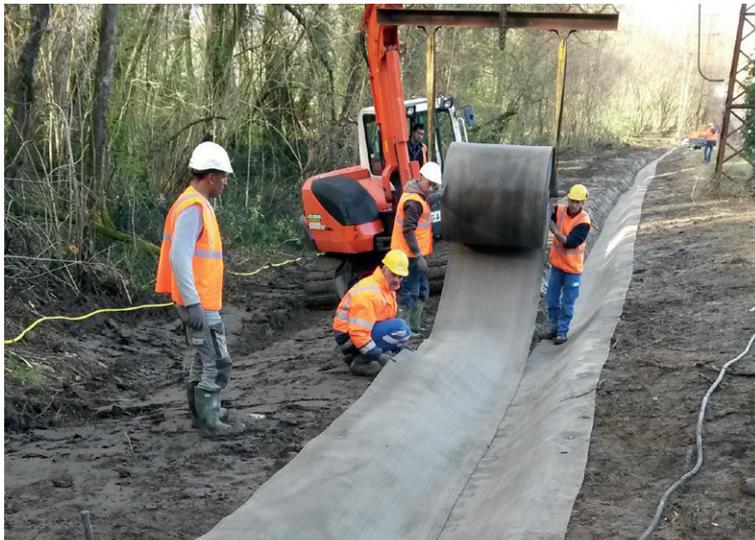
Edge of second layer overlapped the first by 100mm

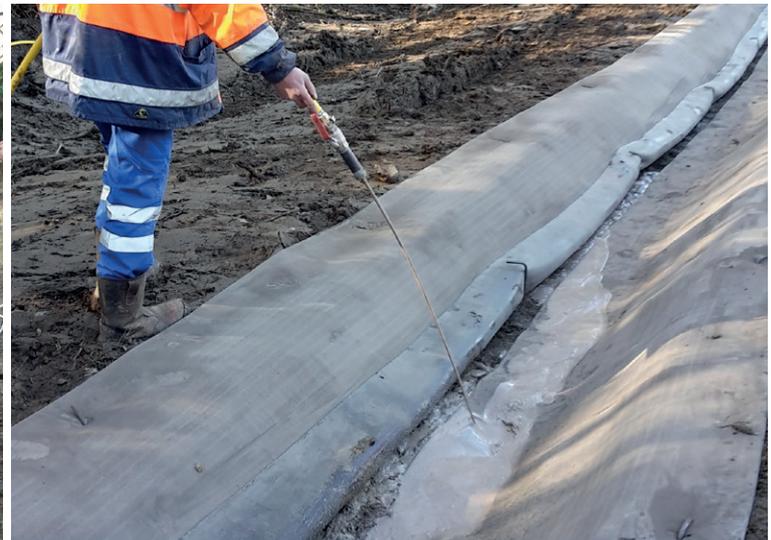
Hydrating under overlaps

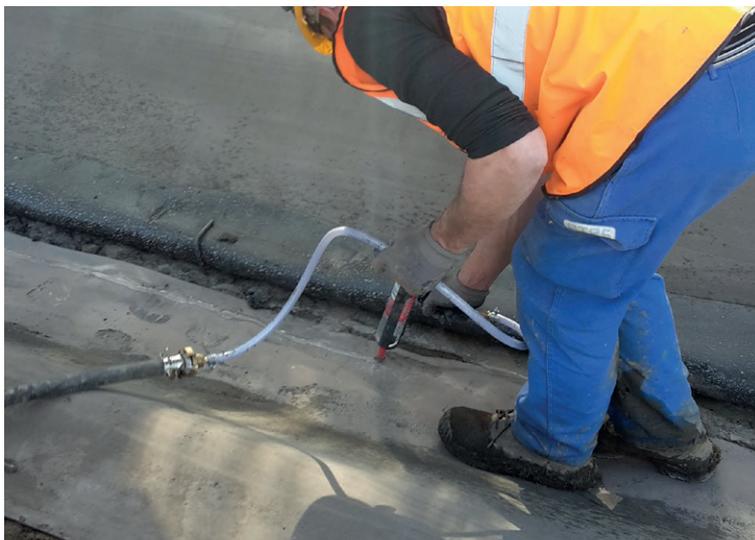
Sealing overlaps

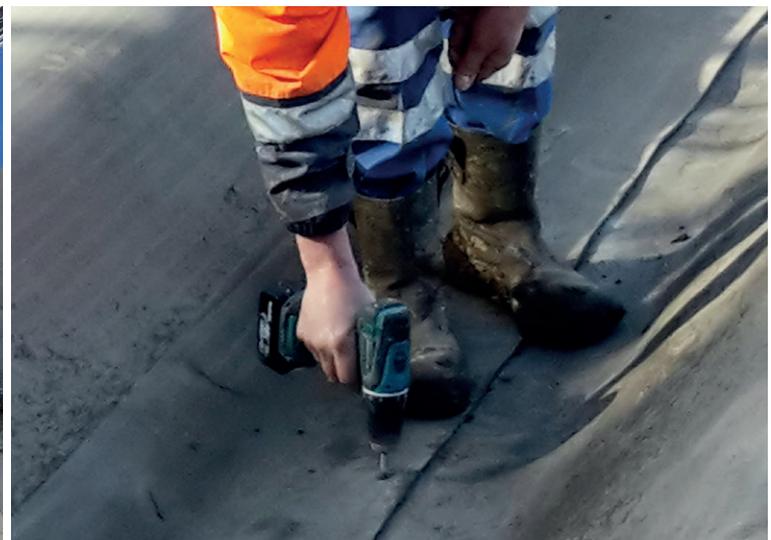
Screwing overlaps
