CC8™ Bulk Rolls

La Mina, Albania-La Guajira, Colombia.

2 Dissipater Channels were installed as part of a trial, to provide drainage, avoid erosion and measure the level of sediment that originates on the main road.

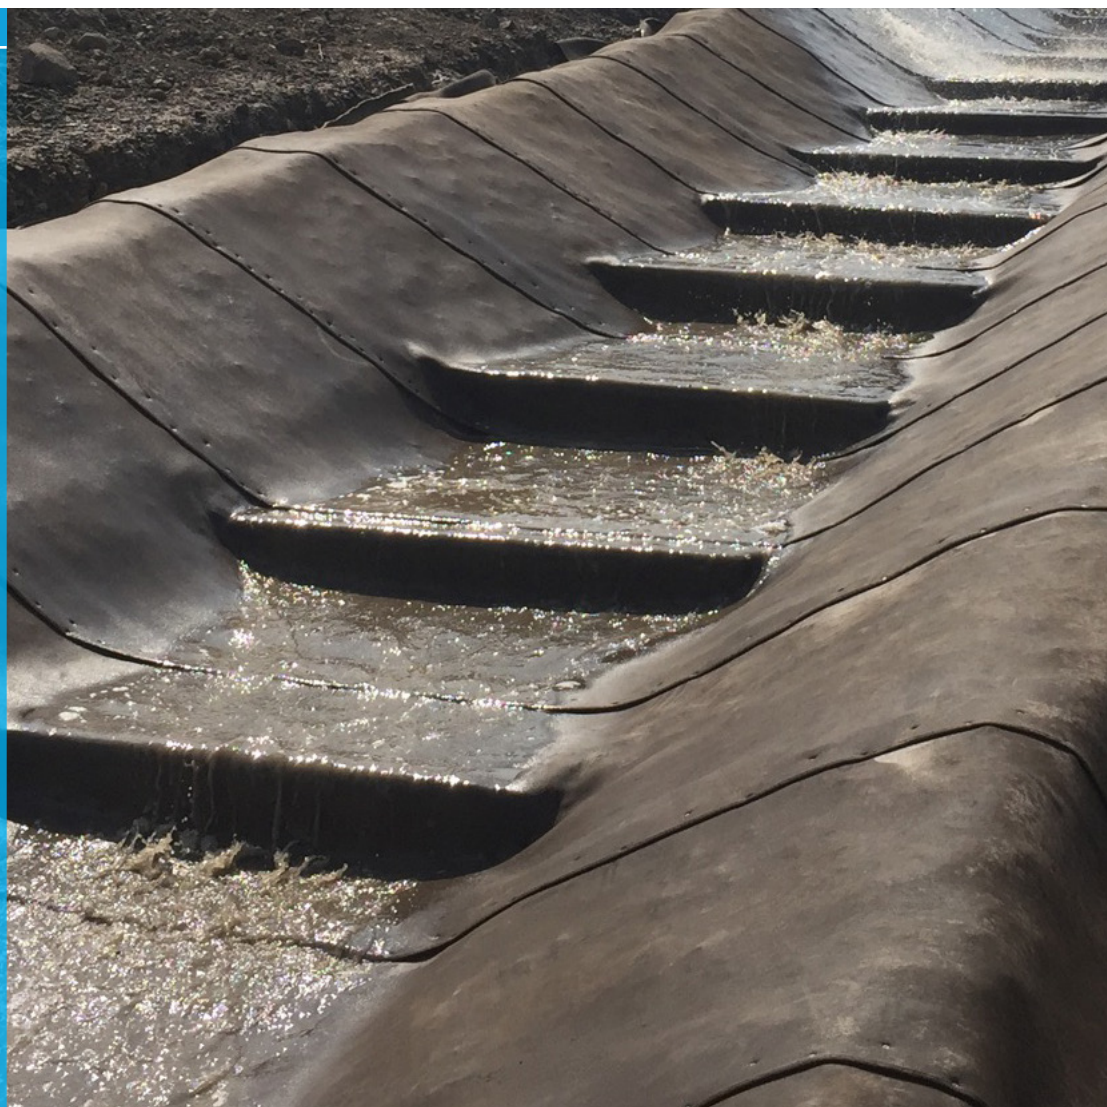
The installation during hydration

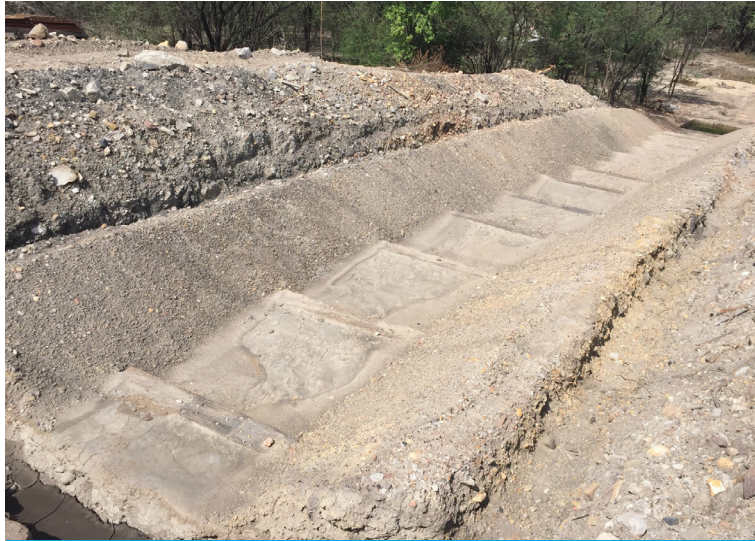
The area was graded after vegetation, loose soil and rock removal

Removal of any vegetation, loose soil and rock took place prior to installation, with anchor trenches being excavated at both sides of the channel. 1.4m transverse wooden bafflings were inserted every 1.2m throughout the installation. The CC was deployed from bulk rolls mounted on spreader beam equipment. The CC was trimmed using knives, anchored to the ground by the use of steel pegs and held in place prior to/during hydration by heavy rocks in places. The overlaps were jointed using stainless steel screws at 200mm centres, combined with wood screws to secure the CC to the wooden bafflings. A 1000 litre tank and hose with a nozzle fitted was used for hydration. The anchor trenches were then backfilled.

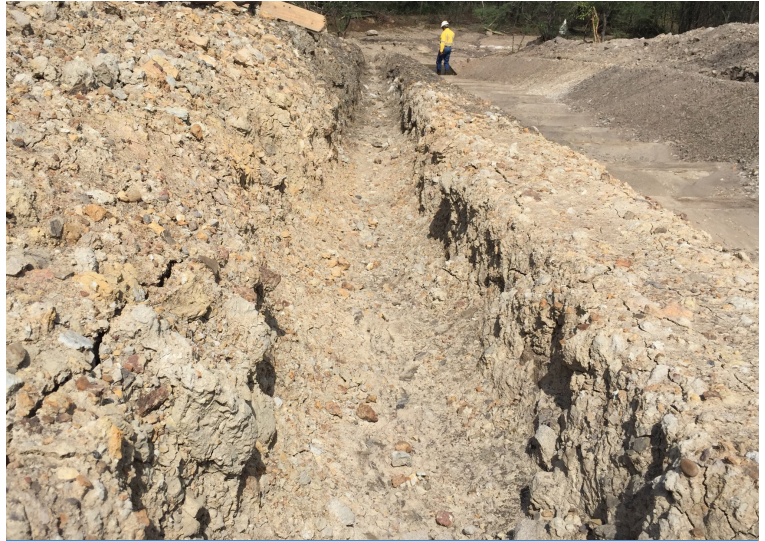
Anchor trenches were dug parallel to the channel

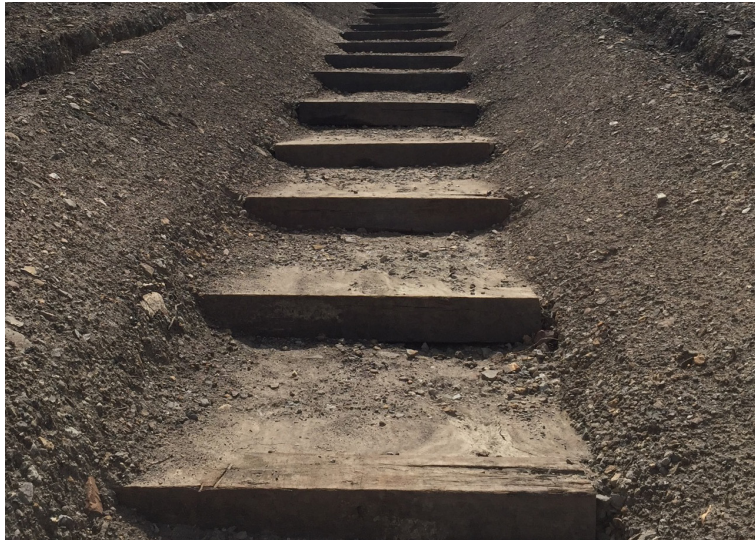
1.4m transverse wooden bafflings were inserted every 1.2m

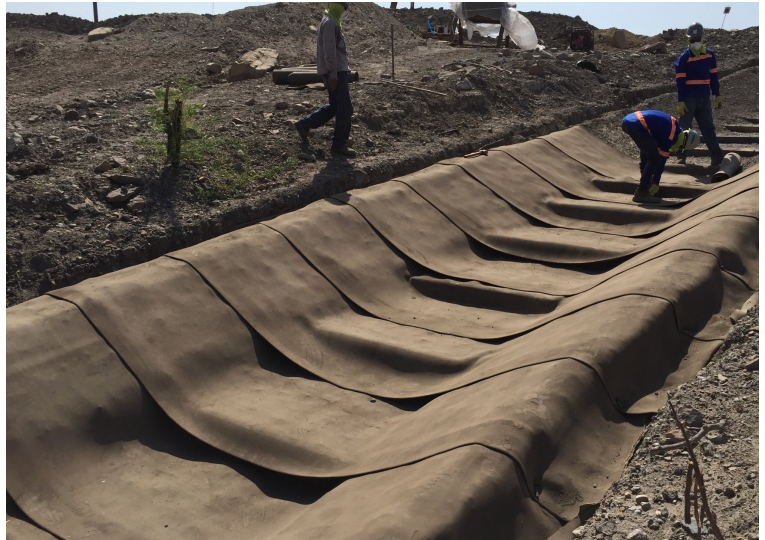
The CC before jointing or hydration

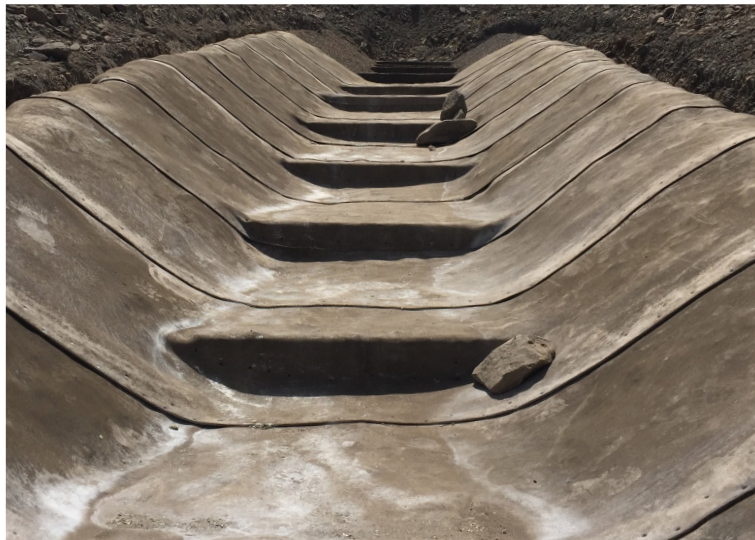
Wood screws were used to secure the CC to the wooden baffling

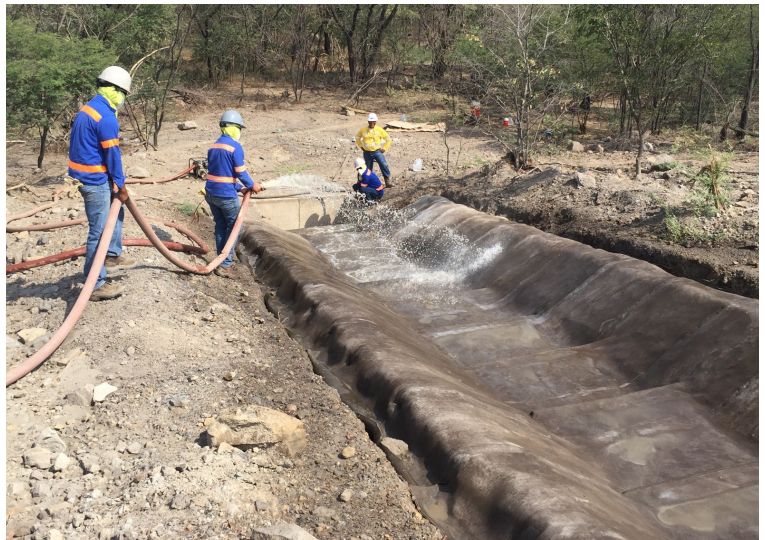
A 1000 litre on-site water tank was used for hydration

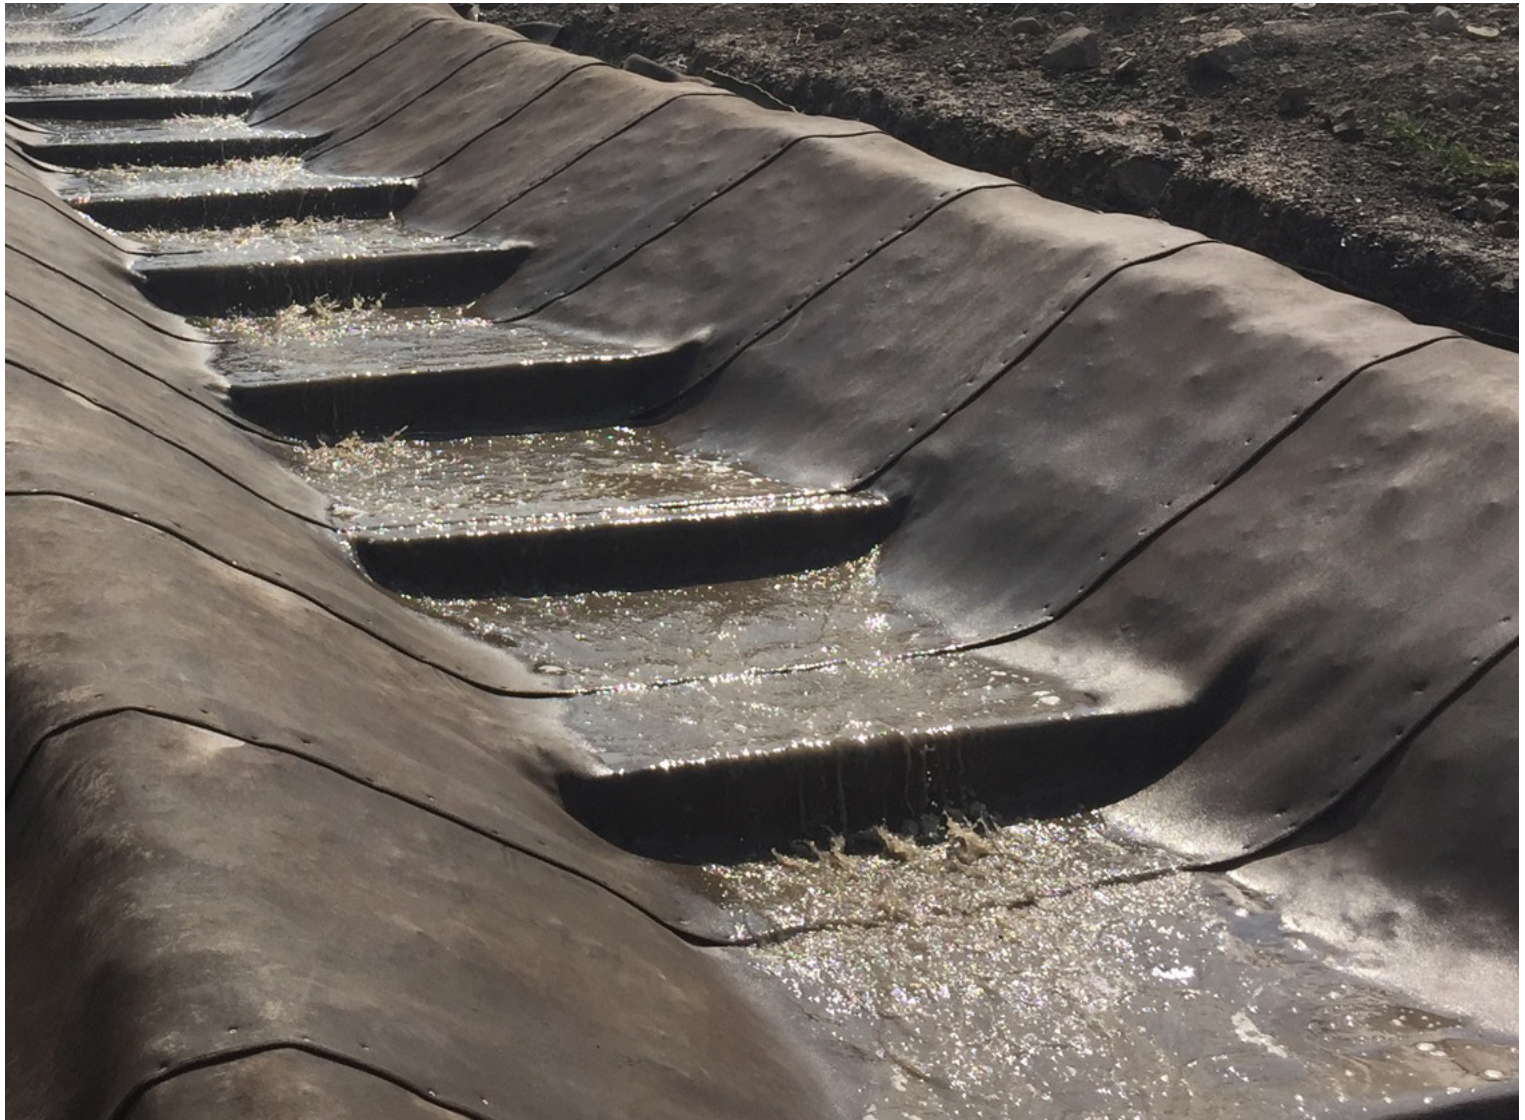
The Dissipater Channel during hydration
