CC8™ Bulk Rolls

Lisburn, Northern Ireland

Concrete Canvas® was used to line an overflow conveyance channel to provide long term erosion control and mitigate future maintenance

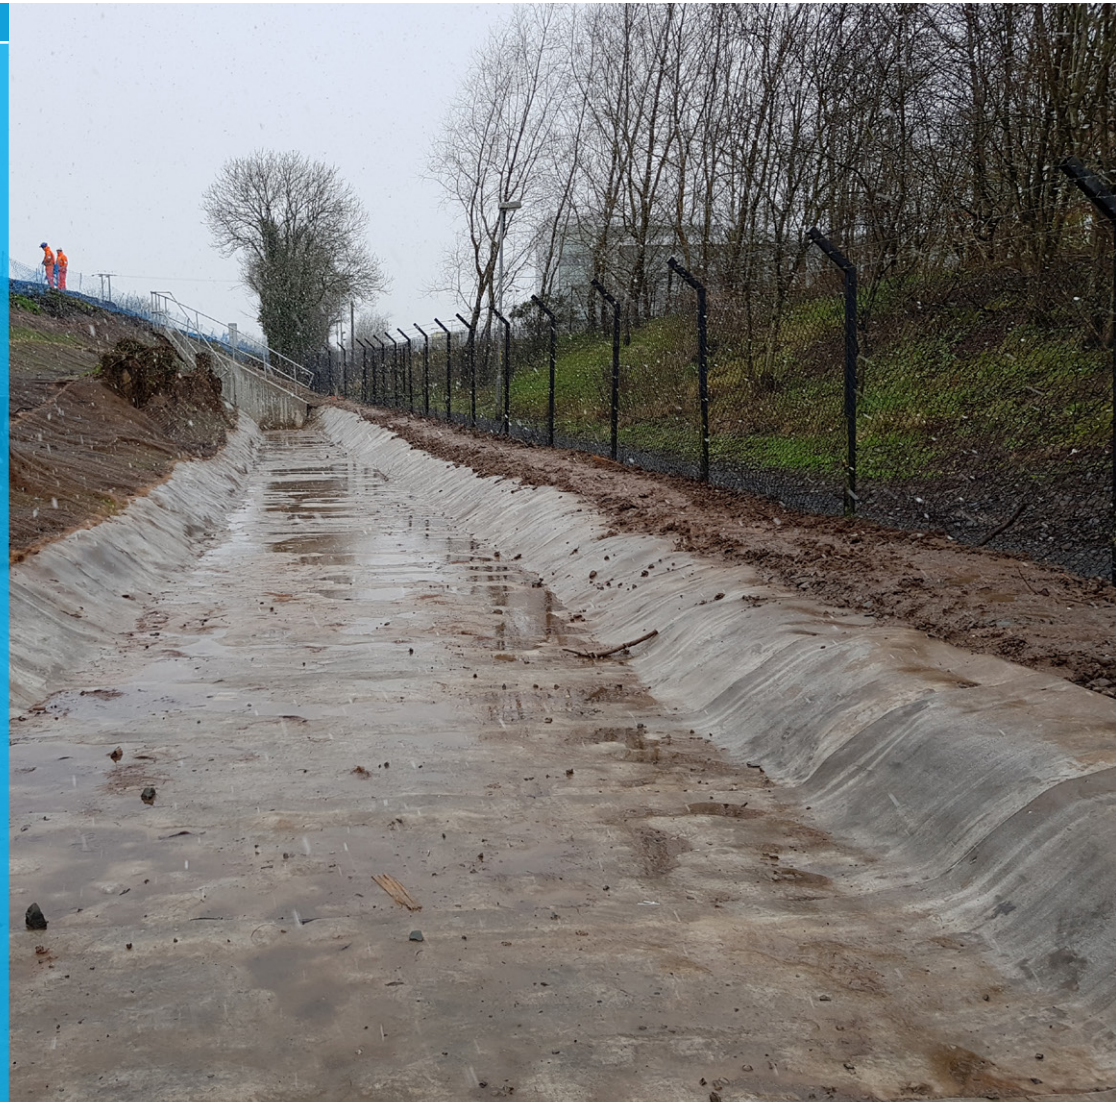
Completed CC lined channel

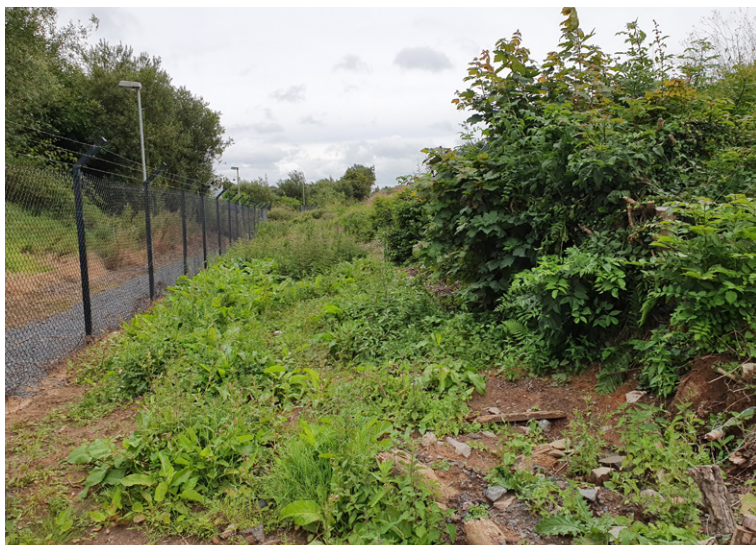
Flood-plain area prior to works

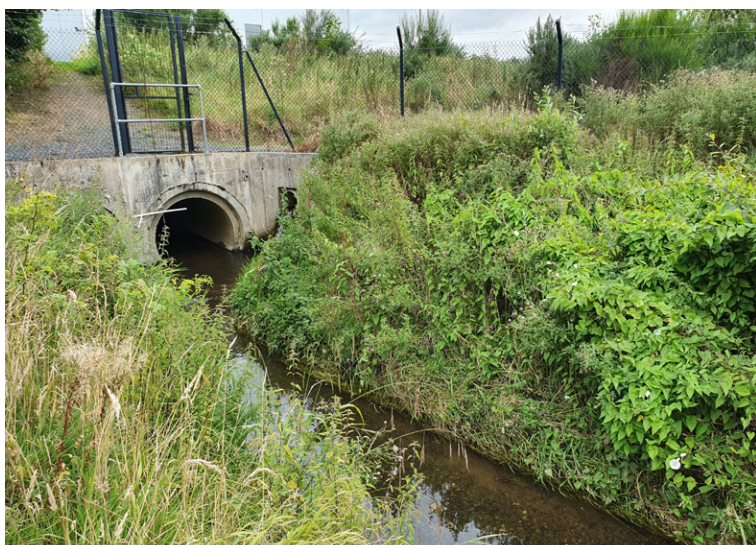
Existing channel during low flow

The existing watercourse collected surface run off from upstream and transported it beneath the railway track through a brick culvert where it was safely discharged downstream into a local watercourse. During heavy rainfall the channel and culvert didn't have sufficient capacity to handle the volume of water, causing flooding and potential issues with the slope stability near the railway track.

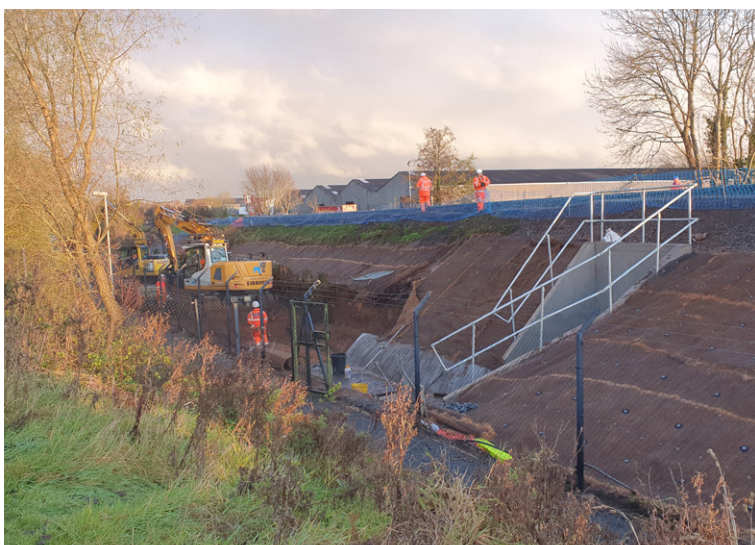
Channel excavation adjacent to railway track

Three standard bulk rolls of CC8™ and a fourth, custom bulk roll measuring 25m² were delivered to site and the channel was excavated with a Komatsu 13T excavator. The bulk rolls were mounted onto a spreader beam and hung from the excavator before being deployed transversely across the channel. The site crew then cut to material to length using a utility blade which eliminated material wastage. The CC layers were overlapped by 100mm, shingled in the direction of water flow, and screwed together at 200mm intervals with stainless steel screws. To mitigate water ingress beneath the material, the edges of the CC were terminated into 150mm anchor trenches on either side of the channel, with the material pinned with 250mm galvanised pegs and backfilled with as dug material.

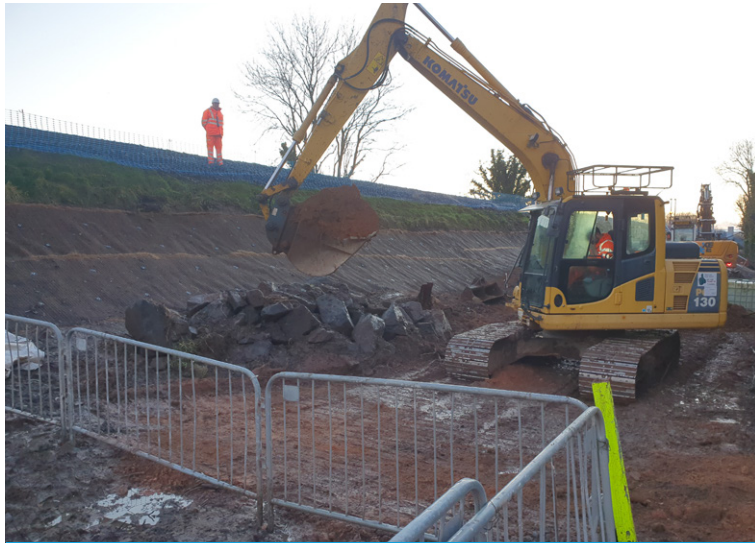
Channel excavation

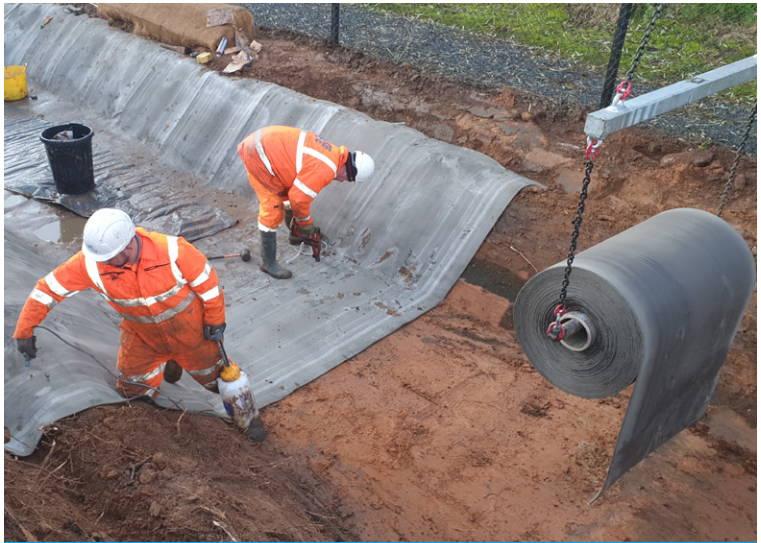
CC8 bulk roll dispensed on spreader beam

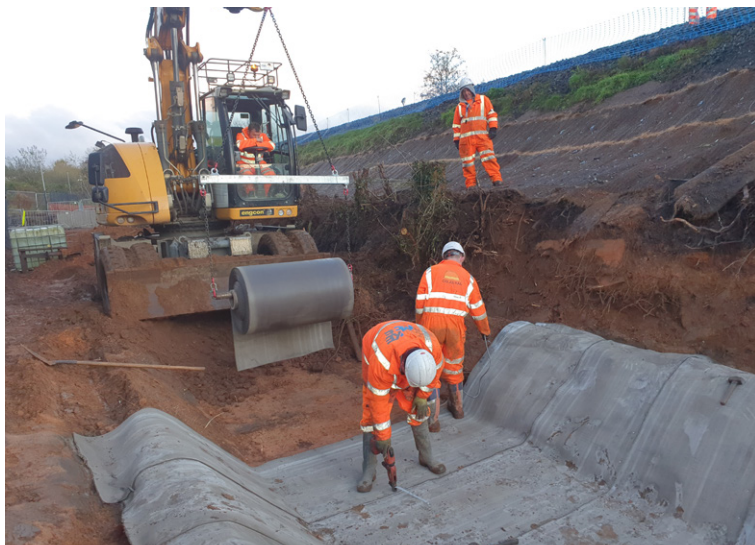
Hydrating underneath the overlap & screwing CC overlap at 200mm centres

The material was hydrated as the contractor moved upstream using a pump and hose with a diffused spray nozzle from a local watercourse. Unlike most concretes, CC uses a specialist high early strength concrete with a limited alkaline reserve. It has a very low wash out rate and when combined with the volume of water required for hydration these characteristics mean that CC run-off can be directly discharged into the local water course without the need for prior treatment.

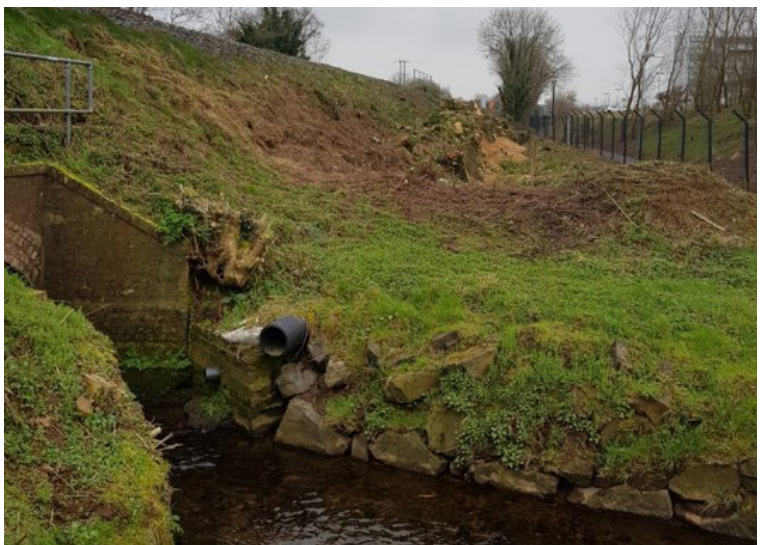
Before - Conveyance channel

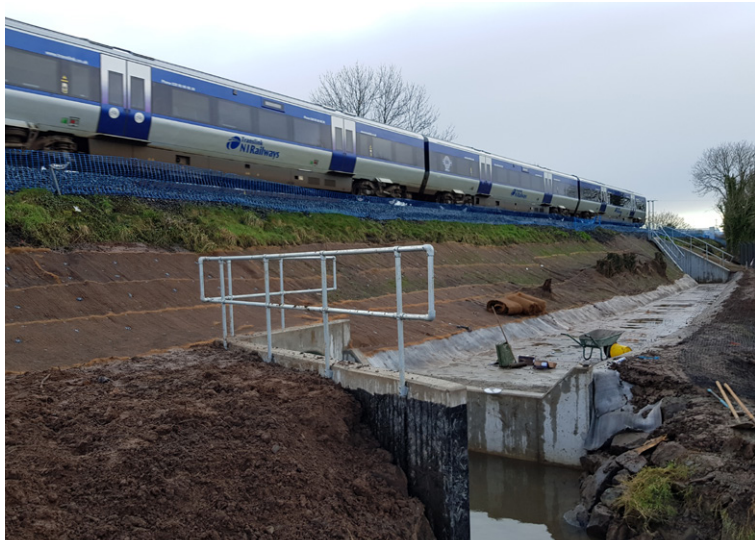
After - Conveyance channel

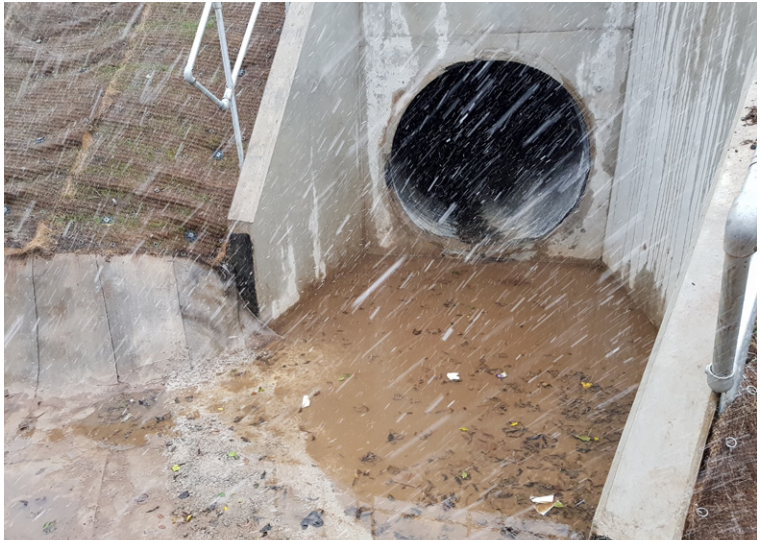
Precast headwall - CC interface

On the upstream and downstream sides, the CC8™ material was terminated into an anchor trench at the precast concrete headwall interface and the trench was backfilled with poured concrete to ensure no water ingress and provide a smooth transition from the headwall into the CC lined channel.

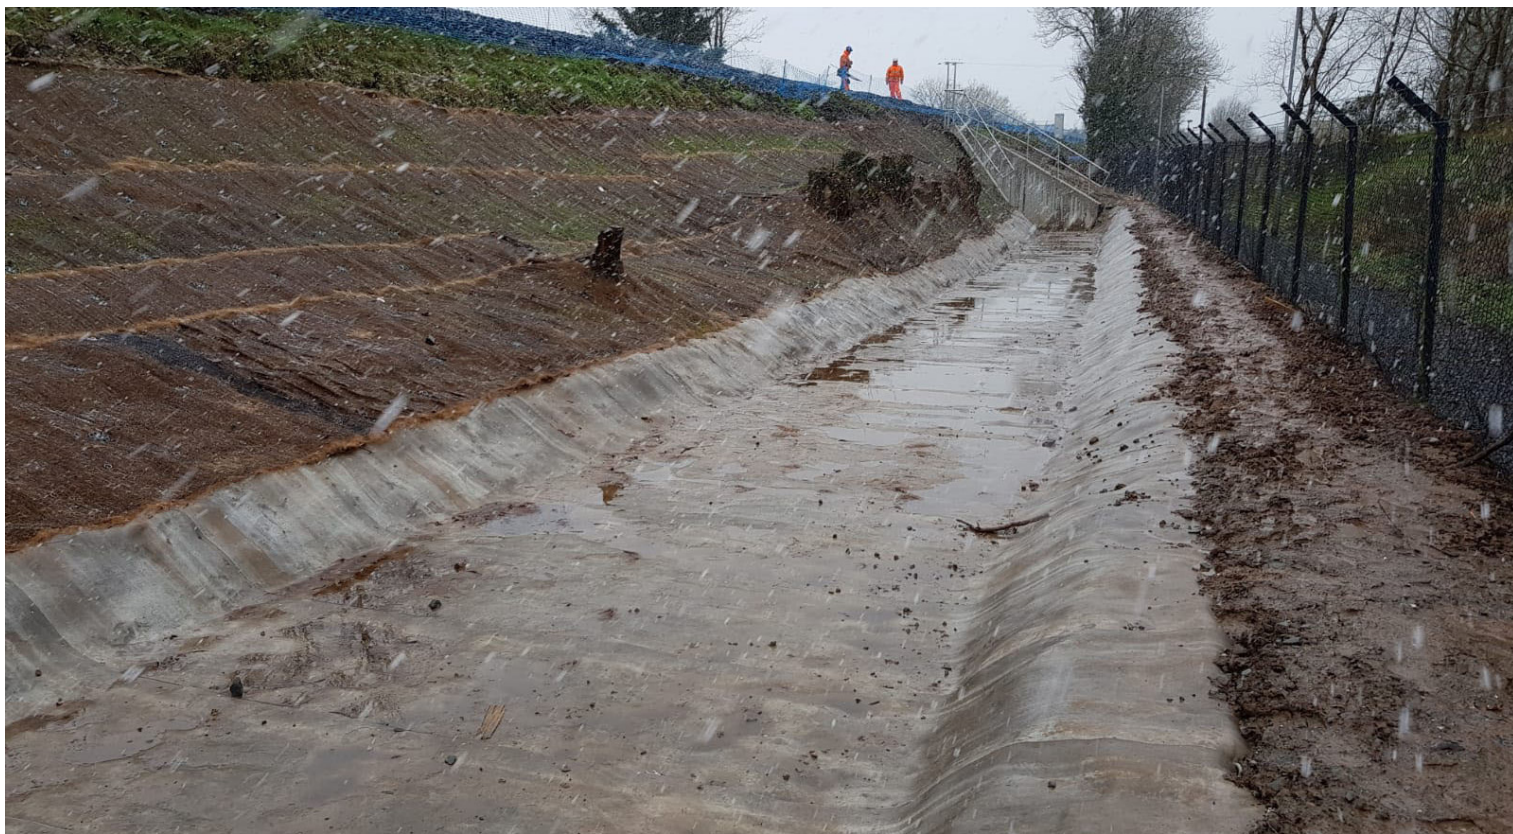
Completed CC lined channel - works were carried out despite inclement weather and restricted site access

400m² of CC8™ was installed within 1 week with an installation crew of 4 people despite the difficult to access site and inclement weather conditions. The material will provide long-term erosion control for the channel and significantly mitigate any future maintenance. The contractor and client were impressed with the ease and speed of installation and the material is being considered for similar schemes in the future.
