DITCH LINING

In November 2010, Concrete Canvas GCCM* (CC) was used to line a ditch adjacent to the M4 in Wiltshire, UK. The ditch needed to be cleared and was in dire need of repair. Originally a series of pipes and headwalls had been considered however there was concern over pipe blockages and future maintenance issues, so an alternative design was sought. CC provided a solution that prevented erosion, suppressed weed growth and eliminated the maintenance issues associated with blocked pipes. Additionally, there was a key requirement to introduce a series of cascades that would reduce the water flow rate. CC enabled simple and cost effective cascades to be constructed using concrete sandbags, over which the CC was easily laid.

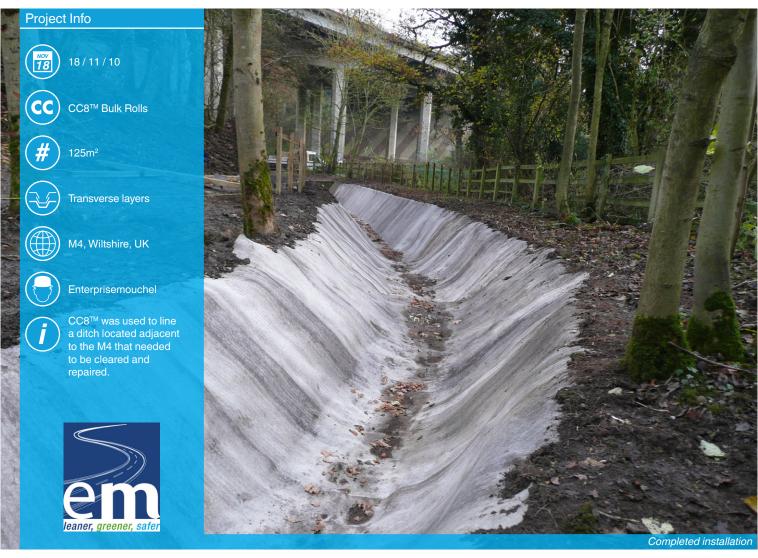
The existing concrete ditch was cleared of debris to ensure intimate contact between CC and the substrate, whilst a new section of ditch was excavated and graded to profile. A small anchor trench was created at each crest, before the cascades were constructed using concrete sandbags located every 3m along the base of the ditch. Bulk rolls of CC8™ were delivered to site and hung from a spreader beam which allowed the CC to be cut to specific profile length, avoiding wastage. The CC was then laid transversely across the ditch with a 100mm overlap between layers. The CC was pegged into the anchor trench through every overlap, but the overlaps themselves were not sealed to create weep paths that would prevent the build up of hydrostatic pressure behind the material. Holes were cut into the CC to accommodate inlet pipes and other existing infrastructure. After hydration, anchor trenches were backfilled to prevent water ingress.

The project was deemed a success and the speed and ease of install allowed a 20 linear metre section of ditch to be laid by a team of 3 in just 1 day.
