CC8™ Bulk Rolls

Norwood Park, Southwell,
Nottinghamshire

CC8™ was specified to
line an existing drainage
channel to prevent erosion
following installation of a
super gully

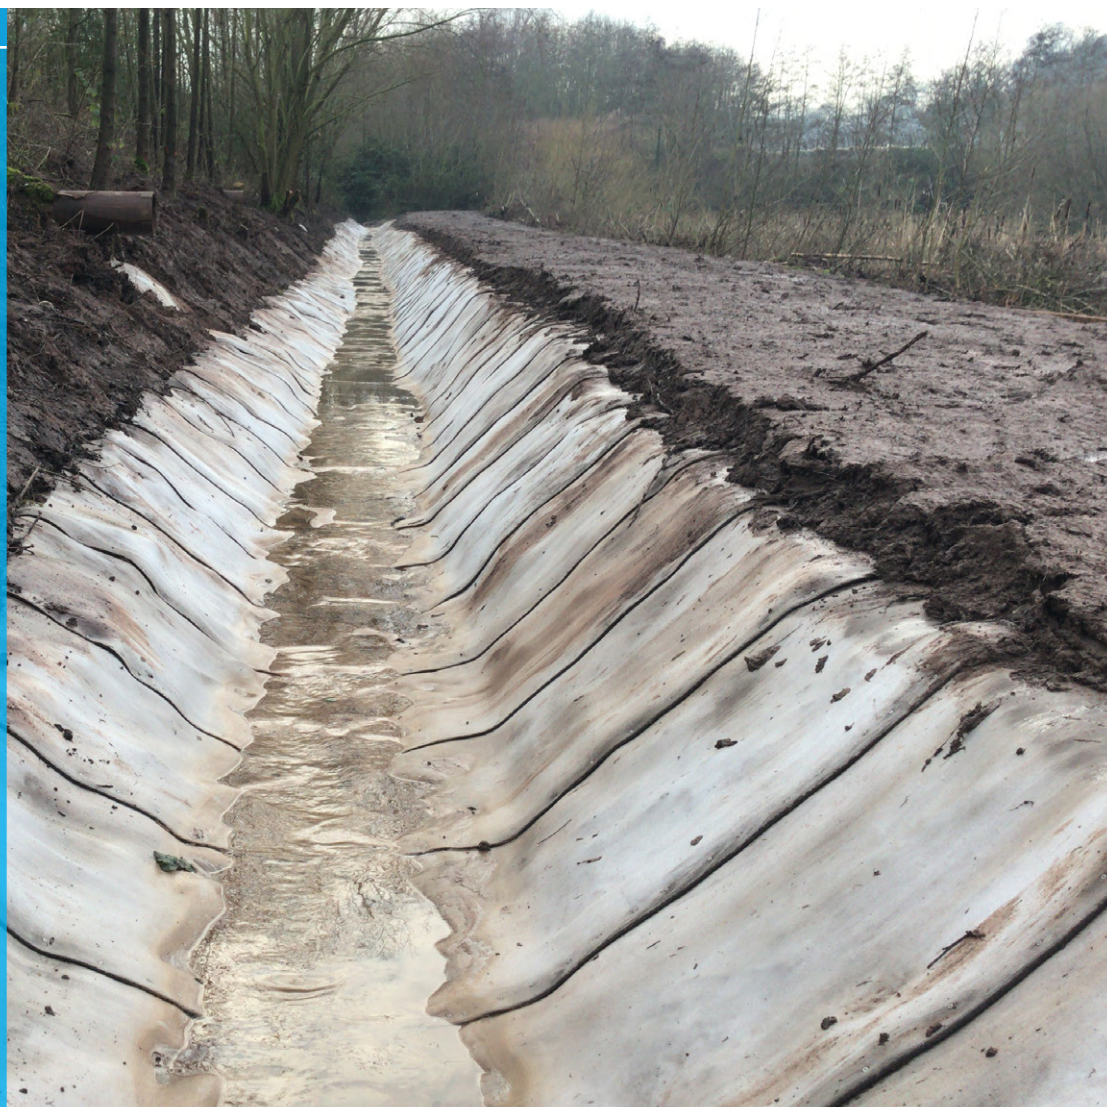
Completed installation in Southwell

In January 2020, Concrete Canvas® (CC) GCCM* was installed as a channel lining solution for an existing 115m long by 4.18m wide (on average) channel which required erosion protection at Norwood Park in Southwell, Nottinghamshire.

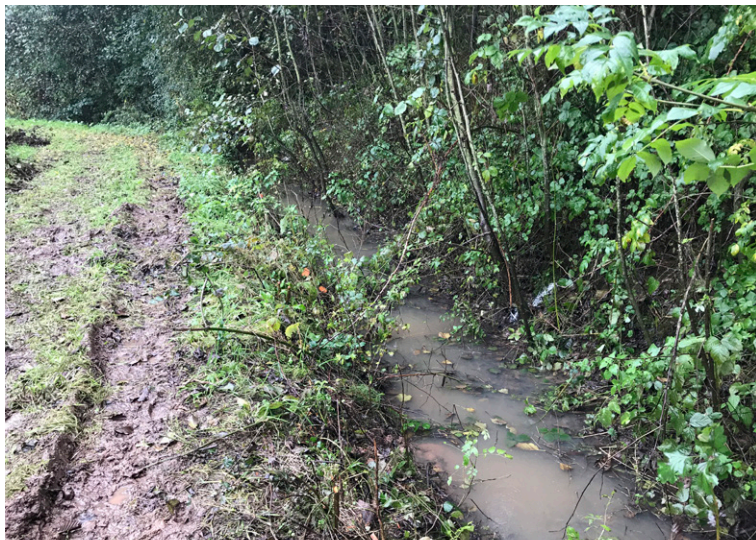
Channel prior to works

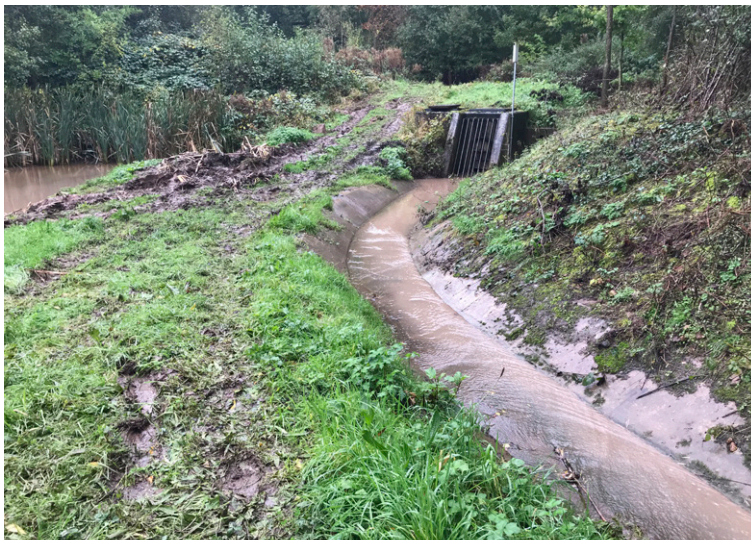
Existing concrete lined section of channel

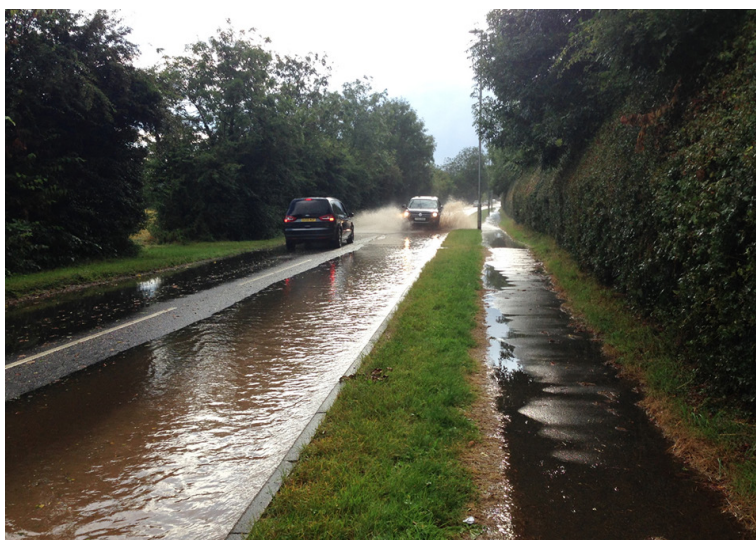
Super gullies were installed to help channel excessive water during flood events

The channel lining application was part of the Flood Alleviation Works on Halam Road in the town of Southwell to help protect up to 250 homes and businesses within the town. Five super gullies were installed in November 2019 to channel excessive water in storm events away from the Halam Road area of Southwell and into the drainage channel, which takes the water into the adjacent attenuation pond. The new super gullies and pipes can be up to nine times more efficient than standard road gullies in extreme rainfall and will help direct previously uncontrolled surface water into the pond rather than overland into the surrounding estates.

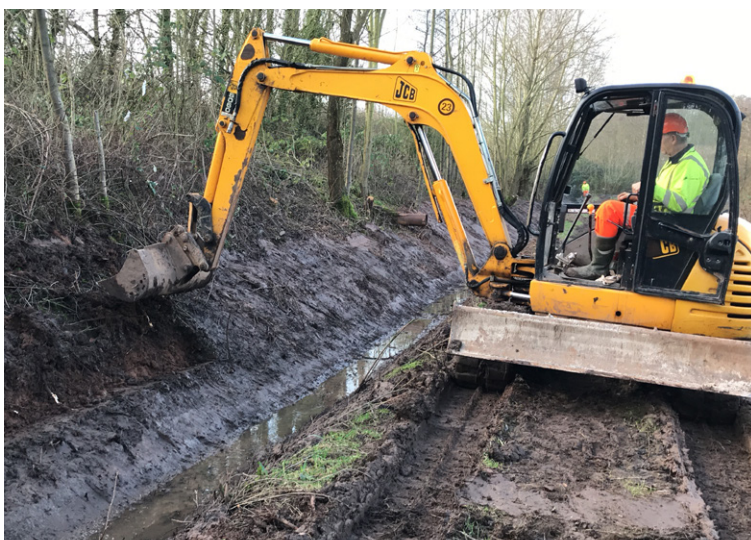
Reprofiling of the existing channel prior to installation

Prior to installation of the specified CC8™ material, the contractors reprofiled and regraded the channel and removed any loose soil and shrubs to eliminate any void space beneath the material.

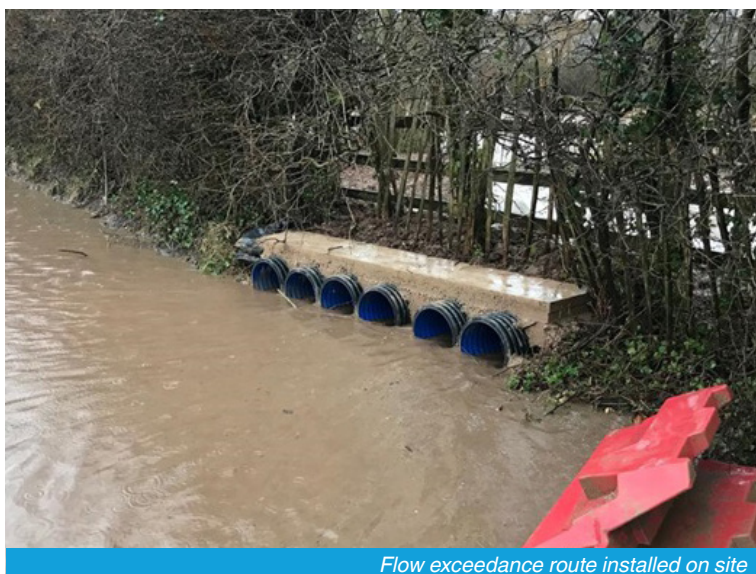
Flow exceedance route installed on site

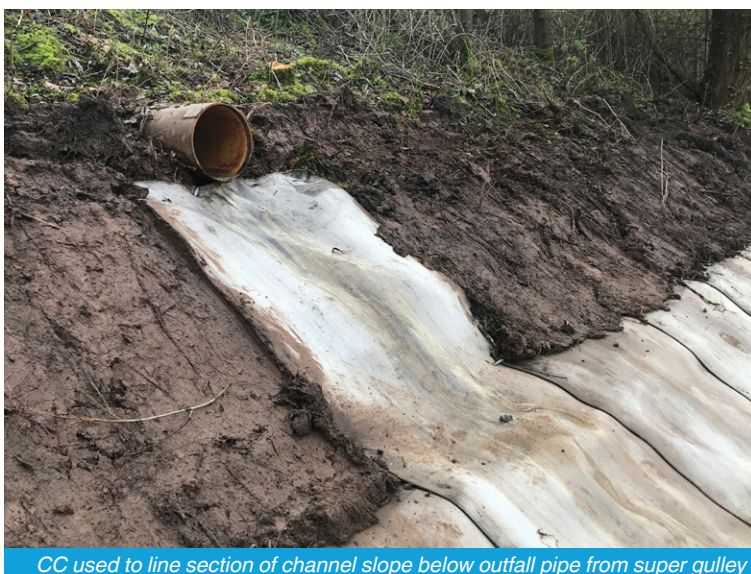
CC used to line section of channel slope below outfall pipe from super gully

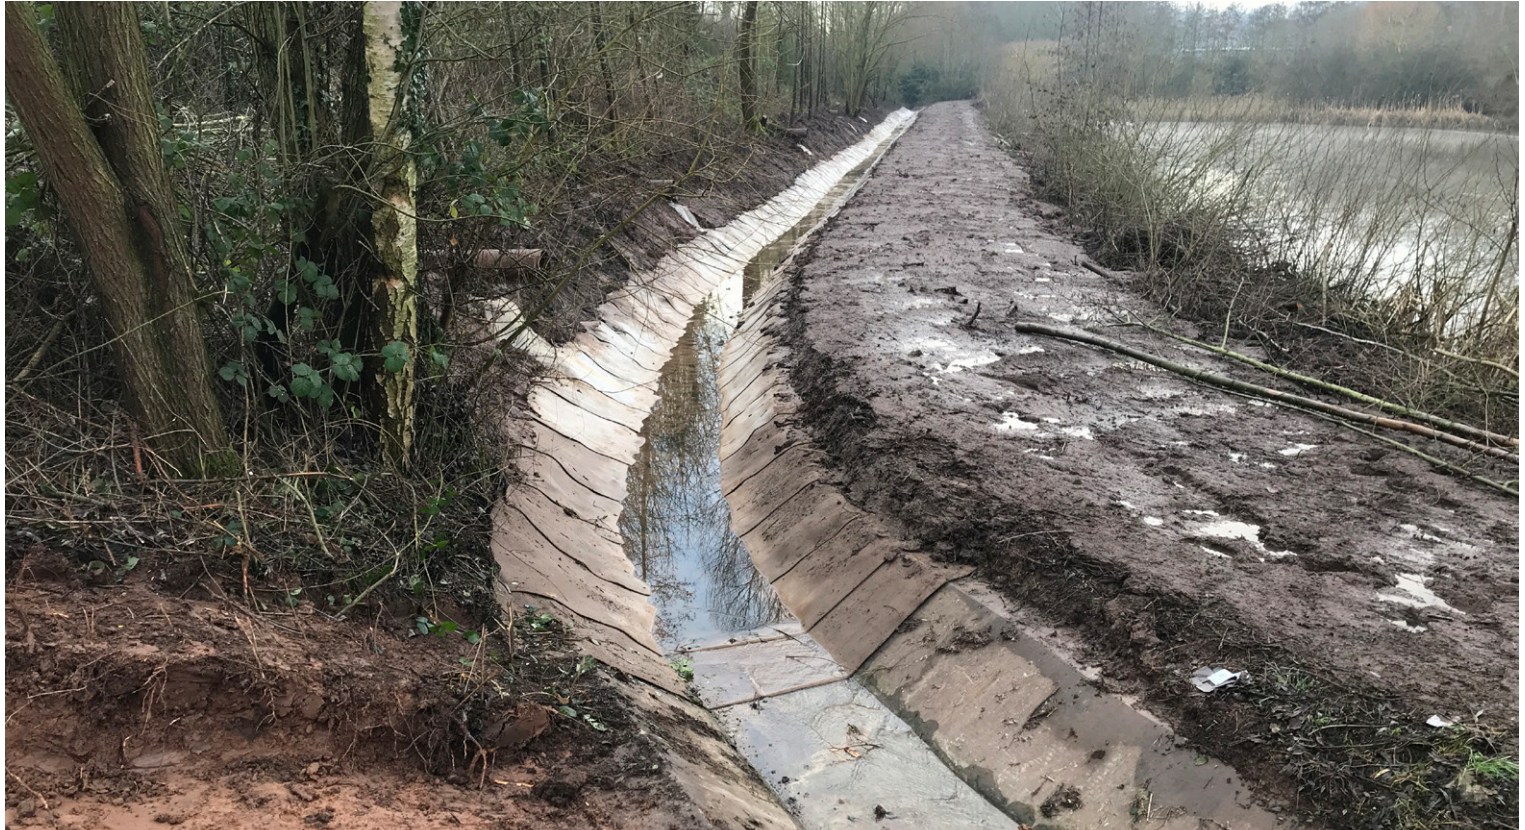
CC terminating against existing concrete channel section

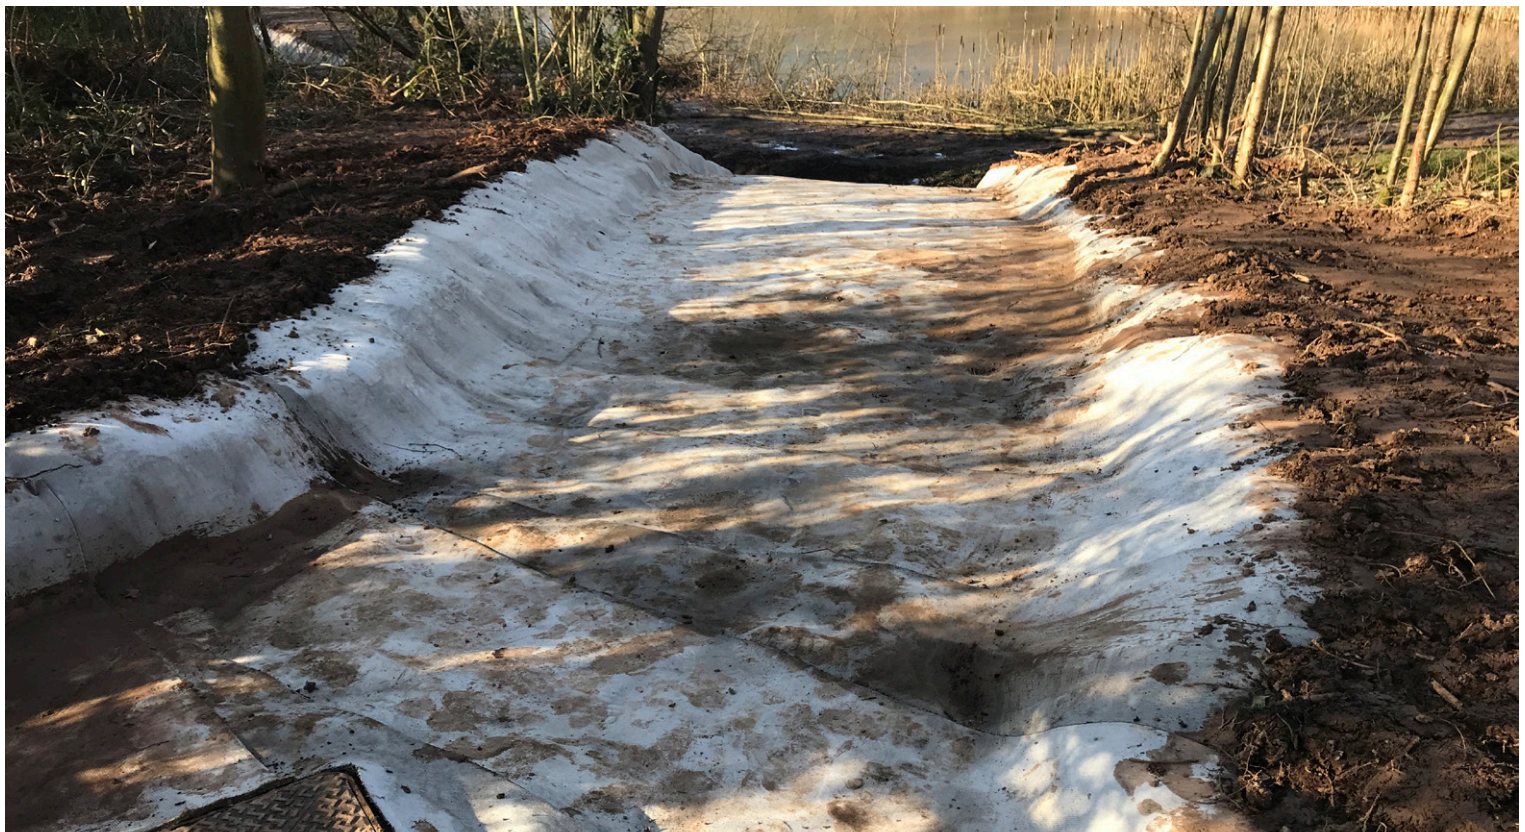
CC lined spillway area leading from newly installed flow exceedance pipes

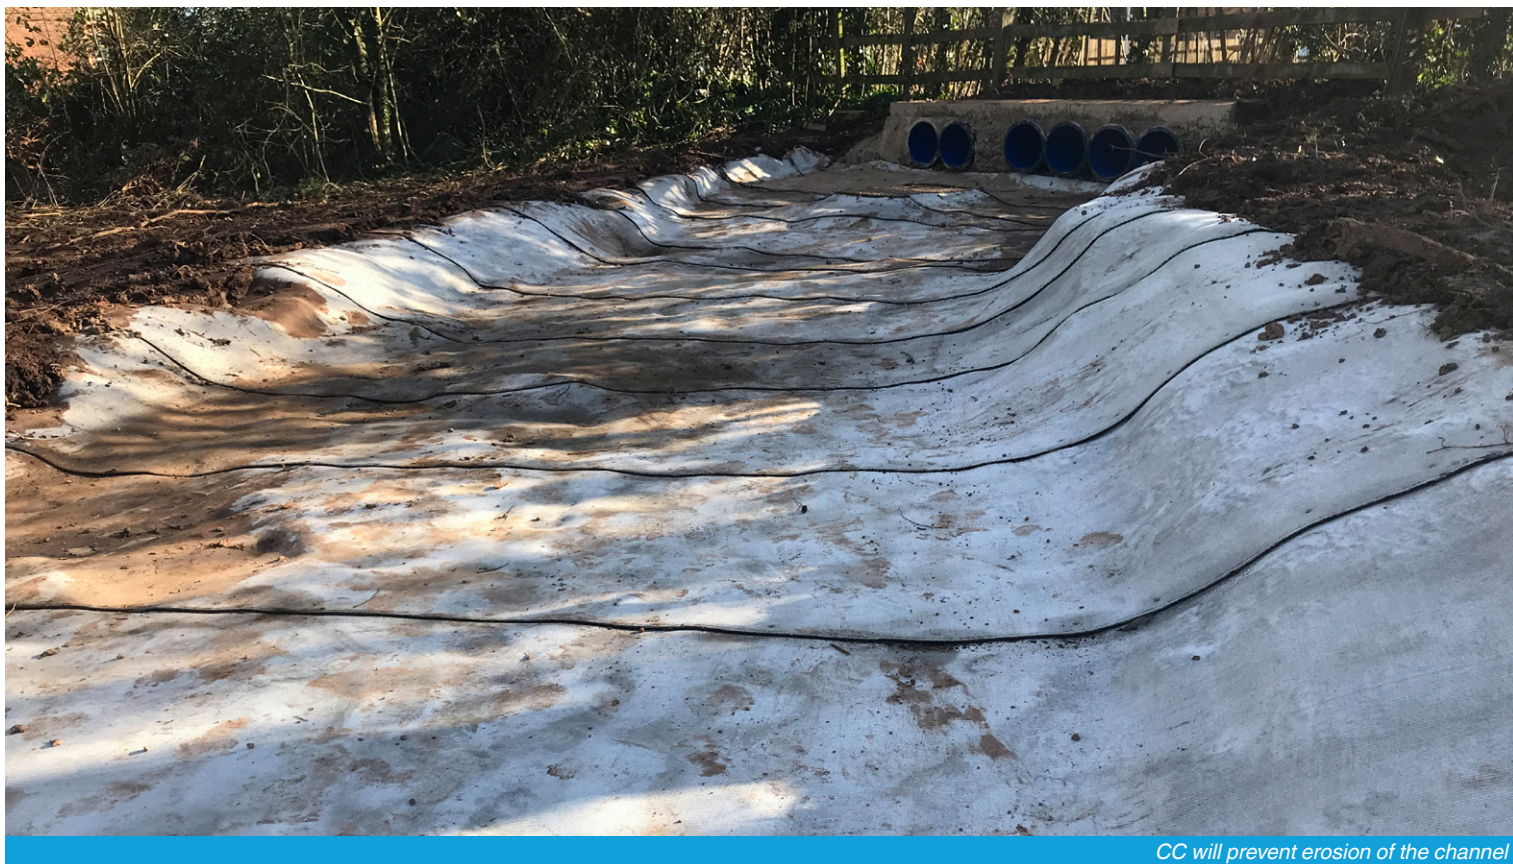
CC will prevent erosion of the channel

The CC8™ was delivered in bulk rolls and cut to required length before being carried from the site compound to the channel and positioned by hand. The material was laid transversely with overlapping layers jointed using stainless steel screws.
