CHANNEL UNING

In January 2017, Concrete Canvas® GCCM* (CC) was used to line a channel in Recife, Pernambuco, Brazil. Due to the site being adjacent to a glass factory, it was considered by the local authorities as an environmentally sensitive area.

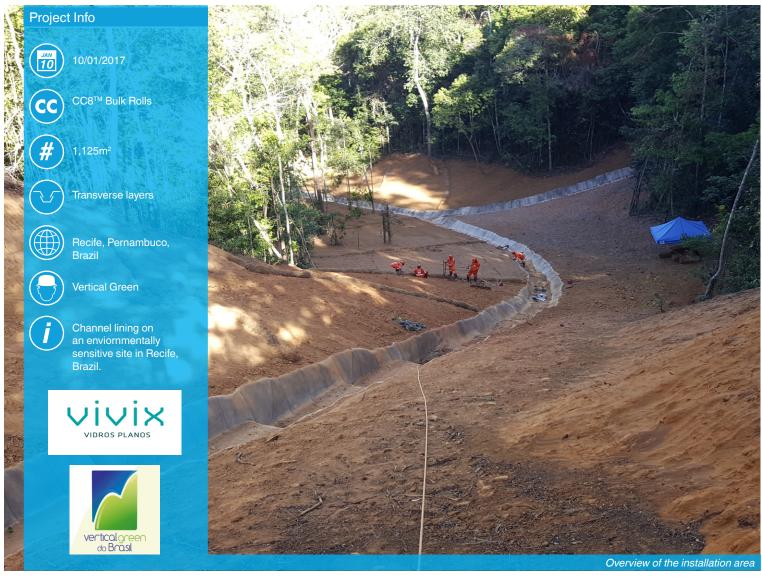
Prior to installation, all existing vegetation from the site was removed as far as the tree line, which, due to environmental restrictions, could not be touched by the team. The drainage of the site was then considered before the CC was laid transversely across the channel, allowing for variations in profile length, with layers overlapping by 100mm in the direction of water flow. The CC was then fixed to the substrate and layers secured at the overlaps. Following installation, a coconut fibre was installed along the slopes surrounding the channel to promote vegetation growth.

1,125m² of CC8™ was installed over a period of ten days by a team of six people, while the project as a whole took three weeks due to the addition of the coconut fibre. A total of nine bulk rolls were required for the channel lining, and some CC was used for slope protection where required.
