CC8™ Bulk Rolls

Slochd, The Highlands,  
Scotland

QTS Group, Ltd on  
behalf of Network Rail  
Scotland

CC8™ used to line two  
crest drainage channels  
catching water and  
routing to a new cess  
drainage to manage the  
flow of water.

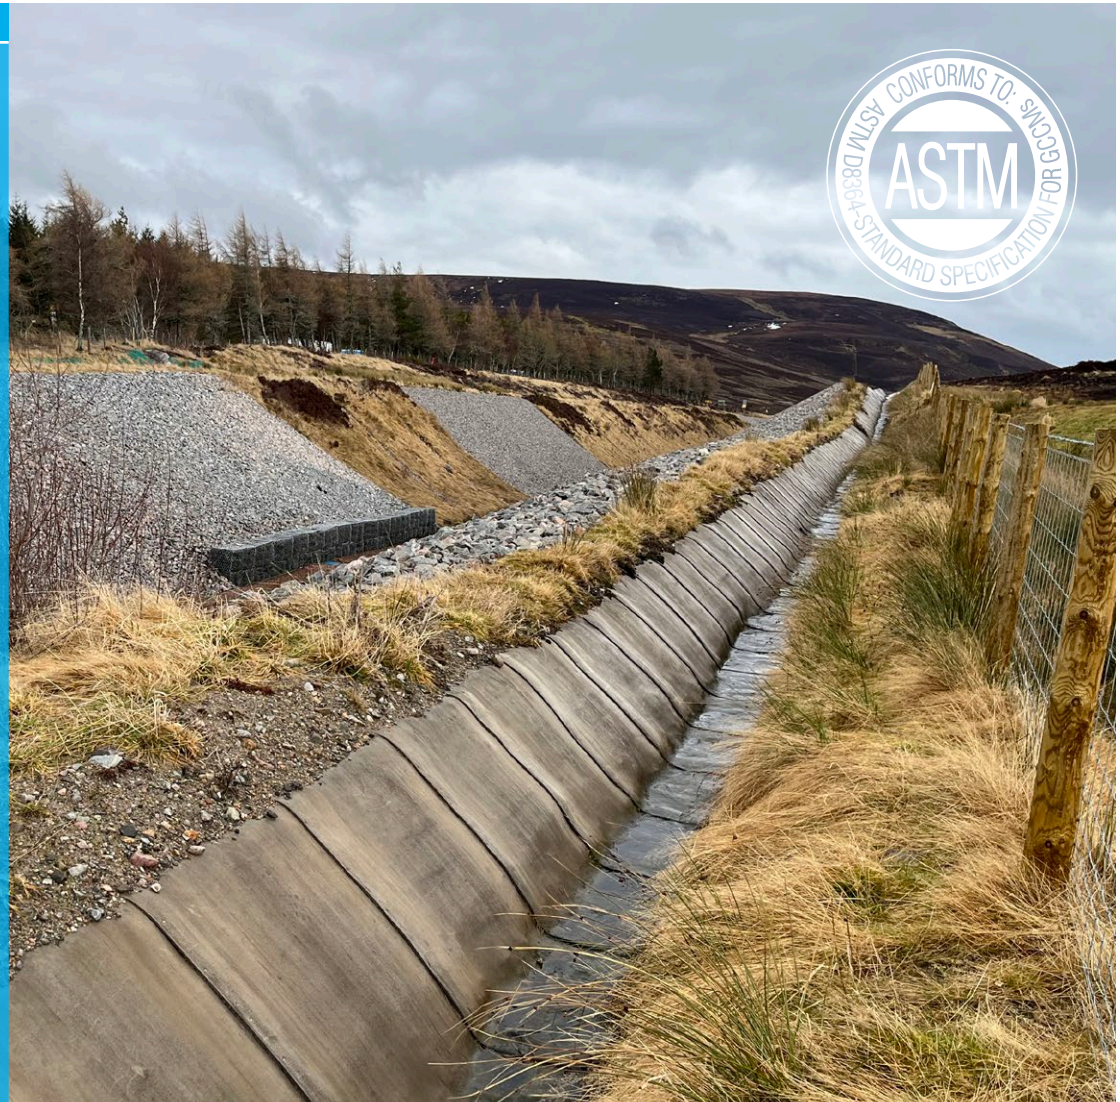
Completed installation

In July 2020, Concrete Canvas® GCCM\* (CC) was used to line two crest drainage channels catching water from the crest of the cutting and routing it to the new cess drainage to manage the flow of water.

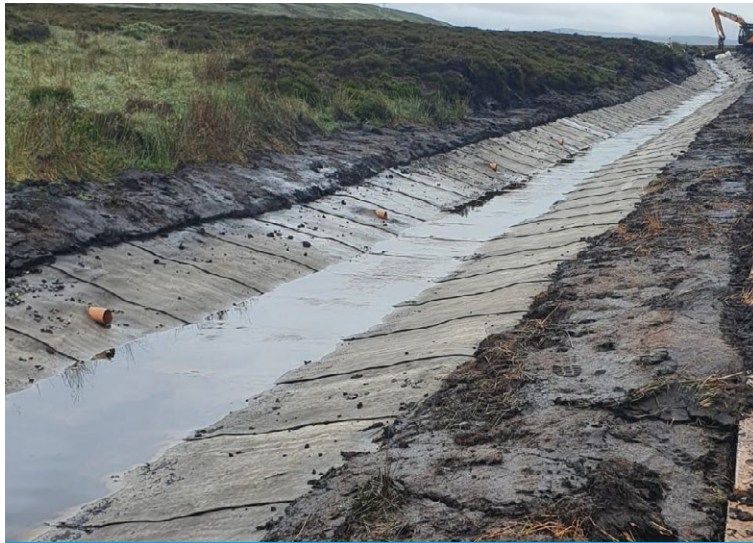
CC8™ (Type II GCCM) cut to length on site & laid transversely across channel

The remote location, site conditions and inclement weather during the installation presented several challenges for the contractor. Due to heavy rainfall and soft ground conditions, crushed aggregate was placed in the channel and compacted to ensure a stable and uniform substrate. The Bulk Rolls were delivered to the remote site and deployed using a spreader beam mounted on tracked plant machinery from the adjacent field. The material was unrolled into the channel transversely and cut to specific profile length. The CC8™ layers were overlapped by 100mm in the direction of water flow and were then screwed together at 200mm intervals using 30mm stainless screws.

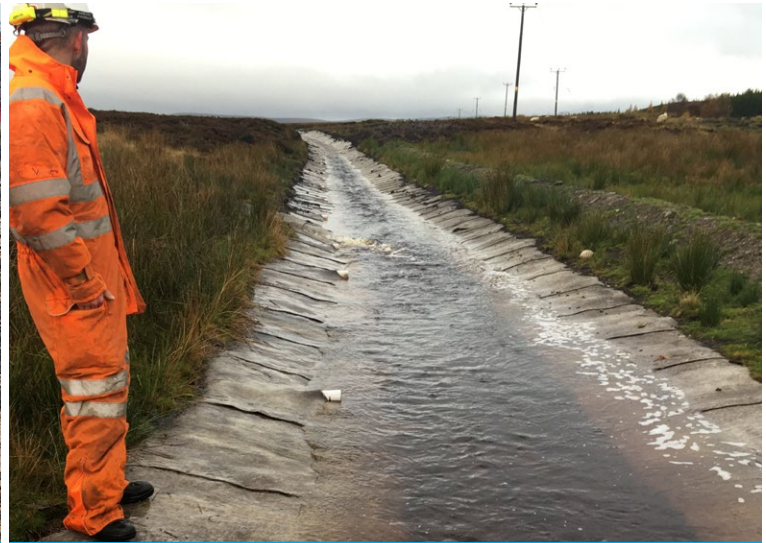
Water flow after installation

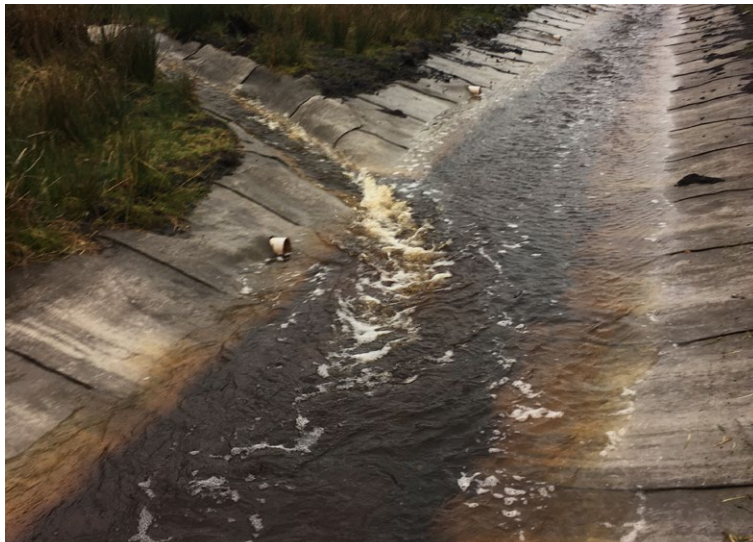
CC Interceptor channel

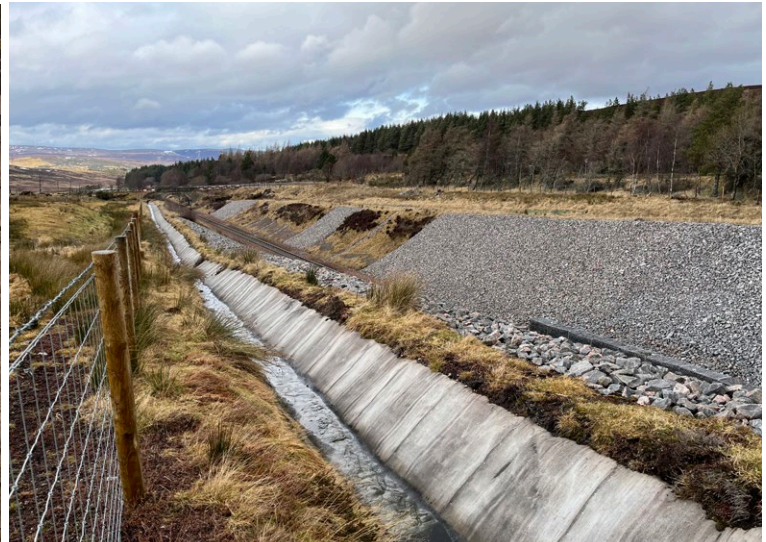
Completed CC Installation

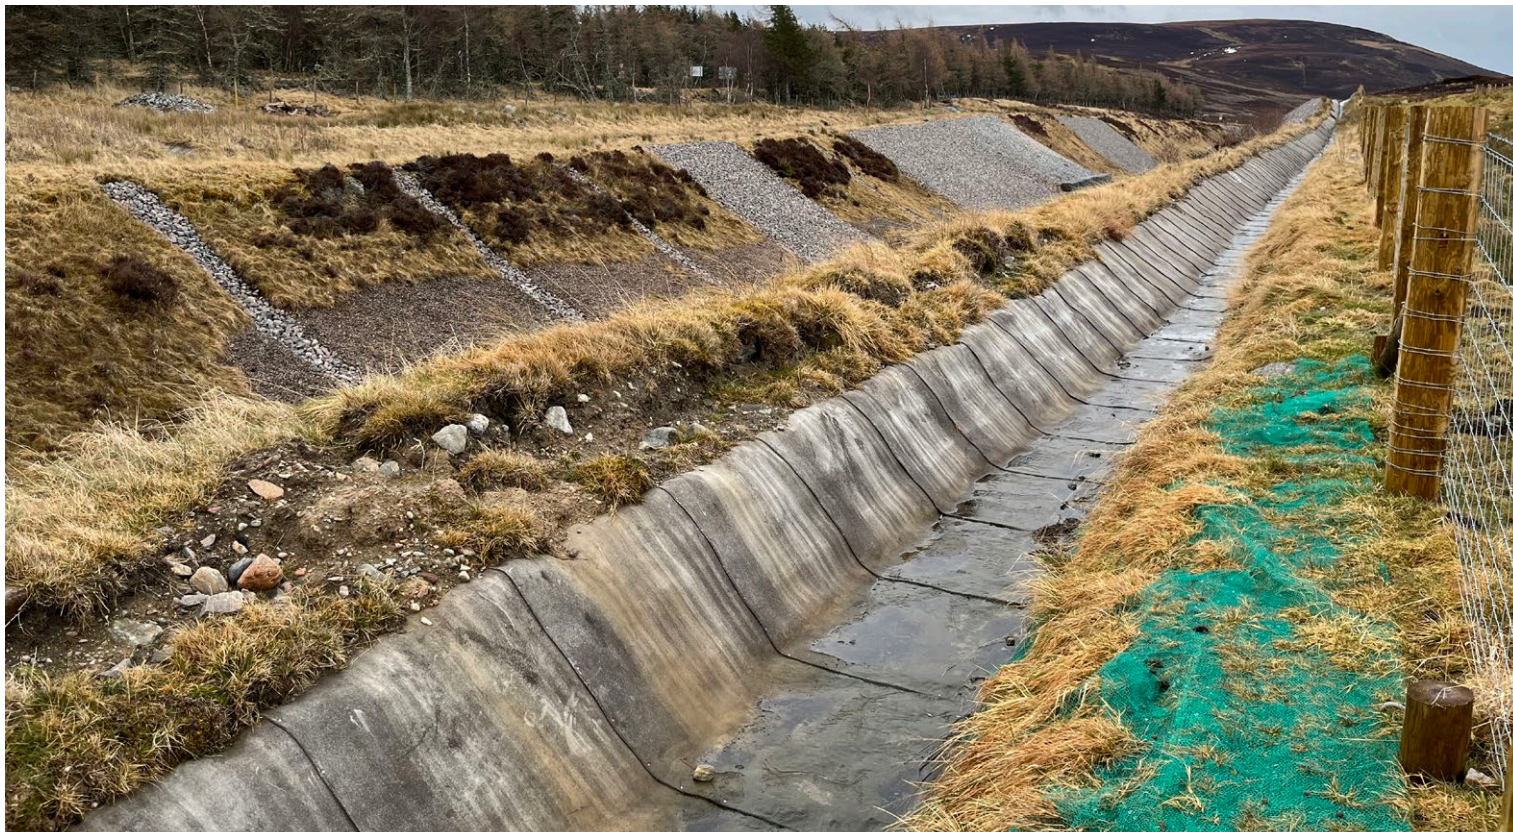
*Completed channel lining works*

The material was terminated into 150mm anchor trenches on either side of the channel and fixed to the substrate using 250mm ground pegs prior to being backfilled with site won material. A permeable erosion control mat was then installed on the field side of the channel which will help keep sediment and topsoil from shifting until vegetation takes root. The contractor ensured that any CC8™ installed during the day was fully hydrated at the end of every shift.
