CC8™ Bulk Rolls

Dunrobin Castle, Golspie,
Scotland

CC8™ used to line a
crest drainage channel
to prevent earthwork
failure within the slope

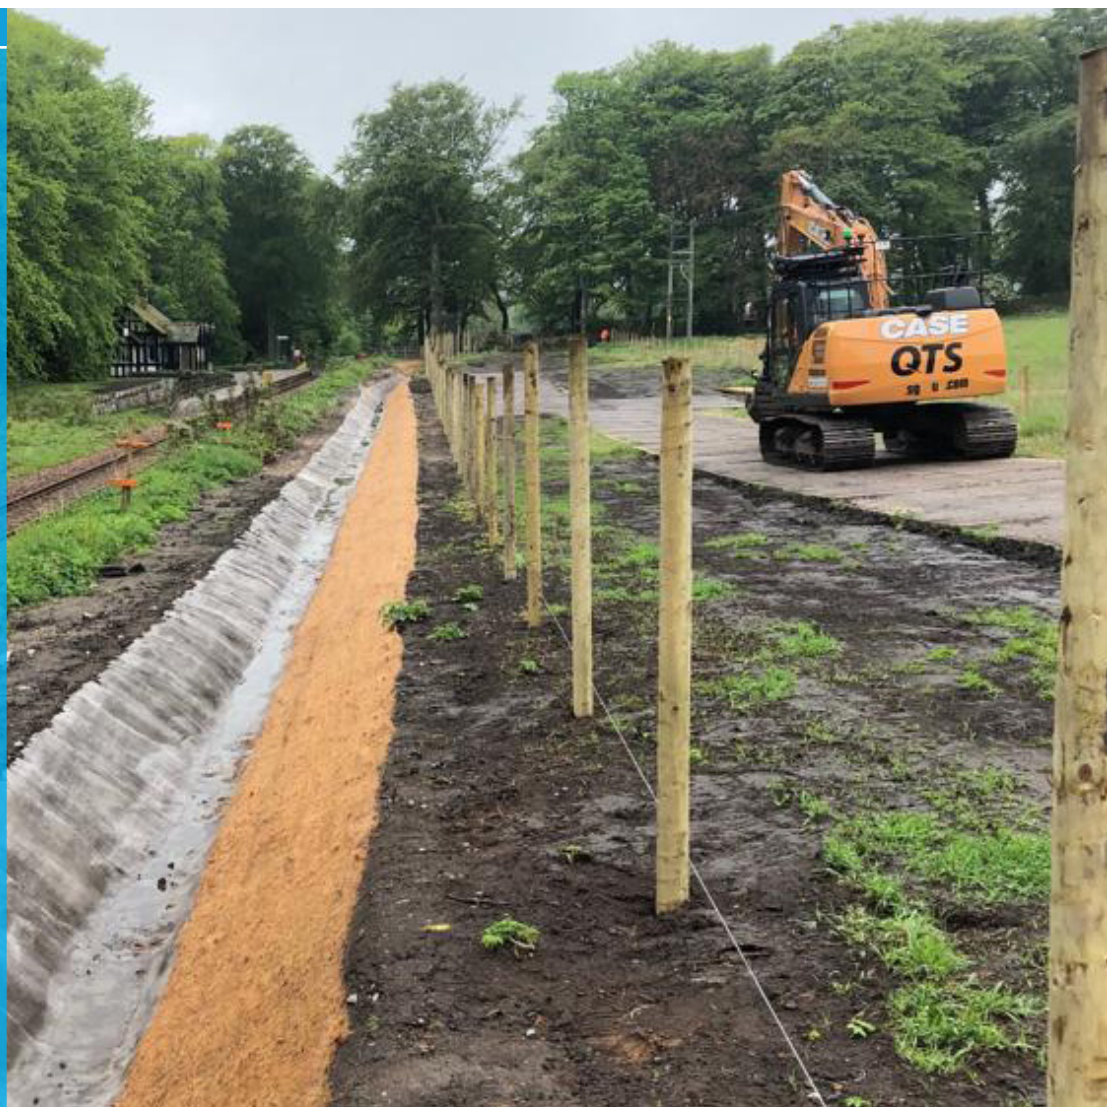
Completed channel lining installation in Sutherland

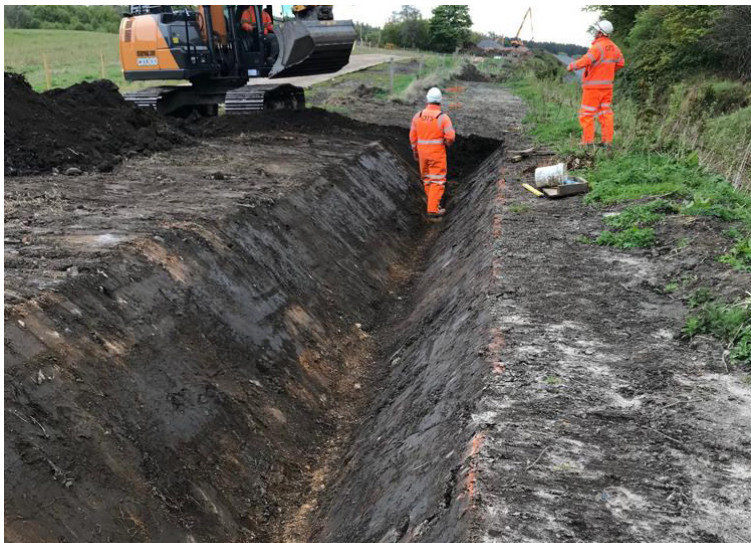
Excavation of the channel profile

Prior to installation, 12 bulk rolls of 8mm thick CC (CC8™) were delivered to the project site and the channel excavated and compacted to profile using an excavator and V bucket. The material was unrolled into the channel transversely and cut to specific profile length. CC8™ layers were overlapped by 100mm in the direction of water flow and were then screwed together at 200mm intervals using 30mm stainless screws.

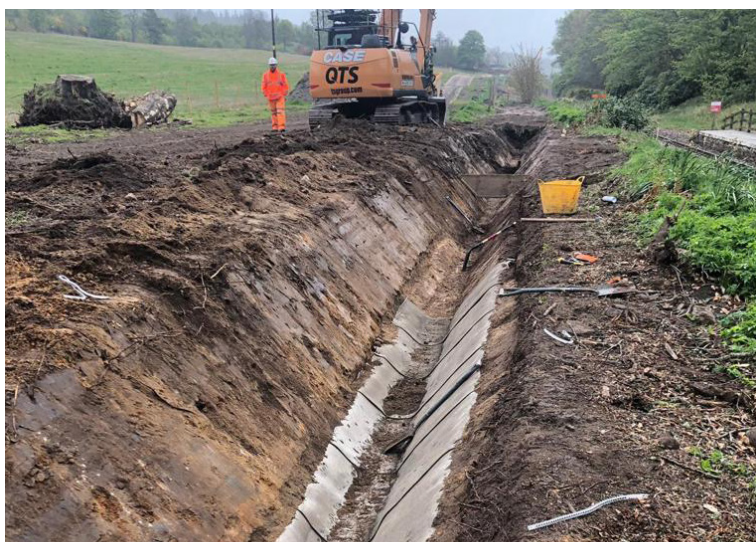
CC laid transversely across the channel

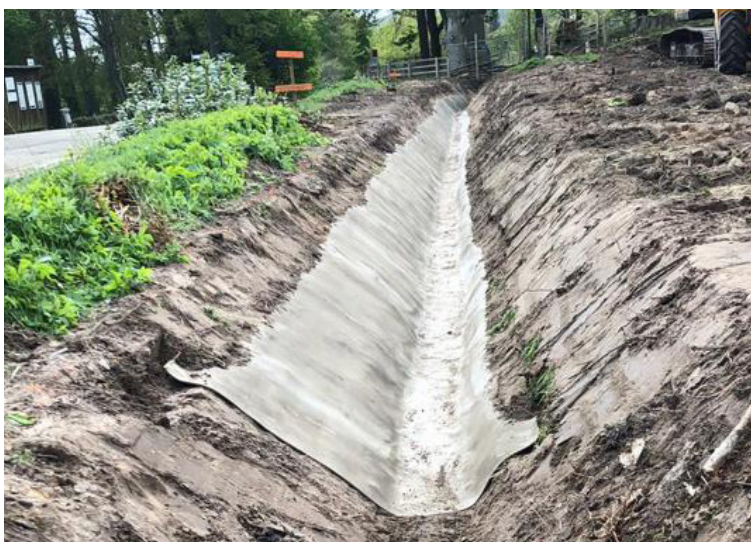
CC terminated into anchor trenches

CC8™ was extended 300mm up the side slopes before being anchored into the slopes by a minimum of 200mm and fixed to the substrate with 250mm ground pegs. A permeable turf reinforcement mat was then installed from the crest of the side slopes and terminated 100mm below the CC material. This allowed surface runoff from the adjacent saturated field to migrate into the CC lined channel and reduce cutting saturation.

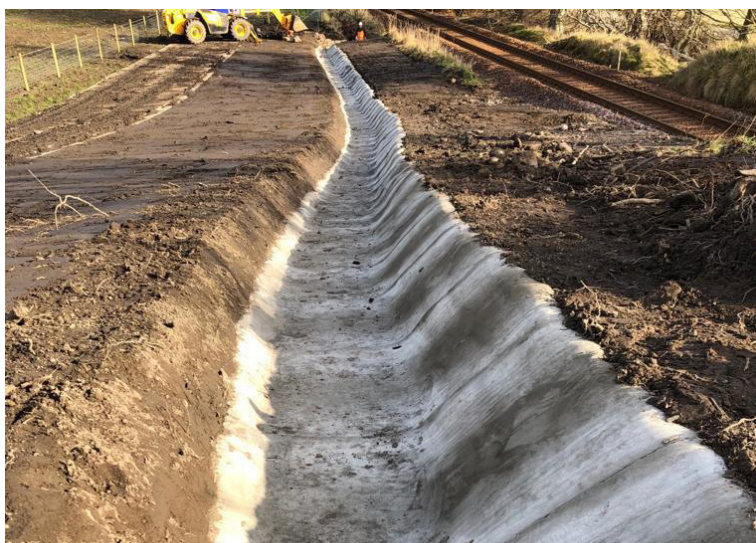
Anchor trenches backfilled prior to erosion mat installation

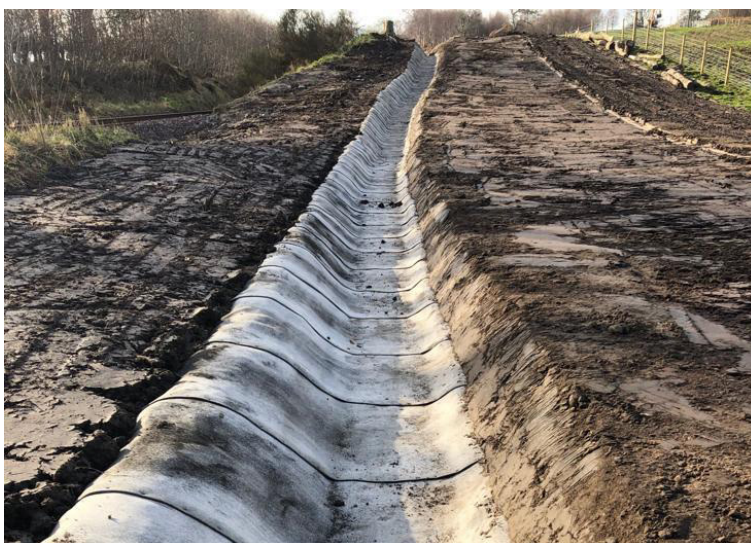
Steep CC-lined channel section

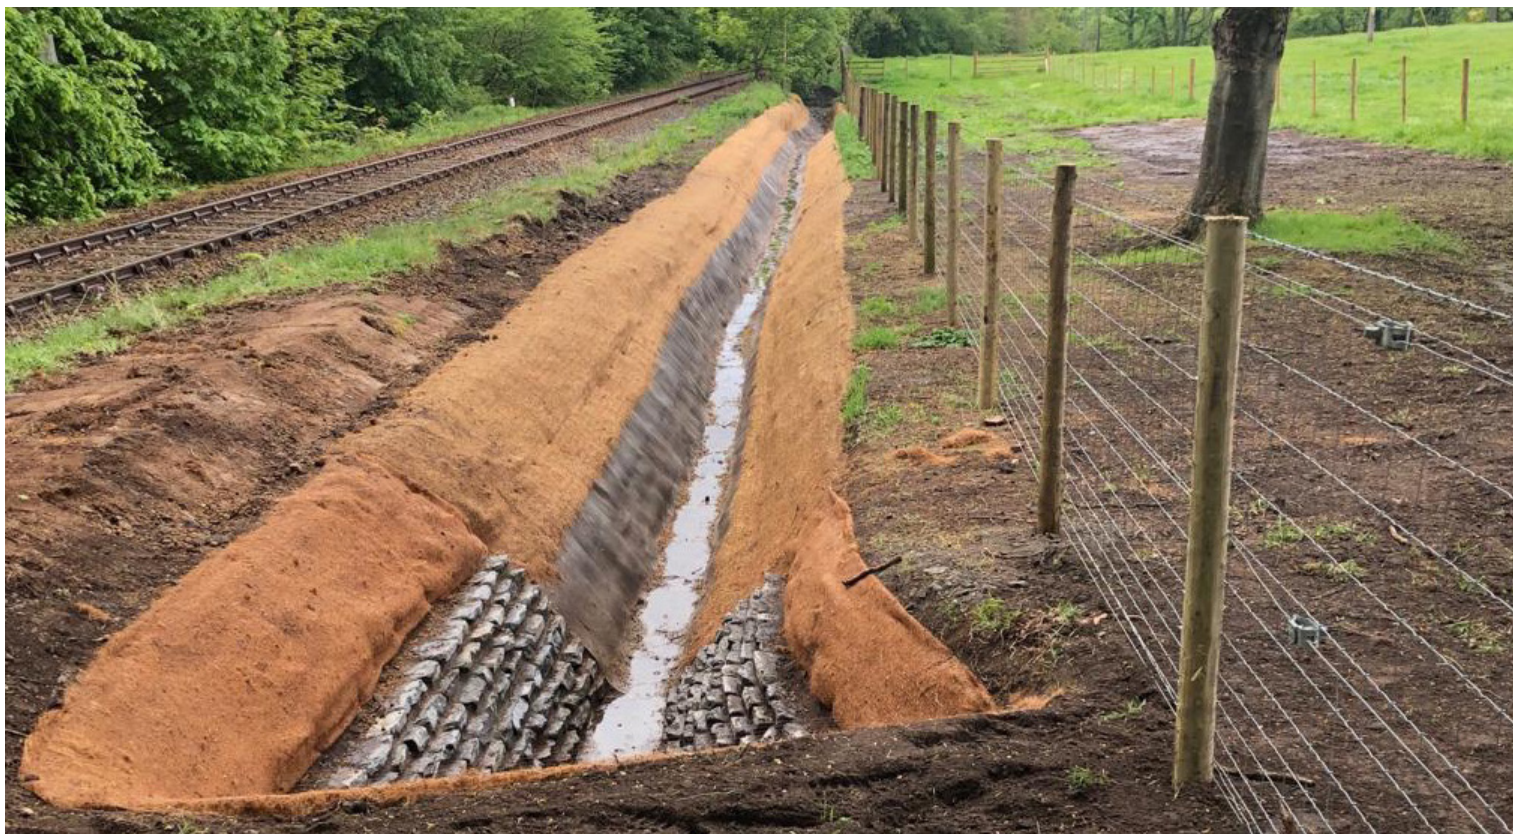
Completed CC lined channel
