CC8™ and CC13™
Bulk Rolls

Willow Creek mine,
British Columbia, Canada

CC8™ and CC13™
used to line a carrier
drain channel directing
contaminated water
from a mine to a settling
pond

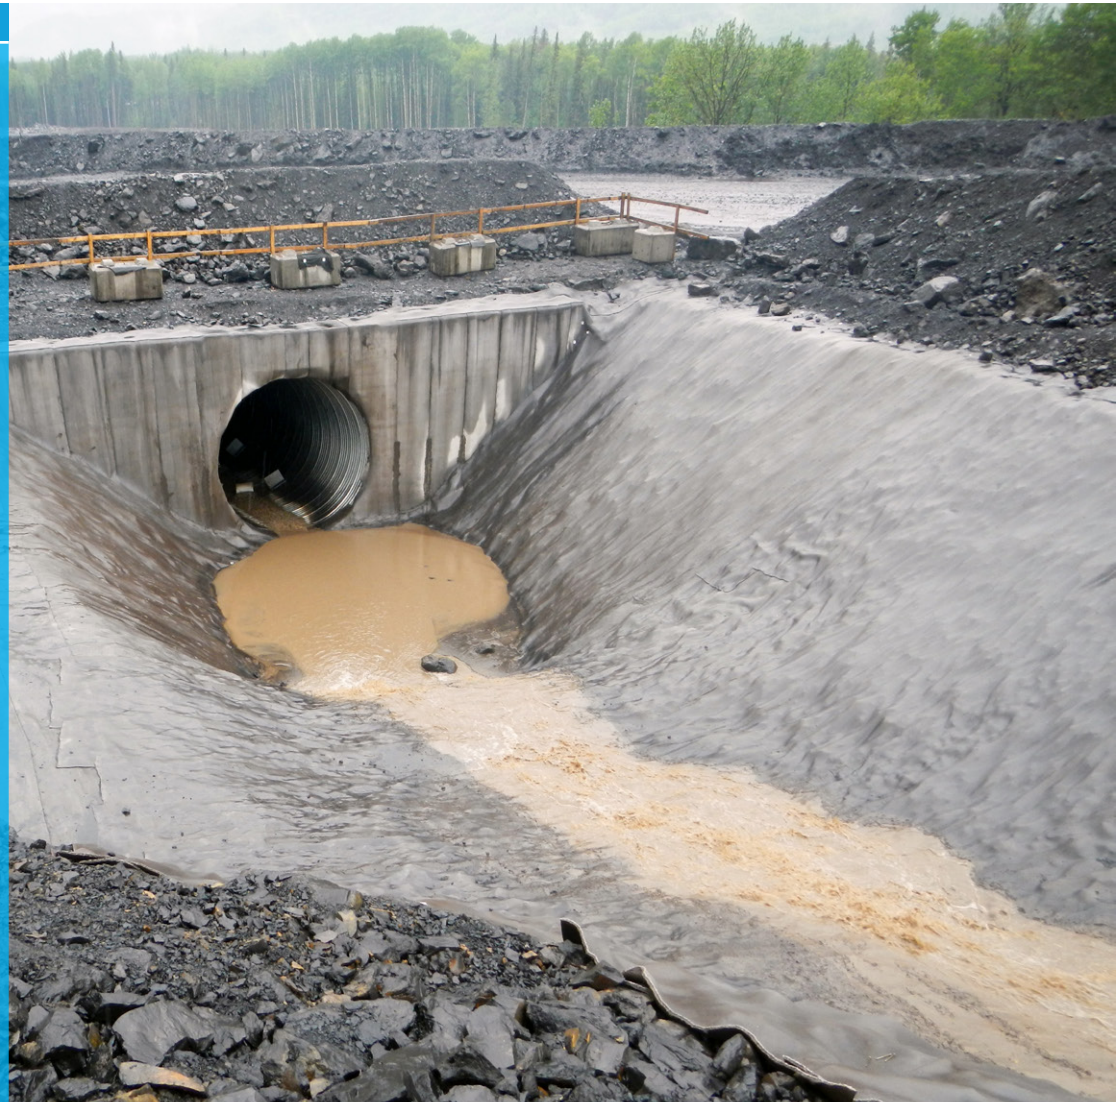
Completed lined channel and culvert

The channel terminated in a 4m diameter corrugated steel and concrete block work culvert and sump which was also lined with CC to ensure minimum water loss. This was imperative as the water was contaminated from tailings and could not come into contact with any other water sources.

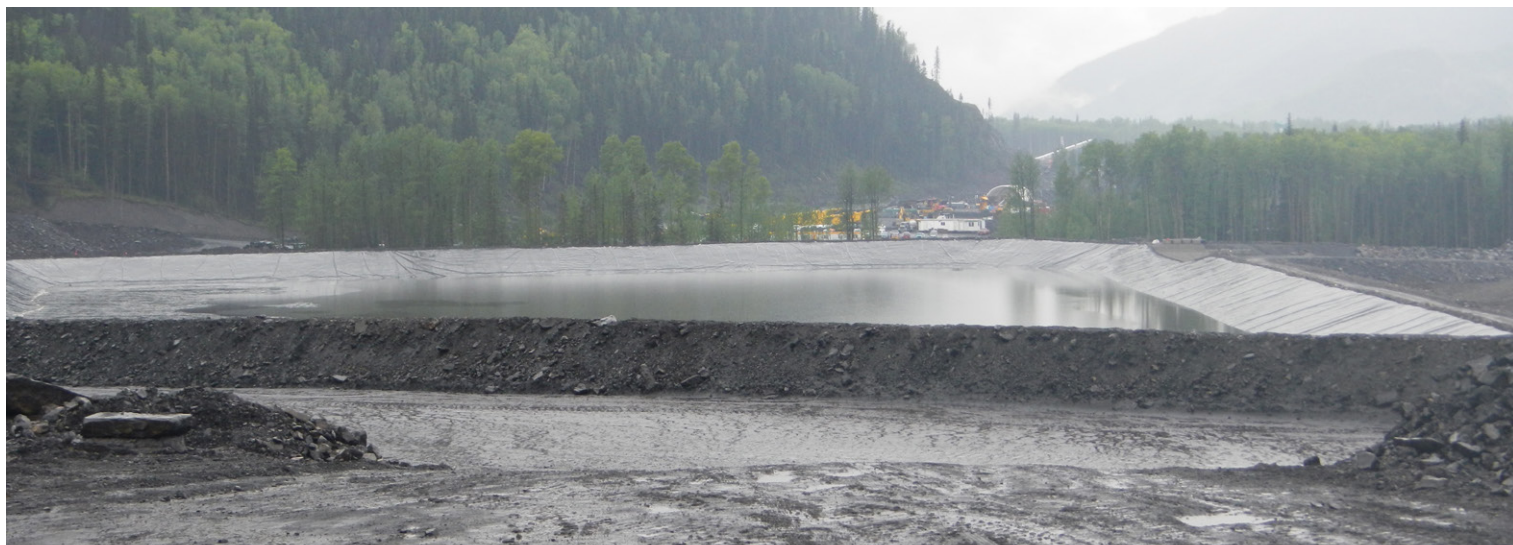
Large settling pond collecting effluent from nearby Willow Creek mine

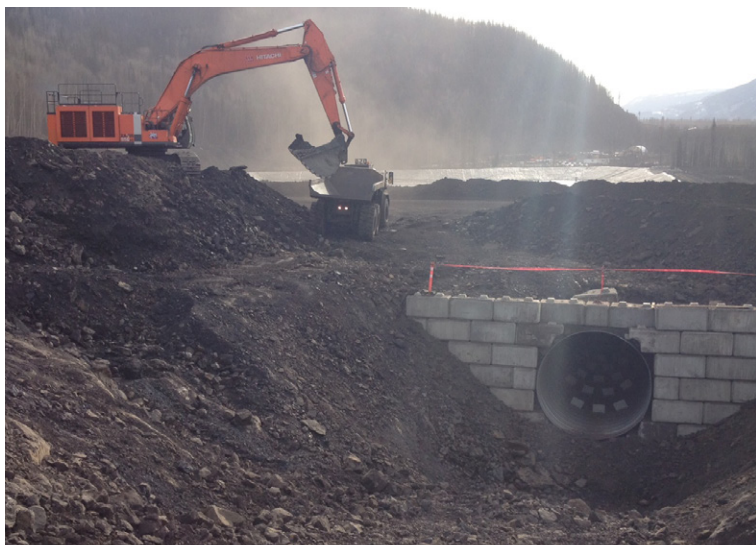
Excavating sump and constructing culvert

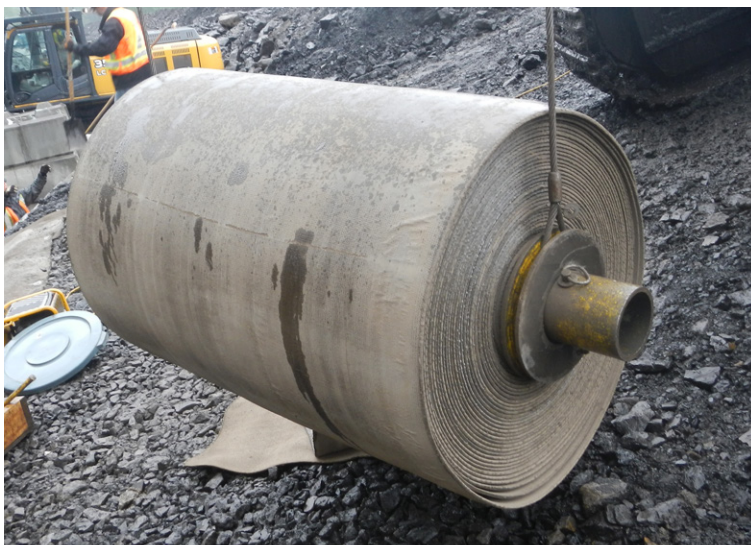
CC bulk rolls dispensed using spreader beam and plant

CC8™ and CC13™ were specified for the project and dispensed in bulk rolls from a spreader beam and plant equipment. The material was unrolled and cut to length on site, minimising waste as lengths were cut to match each section of the channel's profile. No perishable formwork or additional reinforcement was required.

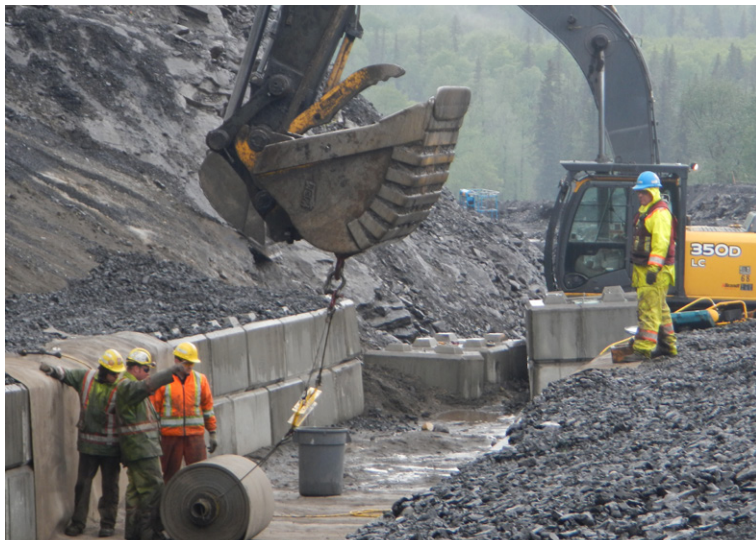
CC deployed across channel width

CC layers were laid transversely across the width of the channel, with subsequent layers overlapping by 100mm and beaded with Sikaflex 1A adhesive sealant to create water tight joints. Overlaps were jointed using 25mm screws to ensure intimate contact with the substrate. Where possible, end edges were buried with loose shale and aggregate to prevent water ingress under the CC and provide a neat termination.

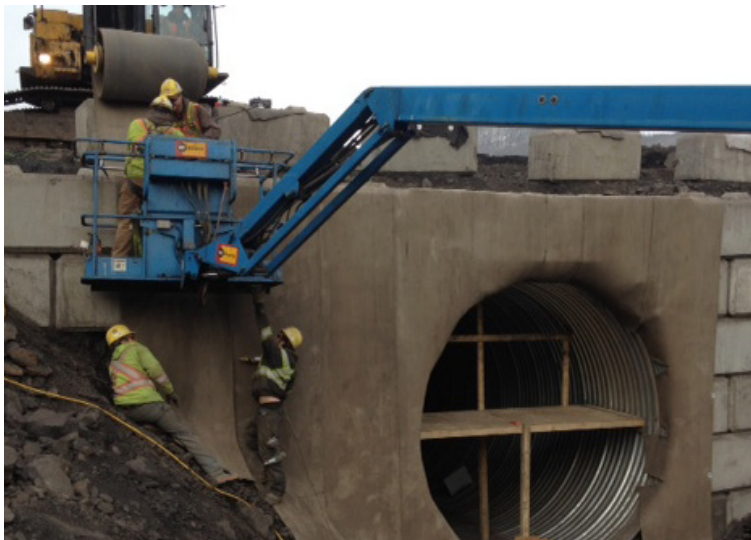
Lining culvert with CC8™

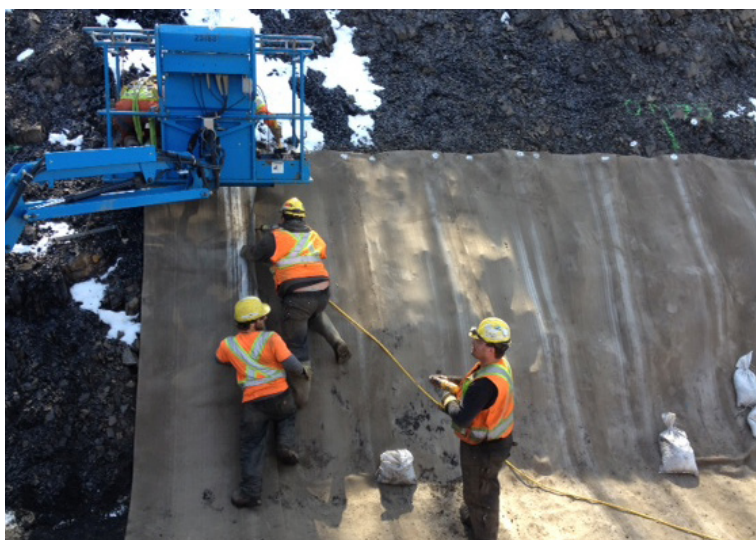
Applying SikaFlex beading to joints

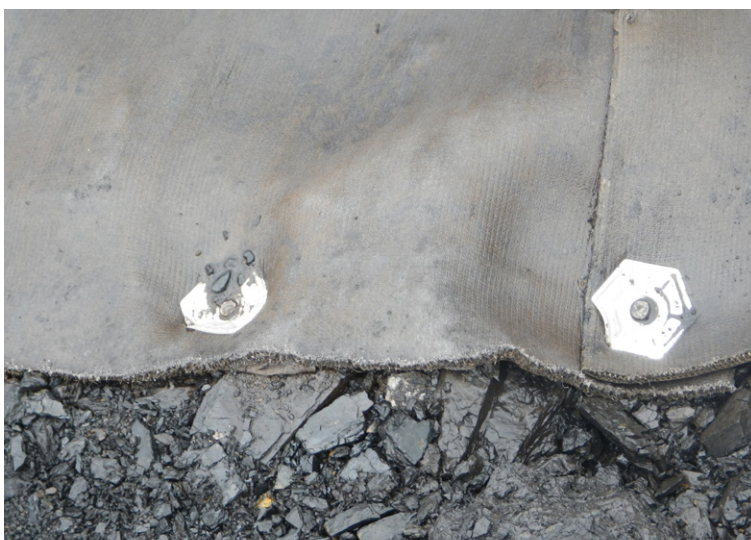
6" steel anchor nails with 1" hex head washers

The channel was excavated from a blasted rock substrate, with some sections reinforced with concrete block work. CC layers were pinned into position at the top of the profile using 10" Ardox galvanised spikes. When fixing CC to the concrete block work, Hilti rock anchors were used.

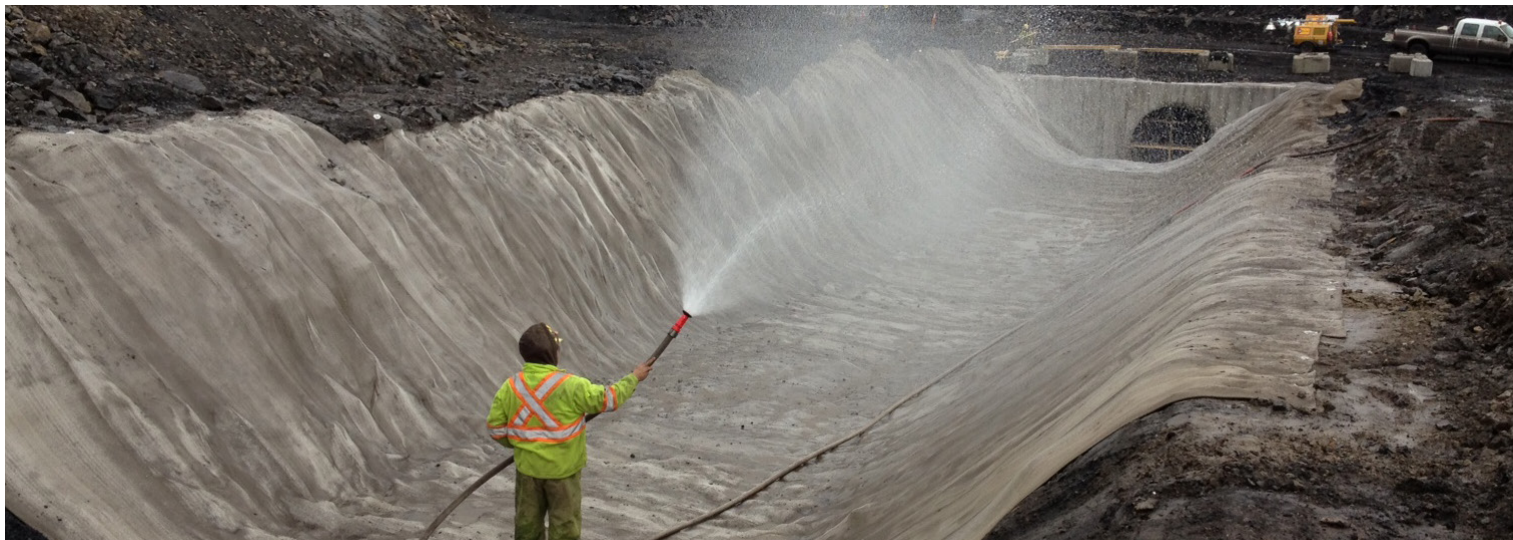
Hydration of lower channel section

CC has a working time of approximately two hours from hydration, meaning that work can continue in very wet conditions. This can reduce programme disruption typically caused by bad weather when using traditional concrete solutions. Plastic sheeting was used to protect the CC during setting when temperatures dropped to below -5°C.

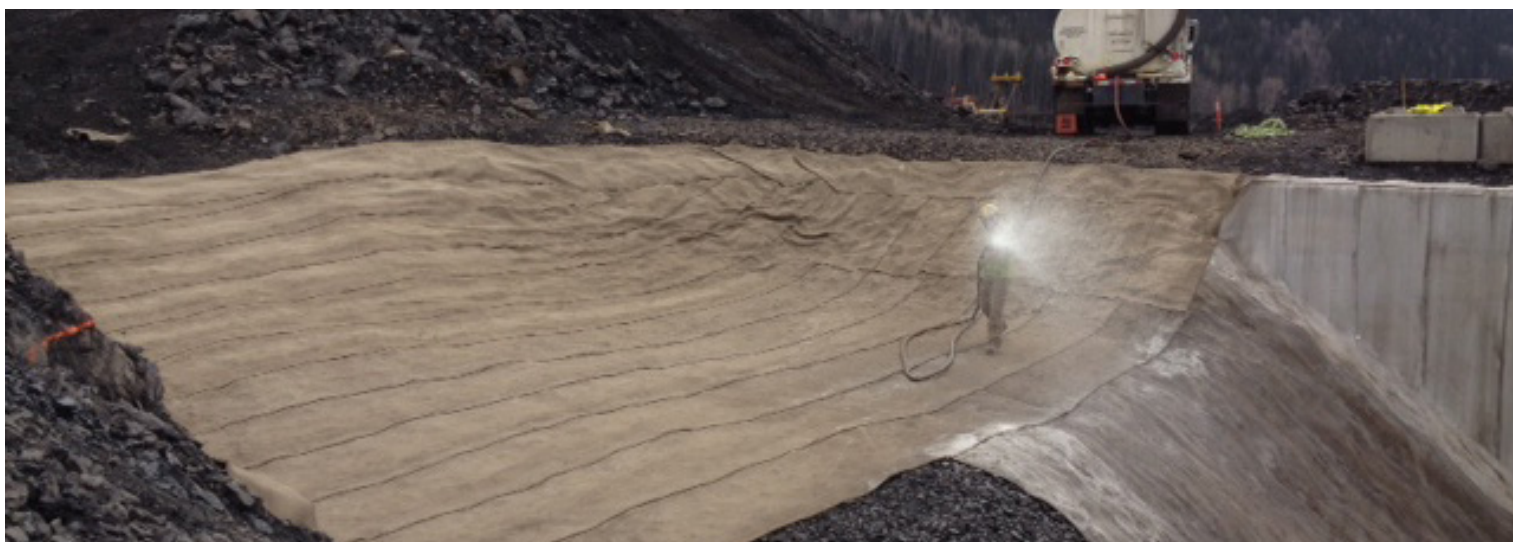
Hydration of top section of carrier channel

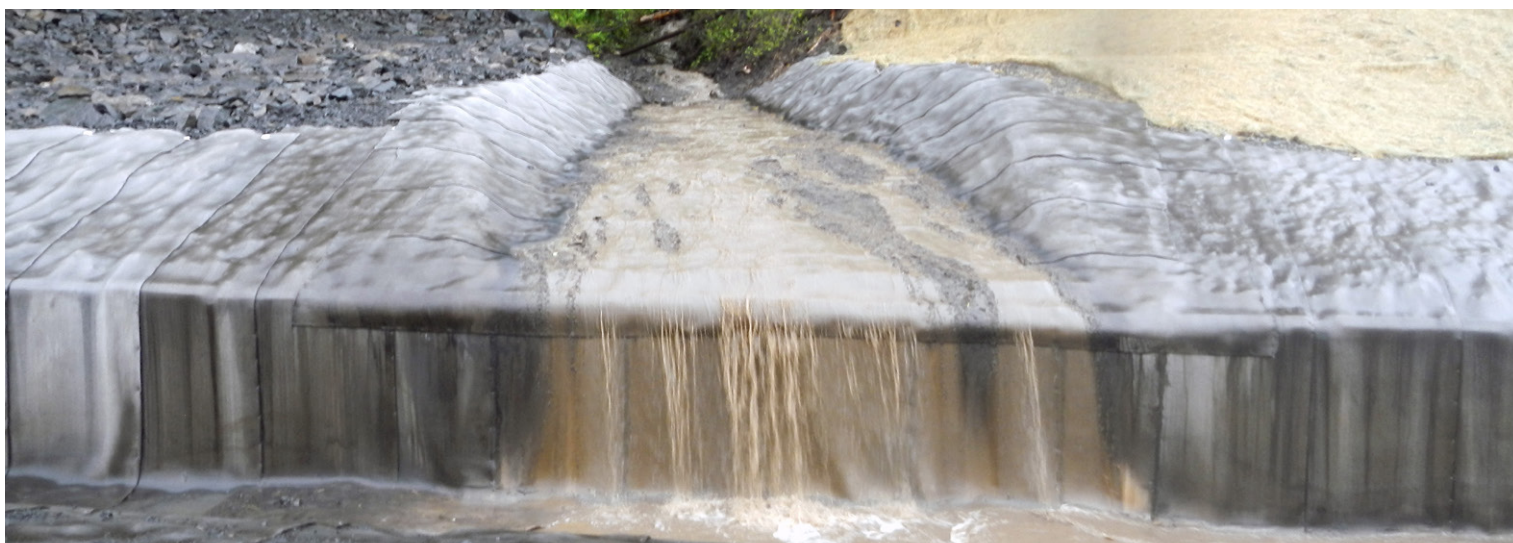
Swale was formed on the north ridge of the channel at a nearby tree line to collect surface rainfall from an adjacent hillside

A swale was formed on the north ridge of the ditch at a nearby tree line to collect surface rainfall from an adjacent hillside, using the ability of CC to closely follow the profile of existing slopes and negotiate tight bends and curvatures.

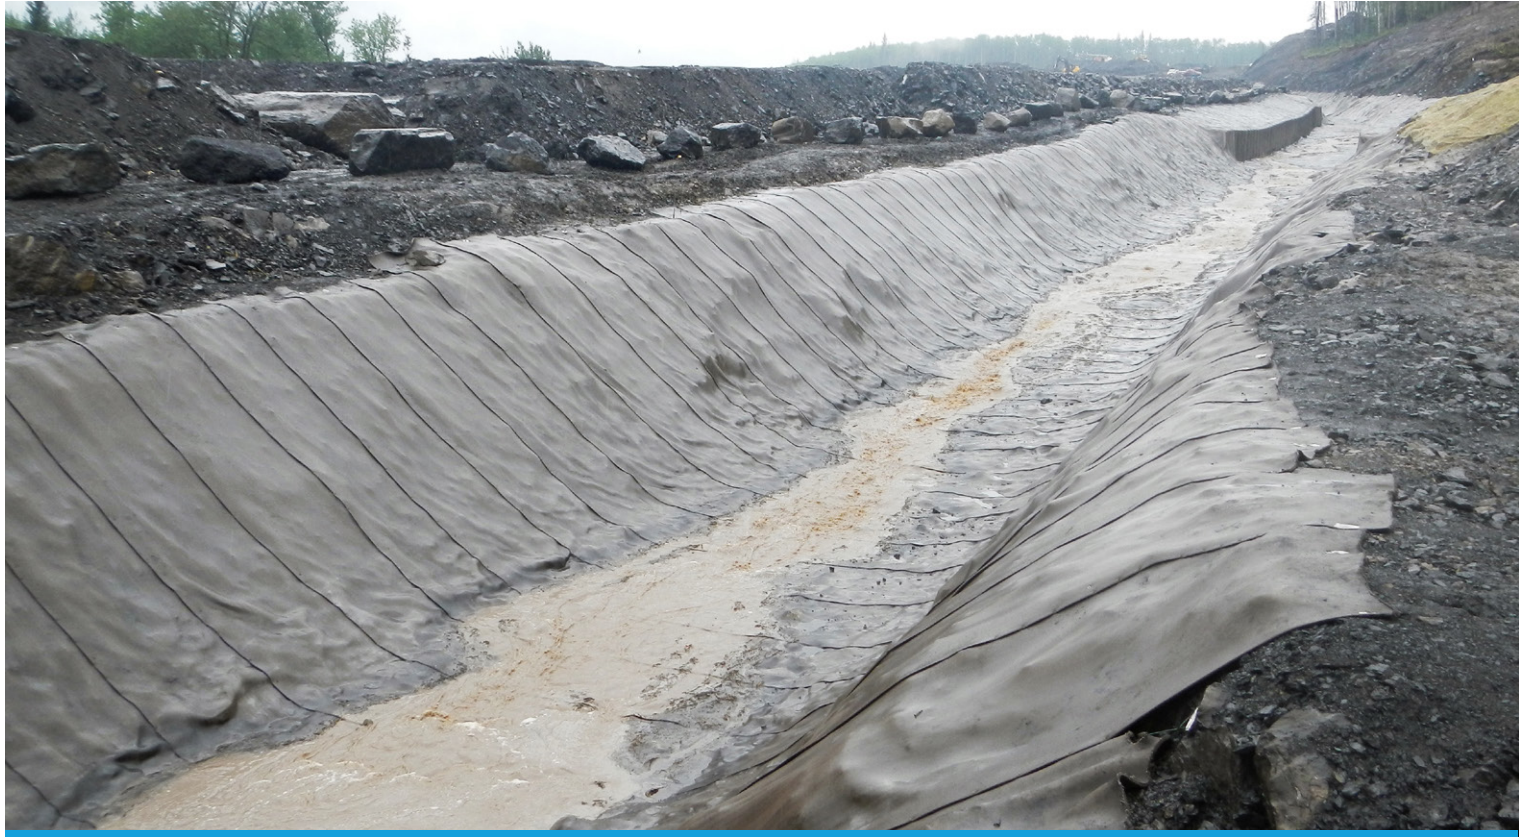
Completed lined channel

A total of 10,150m² of CC material was installed by Ledcor Group on schedule in under six weeks, on a remote site and in difficult weather conditions. Ledcor were impressed with their first experience of installing CC, noting several advantages of using CC compared to traditional concreting methods: speed and ease of installation, minimal amount of training or specialist equipment required, ability to install CC in all weather conditions, minimal waste material compared to shotcreting. CC also provided substantial cost savings for the project.
