CC13™ Bulk Rolls

Threlkeld, Lake District

CC13™ was used to provide a robust layer to a channel linking a dam outfall to a lagoon to prevent water loss.

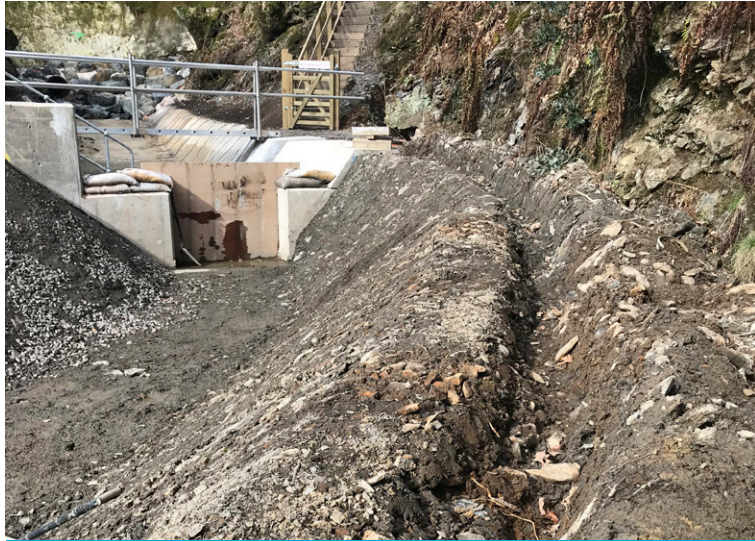
*Channel following regrading, profiling and creation of anchor*

In preparation for the installation, the flows from the watercourse from the outfall pipe were diverted around the installation site by means of fluming and overpumping, involving significant enabling works prior to installation and regrading of the channel to provide a level and consistent profile. This proved a challenge within a Lakeland watercourse during the winter months, however these challenges were successfully met in providing the works.

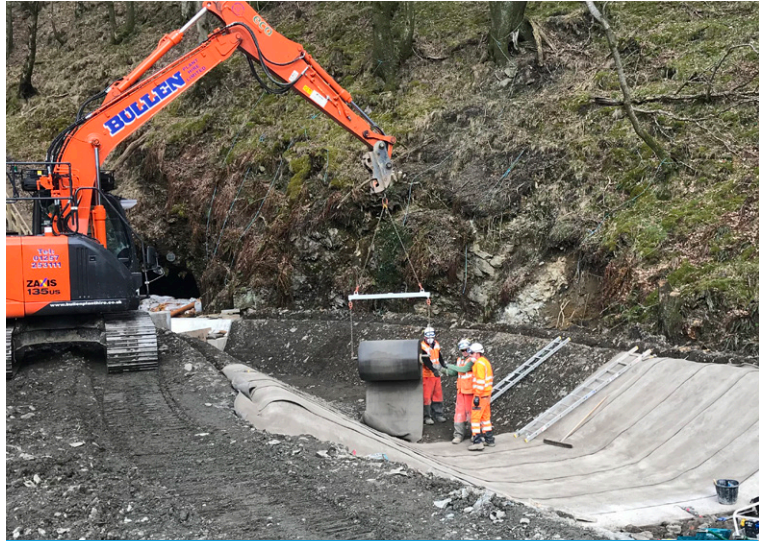
*CC was deployed from a spreader beam and digger and laid transversely*

CC was delivered to site and deployed from a spreader beam suspended by the excavation plant. The material was then laid transversely across the channel, with subsequent layers overlapped and secured using stainless steel screws and sealant. The edges of the CC material were fixed to the substrate with ground pegs within pre-dug anchor trenches which were then backfilled to prevent ingress. Following each day's work, the CC was hydrated using water deployed from a spray bar.

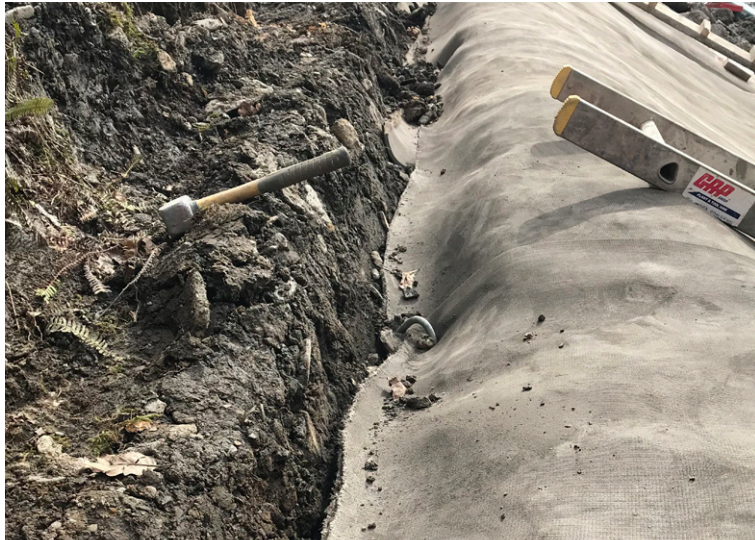
*Ground pegs were used to secure CC edges in anchor trenches*

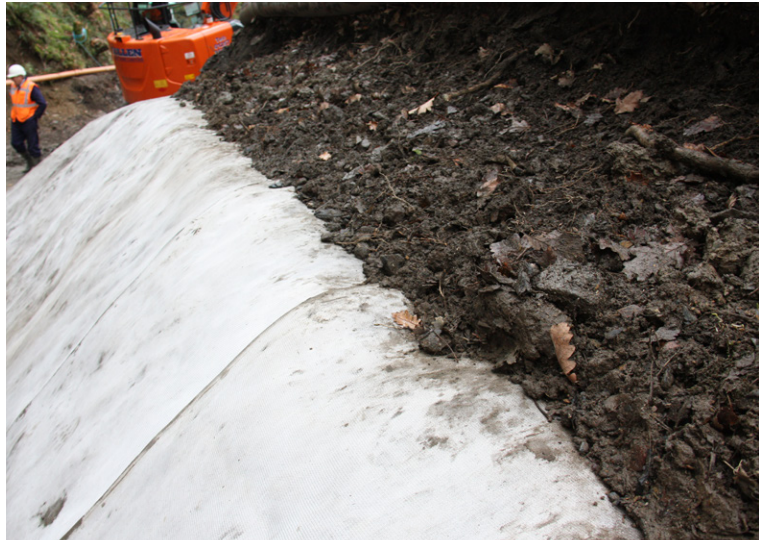
*Backfilled anchor trench*

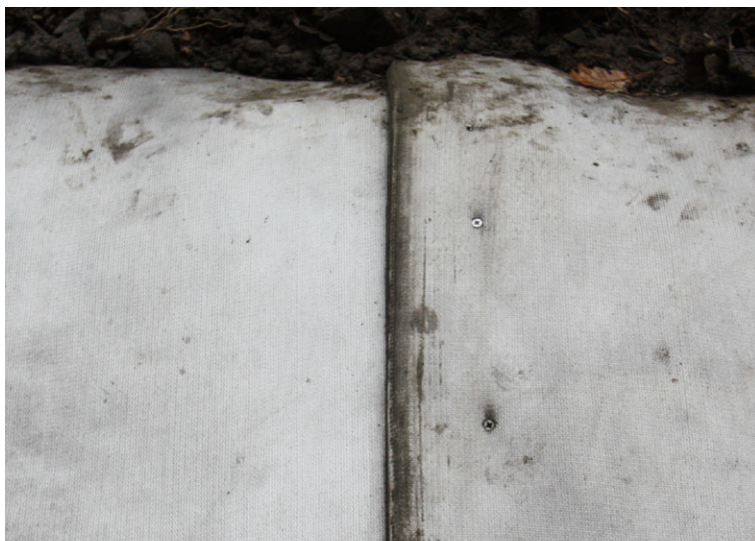
*Stainless steel screws were used to joint CC overlaps*

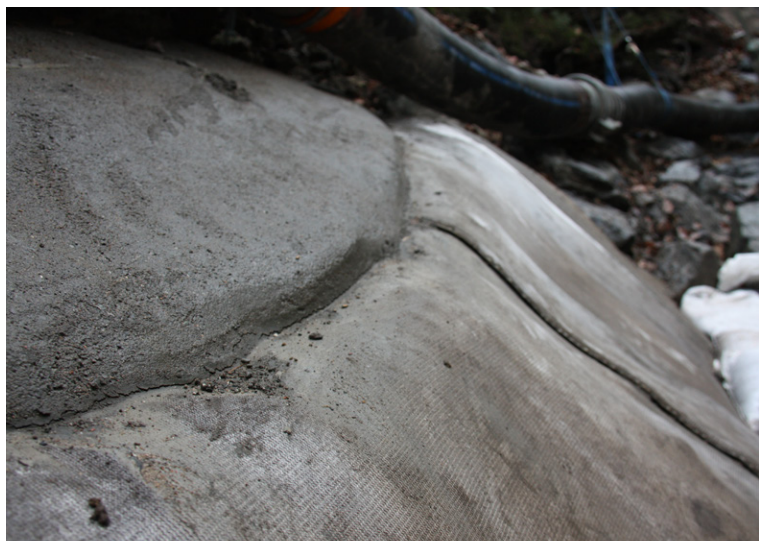
*CC edges sealed using poured concrete instead of anchor trenches*

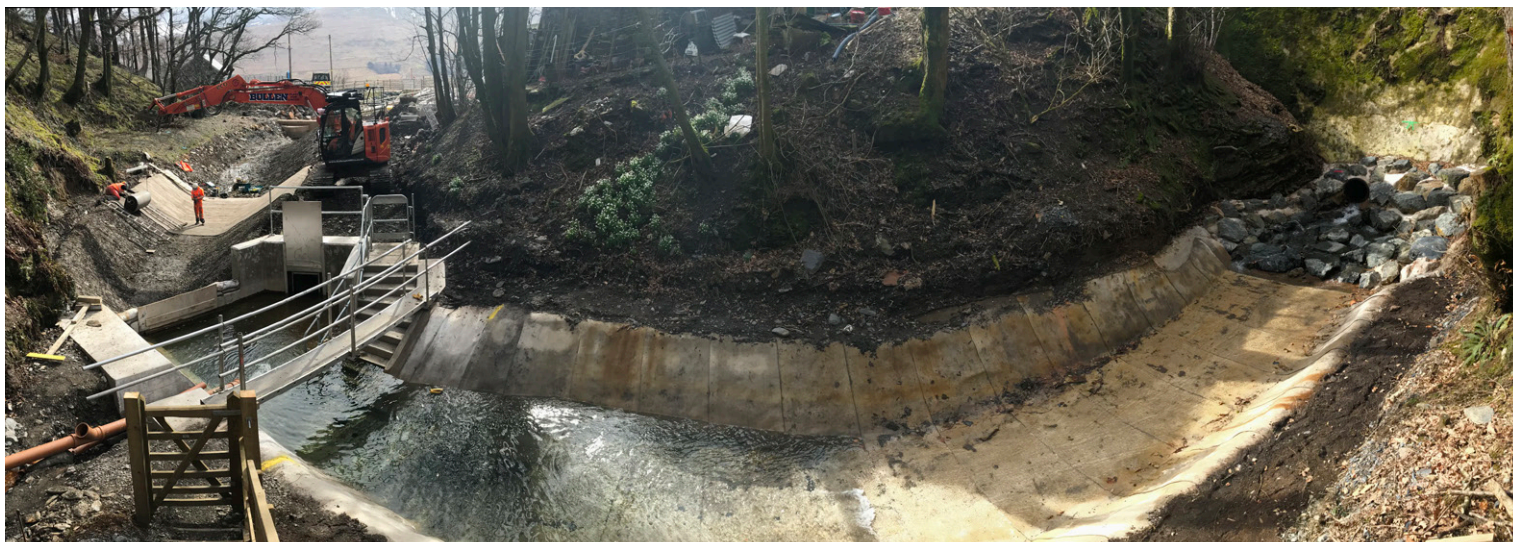
*Panorama of installation site, with section two installation underway*

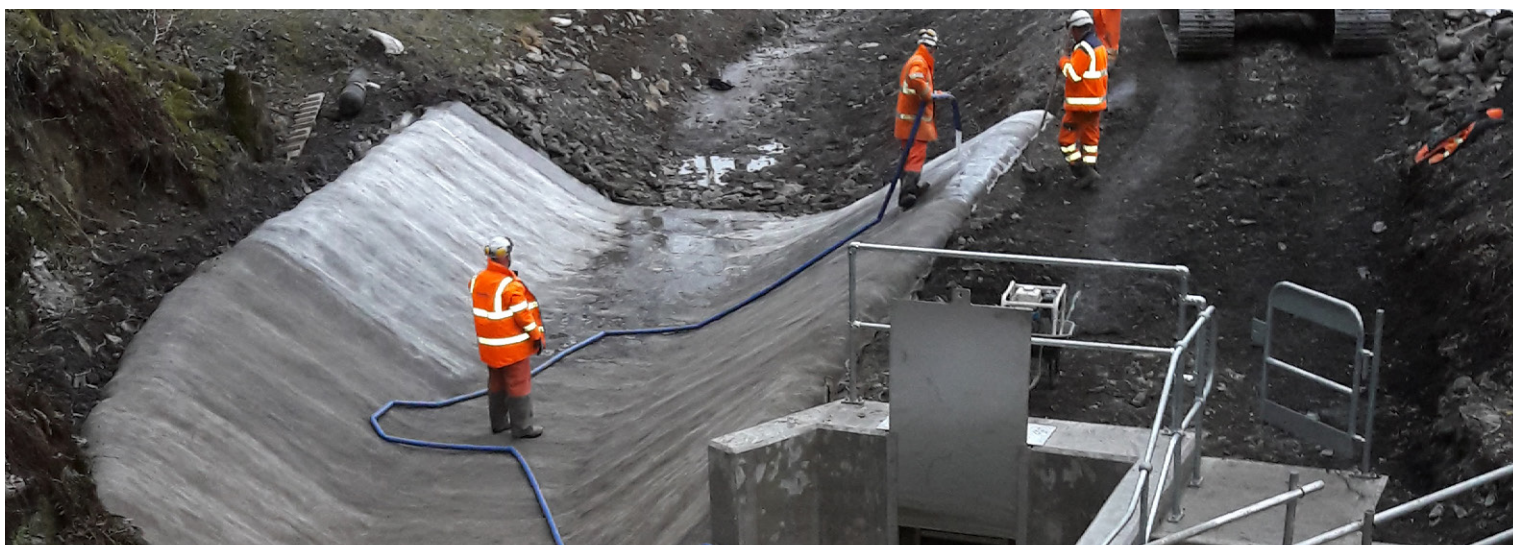
*Hydration was given at the end of each day using water from the dam*
