CC8™ Bulk Rolls

Takhini River area,  
Whitehorse, Yukon

CC installed to provide  
surface & storm water  
containment and  
eliminate water path  
erosion.

In September 2014, Concrete Canvas® (CC8™ - GCCM) was specified as a channel lining solution in a trial application on Gully Road, intersecting the Takhini River road in Whitehorse, Yukon, the smallest territory in Canada, located in the north-west of the country.

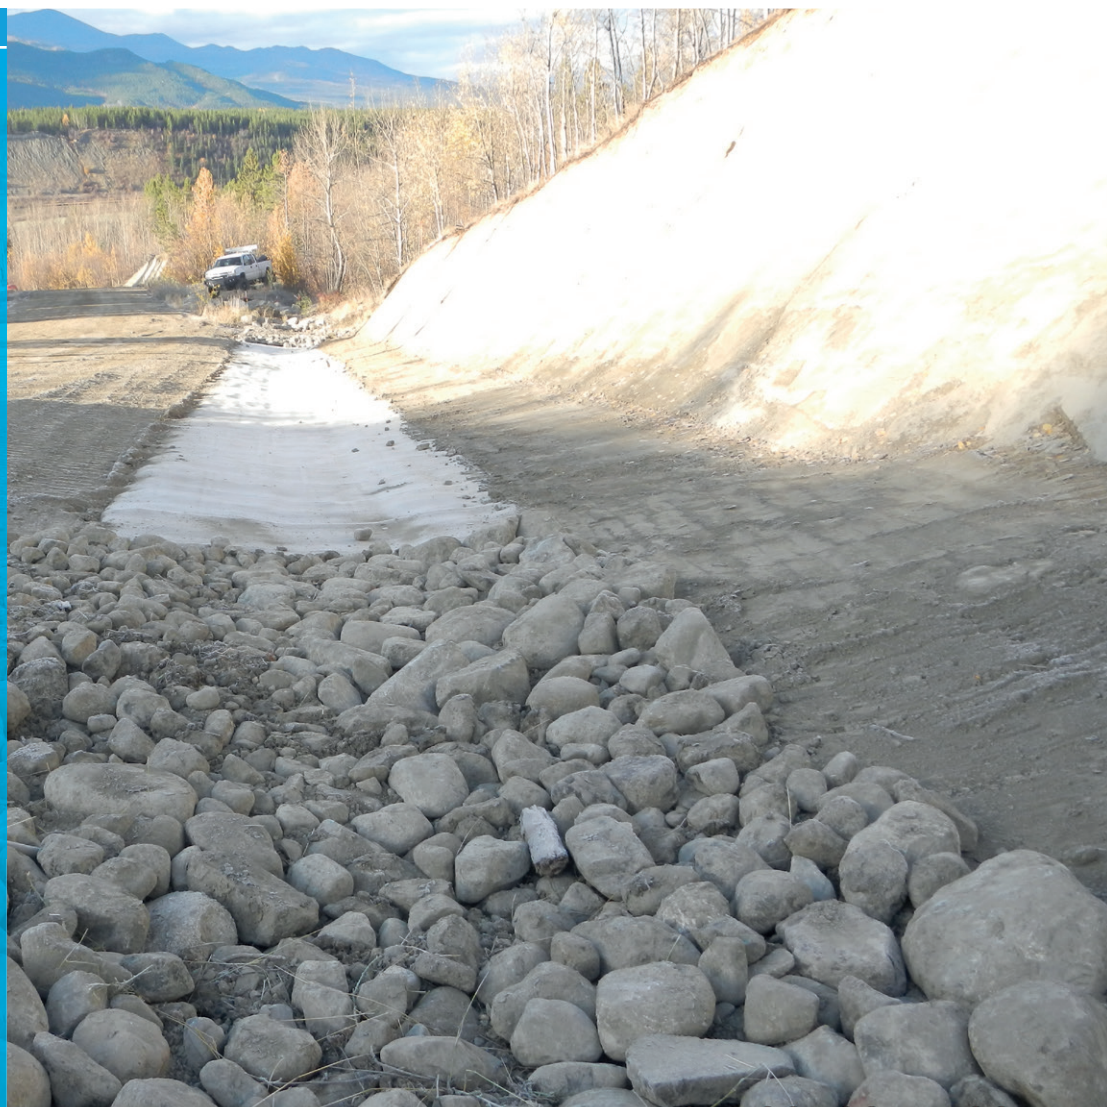
Completed channel

The project was completed by a team of three in just 8 hours. Since installation, the client has observed no migration or damage to the CC and no undermining or erosion of the substrate below. Water is travelling within the confines of the lined portion of the channel as designed.

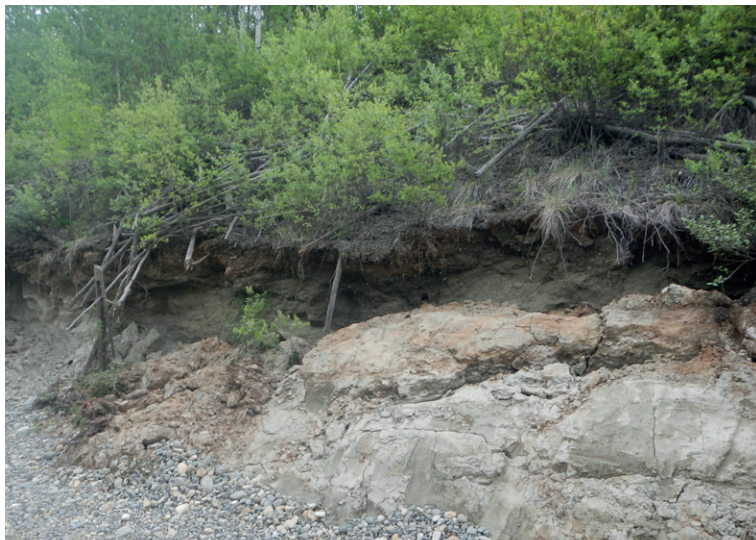
*Condition of slope prior to installation*

Gully Road carries surface water runoff and precipitation from natural benches on the top (farms), down to an area at river level. Gully Road was constructed through a natural drainage and water is carried by roadway channels and a small natural drainage system to the North West. The natural soils of the area consist of sand and are free from any rocky or angular material, making them prone to erosion. The slopes in the area have previously been re-graded and the channel re-profiled in attempts to mitigate water path erosion. This compromises both the stability of the back slope and the roadway.

As water path erosion begins to undercut the slope, sloughing occurs, creating a temporary damming effect. This damming effect changes water direction and causes erosion to the roadway surface, making it unstable and potentially dangerous. During changeable weather conditions, which cause freezing at night and thawing during daylight hours, there is also potential for frozen slurry to create a damming effect.

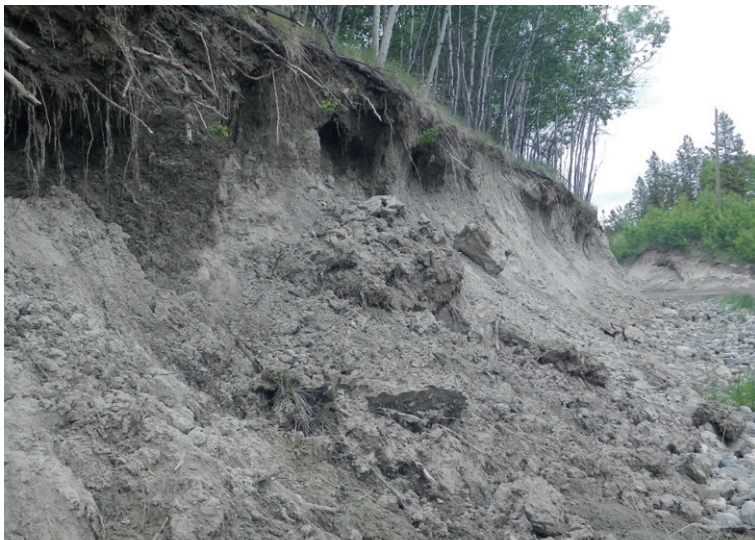
*Sand-based substrate in the area was prone to erosion*

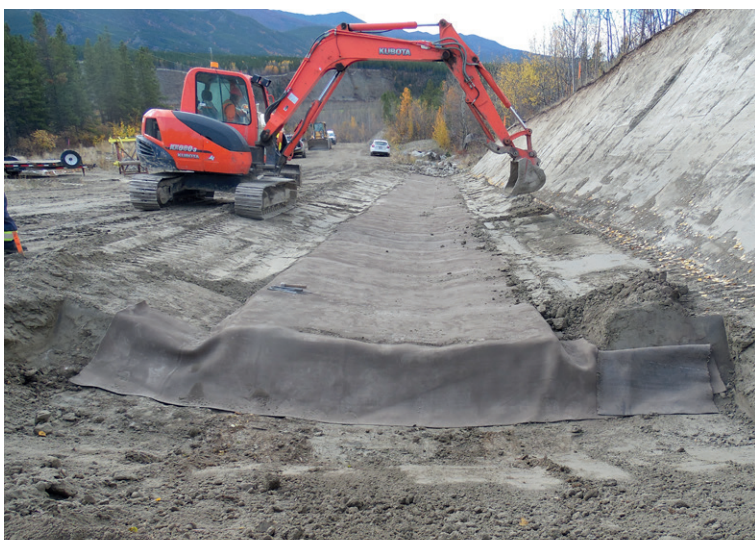
*CC edges were captured in a large anchor trench which was later backfilled*

An area was selected to install and observe the overall suitability and performance of the CC during melt conditions. In preparation for the installation, vegetation was removed from the substrate and the slope re-graded to 1:1. The channel was then re-profiled. The CC was deployed using a transverse layup with a 100mm overlap in the direction of flow. Overlapped lengths of the CC were jointed with 22mm screws at intervals of 300mm. The outside edges of the material were captured in an anchor trench and fixed using spikes.

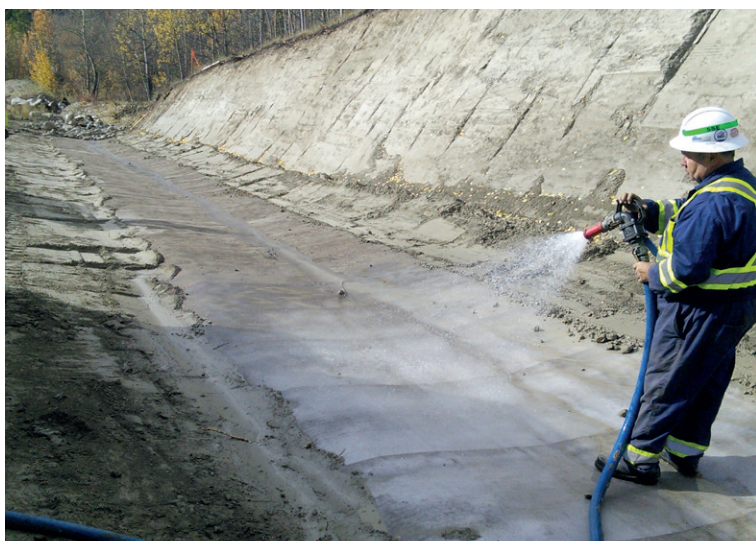
*Hydration*

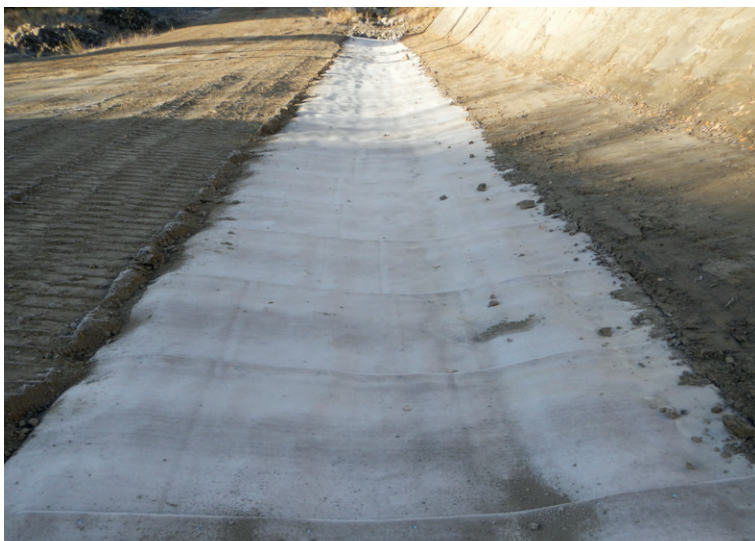
*Completed channel trial installation*

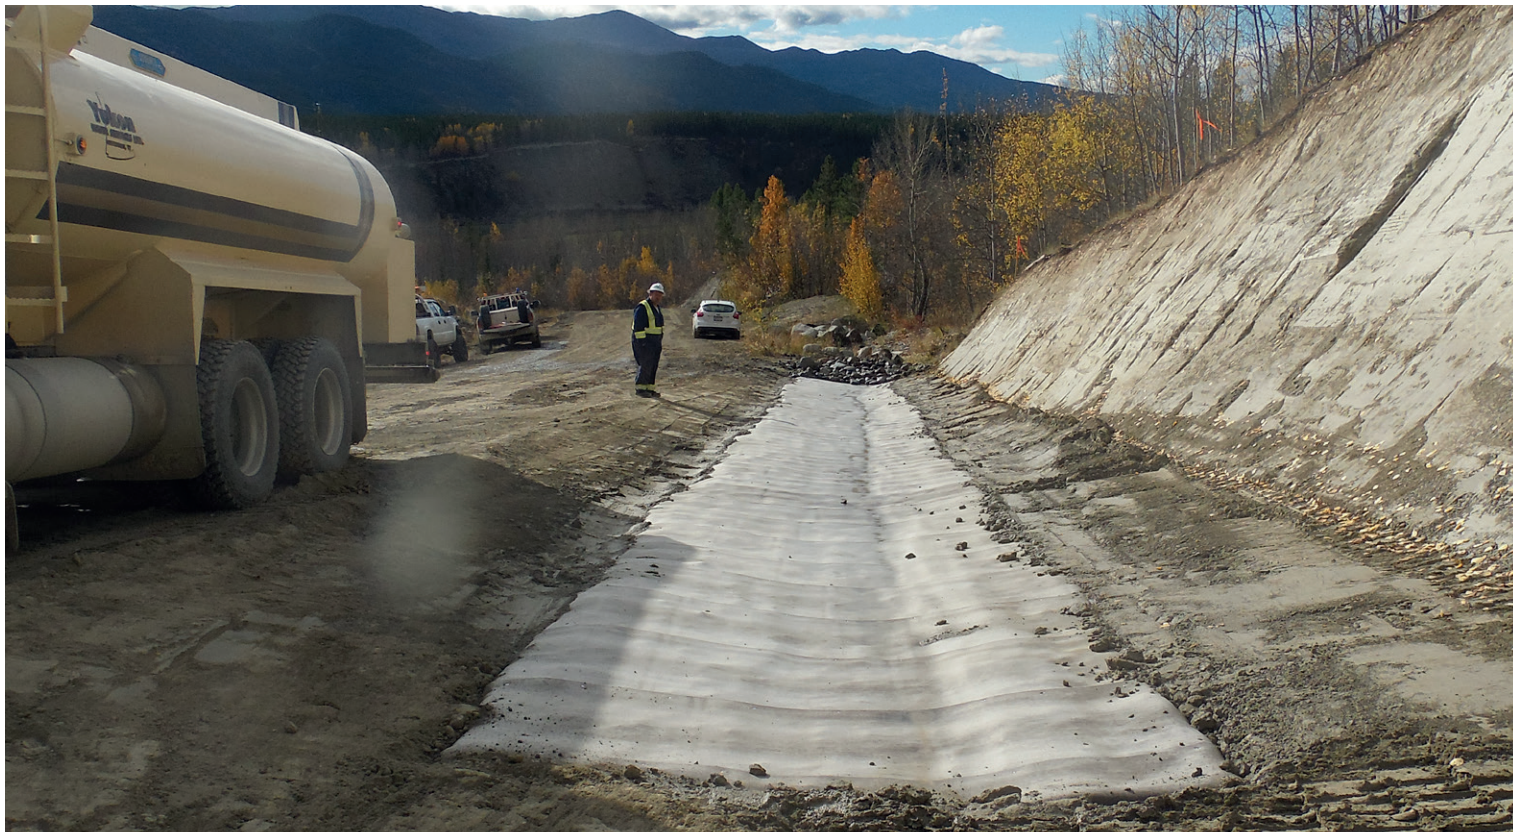
*Completed installation*
