CC13™ Bulk Rolls

Halfway Bridge, West Sussex

CC13™ used to provide scour protection to a culvert under the A272

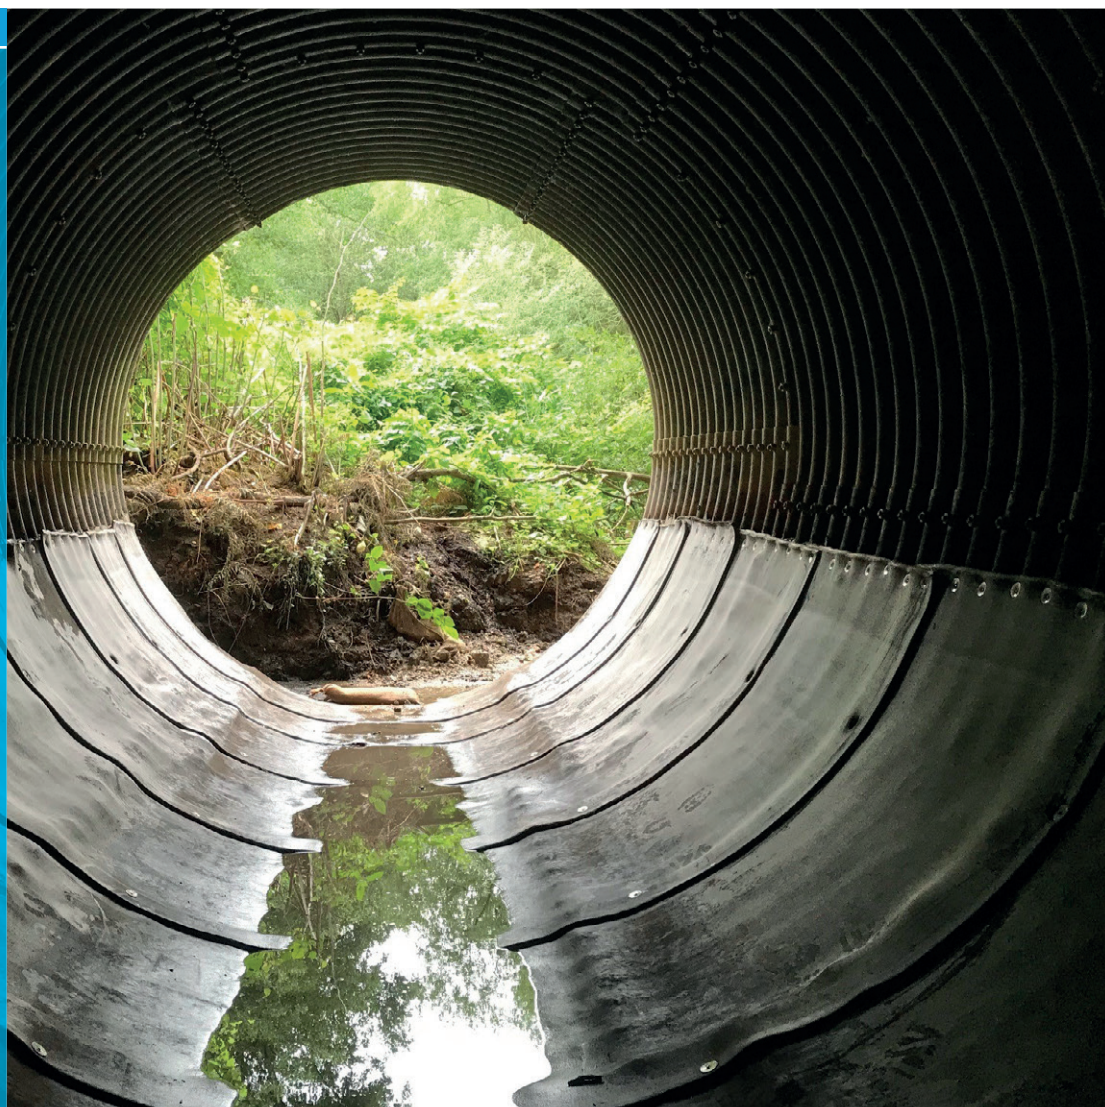
Completed CC culvert lining installation

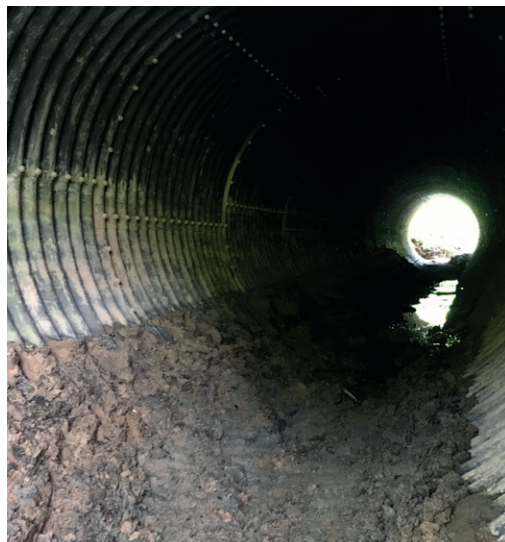
The culverts direct the river Rother under the A272 at Halfway Bridge, and were degrading due to sediment flow. One of the three was becoming increasingly affected, with a large amount of silt build up reducing its capacity.

Thick silt build up in culvert 1

Following damming, silt build up was removed from the culvert inverts by hand, and the corrugations filled with grout. The specified CC13™ material was delivered to the site in bulk rolls, allowing the team to cut the material to required length on site. The CC was installed transversely and fixed to the culvert using Hilti shot-fired nails, while material overlaps were jointed using adhesive sealant for increased impermeability.

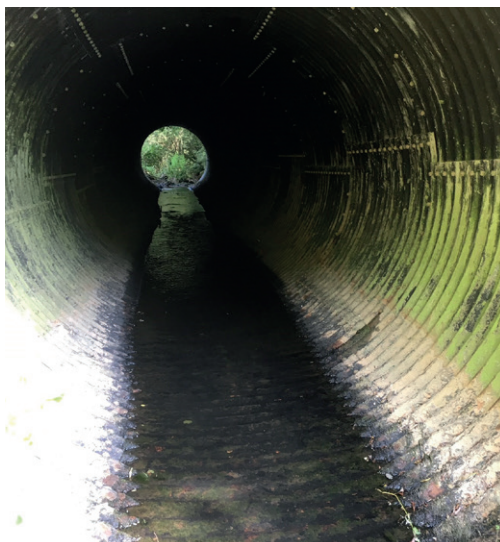
Culvert 2 prior to works

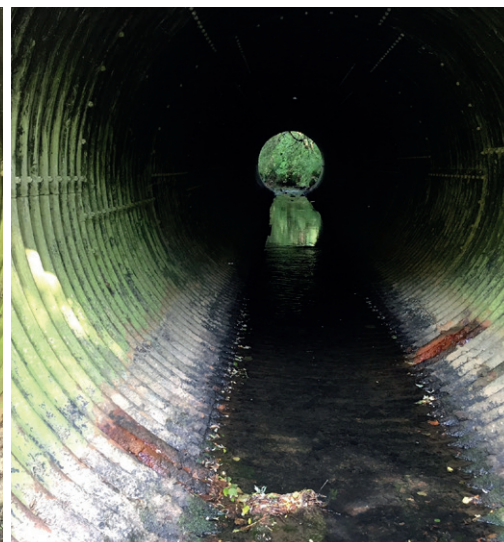
Culvert 3 prior to works

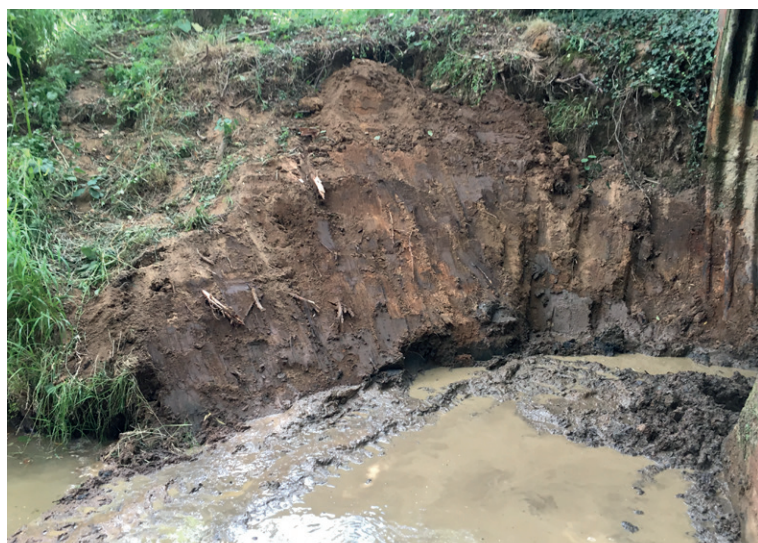
Silt and substrate removed from beside culvert 3

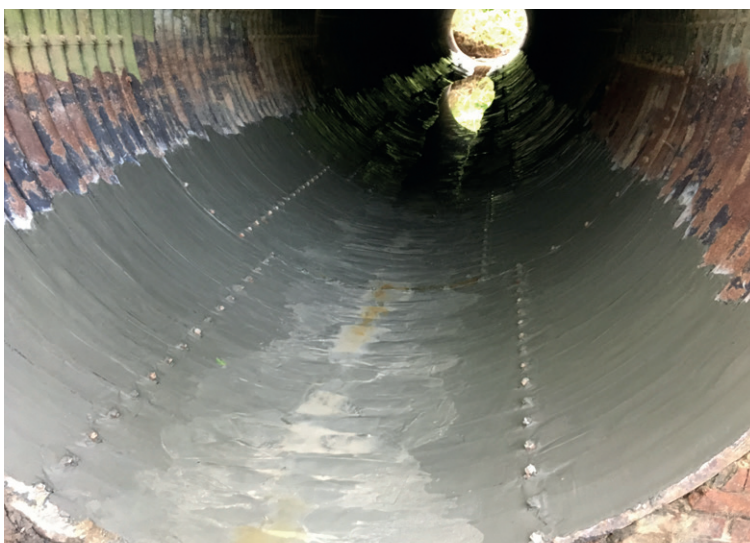
Grout applied to inverts following damming to prevent waterflow

Installation for each culvert took around 8 days, with 5 days required to grout the inverts, and 3 days for installation, including capturing the edge layers in an anchor trench, backfilling and hydration.

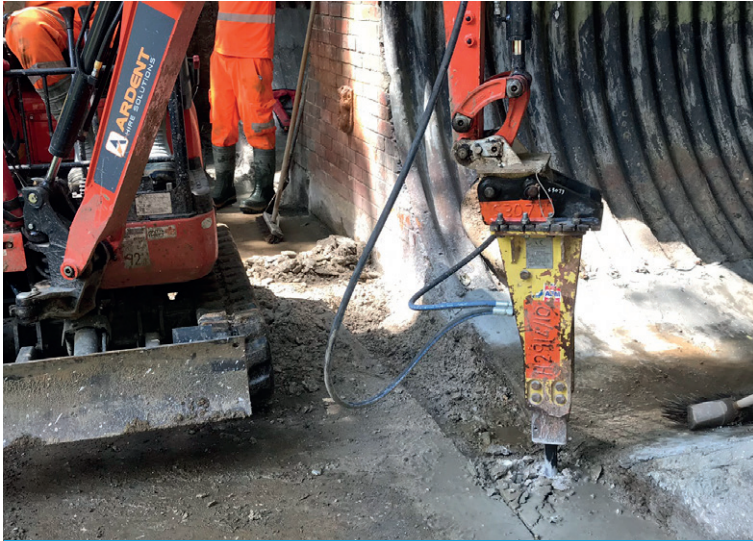
Existing concrete outside culvert removed to create anchor trench

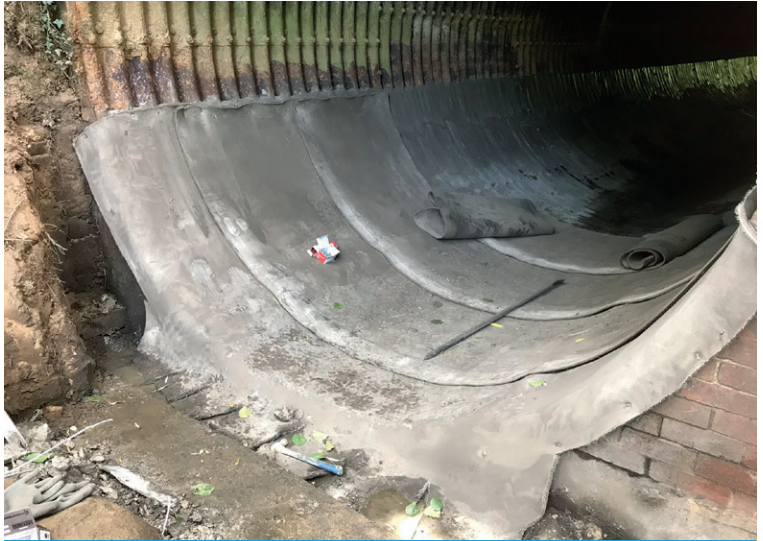
Installing first layers of CC

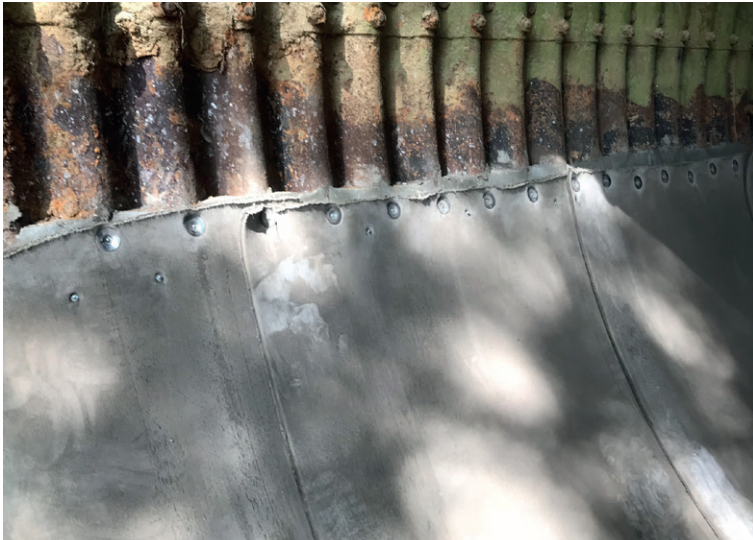
Hilti shot-fired nails used to fix CC to culvert

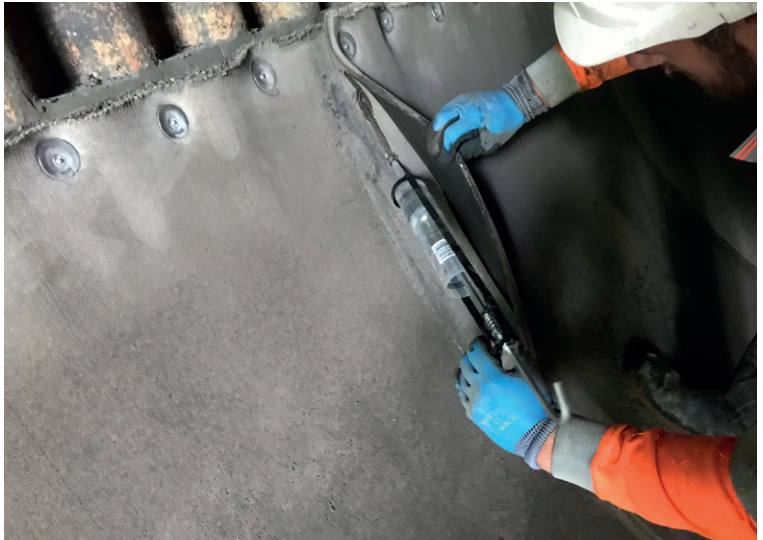
Sealing joints

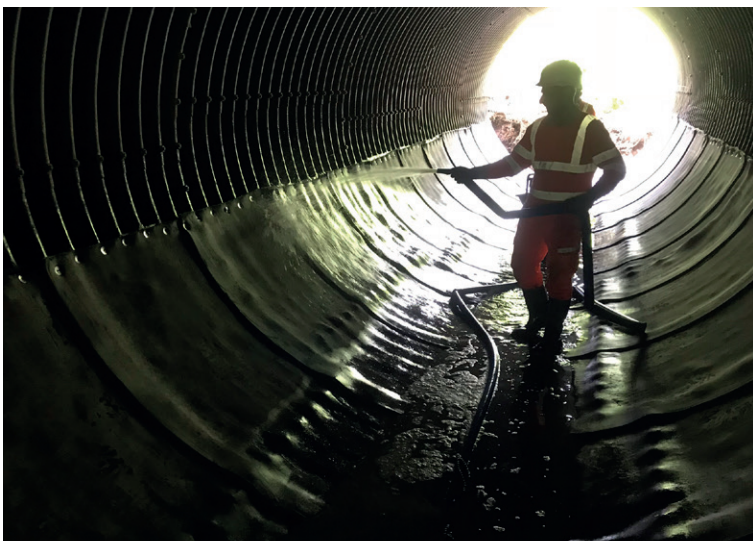
Hydration

Once installation was completed throughout the culvert, the dams were removed and water allowed to flow through it to hydrate the material on the culvert floor. Water was then brushed up the sides of the culvert to hydrate the remaining material. In some cases, the water was hydrated using a hose and the river water.

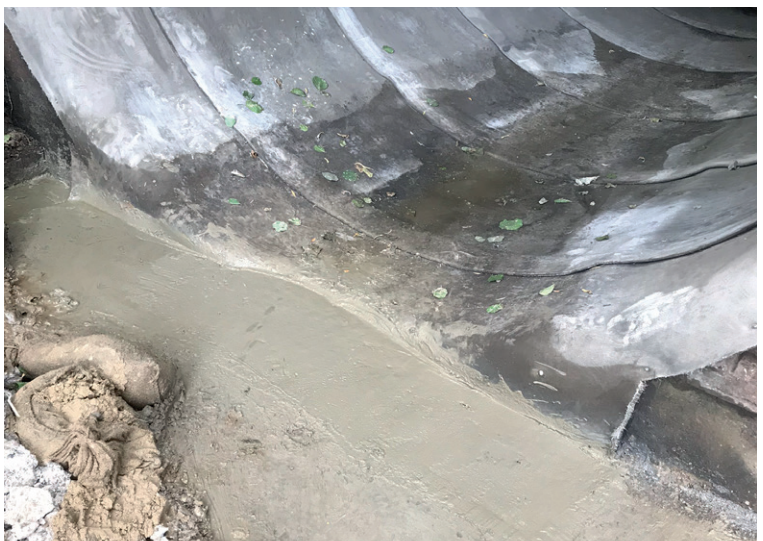
Edge of CC secured to archway and buried with poured concrete

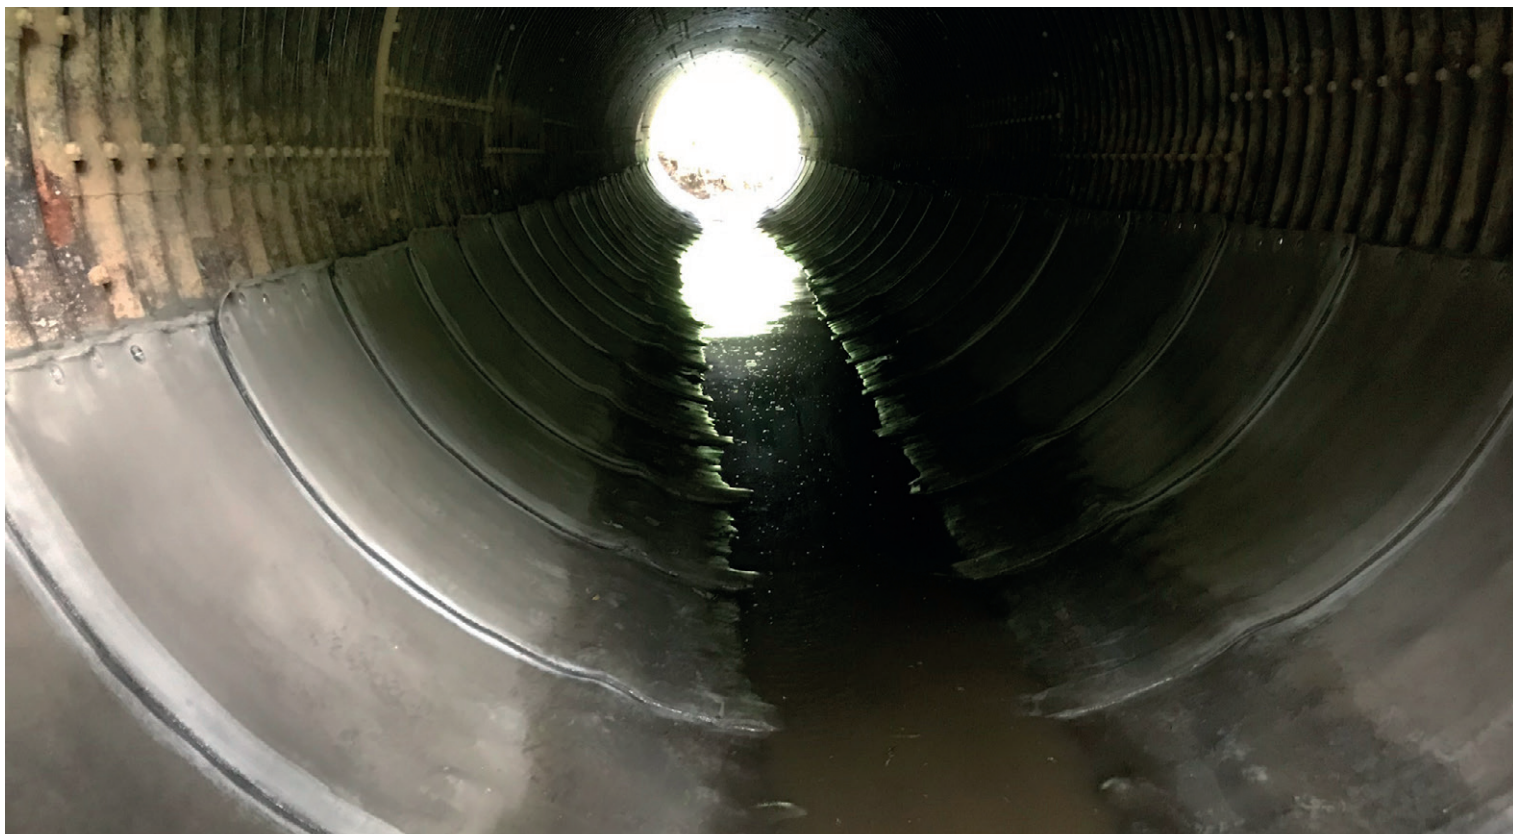
Completed culvert installation

The project was a success, with a total of 560m² of CC13™ installed by a team of four, and completed one week ahead of schedule. The clients and contractor were once again very pleased with the outcome of the project, having used CC on the Cooks Bridge installation the previous year. The use of CC will once again prolong the life of the culvert, without requirement for asset replacement, saving the clients both time and money, due to the difficulties of accessing the site.
