Project Info

Kaymac Marine &
Civil Engineering Ltd

CC used to line a
damaged culvert to
extend its working life

Completed culvert lining project below the M4 near Hendy, Wales

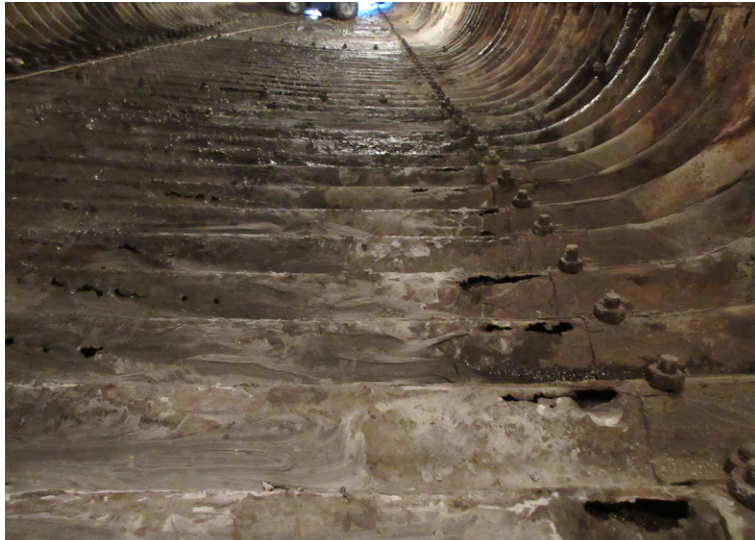
Several tonnes of alluvial silt were removed from the invert of the culvert before remediation work could begin. The removal of the silt exposed numerous holes in the floor of the steel culvert that had formed over time. The corroded holes, some as large as 100mm by 50mm, were filled with a marine grout. The removal of the silt also exposed rows of bolts that connected the pieces of the culvert together, which protruded above the culvert floor by approximately 50mm. In order to provide a level and smooth surface on which to install the CC, the inverts of the culvert floor were filled and the floor raised by 50mm to also cover the bolts.

Damaged culvert floor and sediment build up

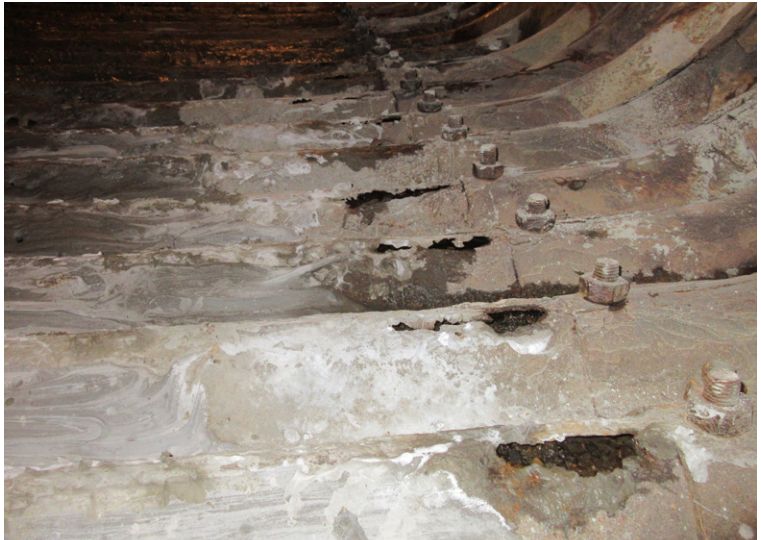
The original culvert had been installed in the mid part of the 20th century and was in need of upgrade. The invert had corroded, which would eventually lead to undermining of the structure.

Corroded culvert floor and protruding bolts

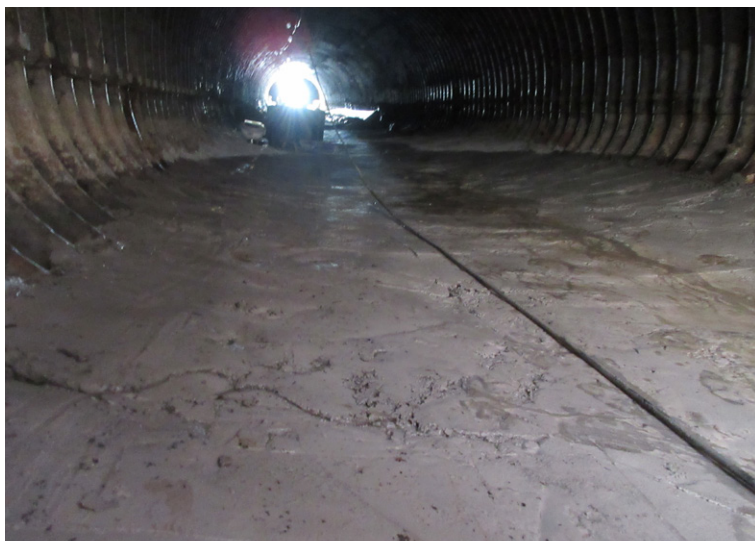
Corrugation inverts filled and floor levelled with grout to cover protruding bolts

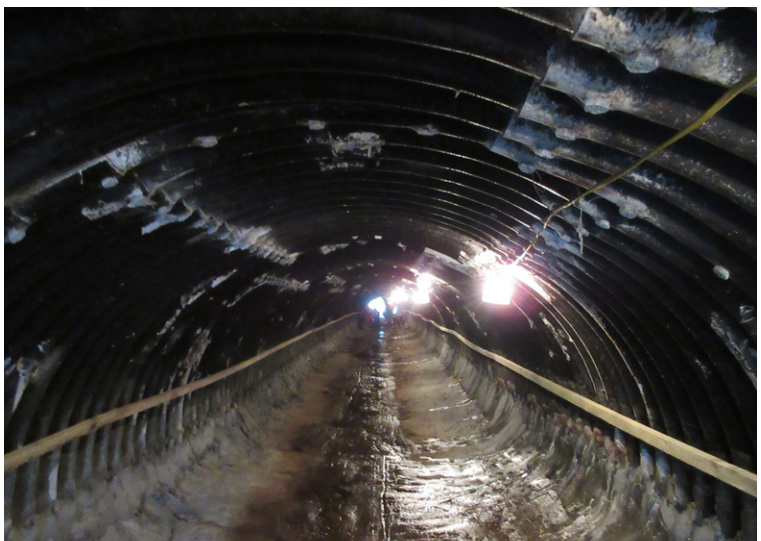
Culvert following preparation works and installation of wooden battens

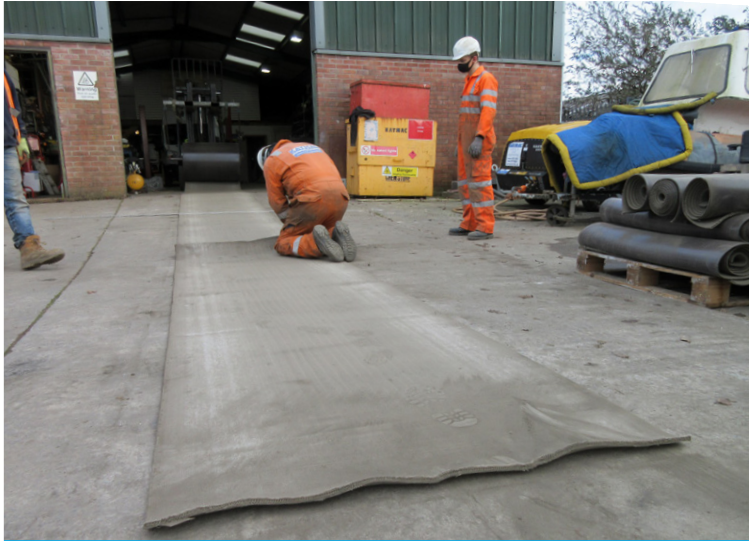
CC batched to required lengths off site

The restricted space on site meant that cutting of the CC8™ bulk rolls would have been complicated. As a result, Kaymac Marine & Civil Engineering Ltd's works manager made the decision to pre-batch the material to the required 3.5 linear metre lengths at their headquarters, where the material was delivered. The batched rolls were then easily transported to site via van and trailer, and carried to the culvert for installation.

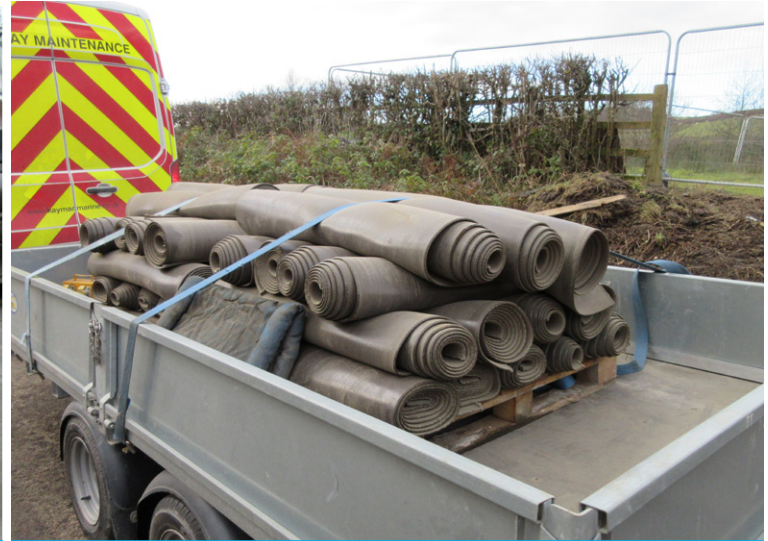
Custom length rolls transported to site on a trailer

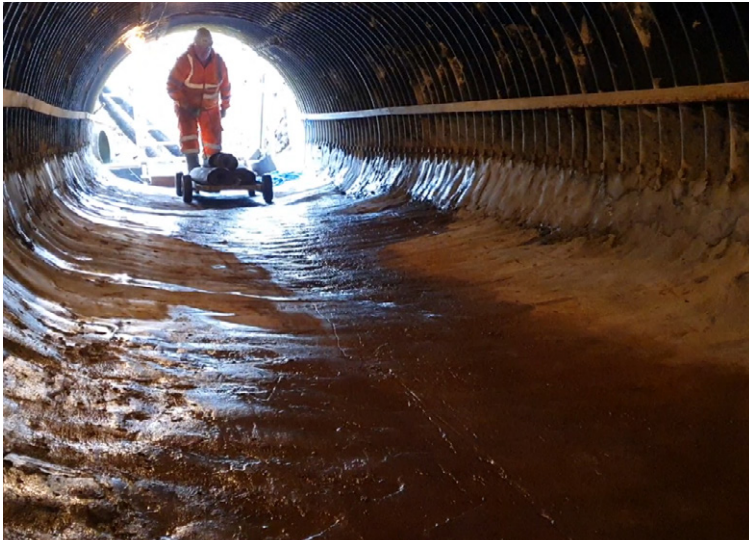
Trolley used for easy transportation of batched CC lengths on site

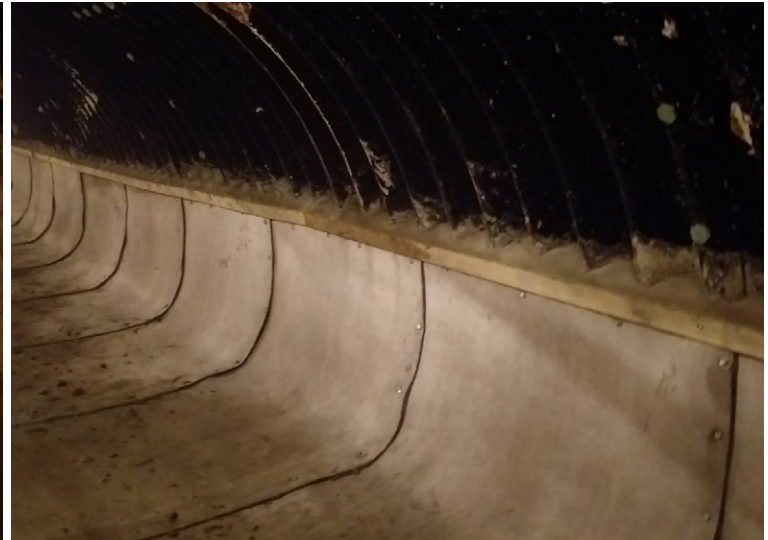
CC laid transversely across culvert floor and secured to walls

The lengths of CC8™ were deployed transversely across the culvert floor and quickly and easily fixed to the grouted inverts and steel culvert using M8 stainless steel 50mm self-tapping masonry screws. CC's 3D fibre matrix prevents dislocation of the cementitious fines contained within the material. This meant that the contractors could hang the material vertically part-way up the culvert walls during installation which significantly increased the speed and ease of the operation. For a neater termination, easier installation and to avoid voids behind the material, the edges of the CC lengths were terminated against a timber batten fixed to the culvert using additional M8 screws.

The screws were placed at 150mm centres along the edge of the material on the vertical sides of the culvert and at 200mm centres across the culvert. The screws were driven through the 100mm lap joints and topped with a 25mm diameter stainless steel washer to prevent pull-through on the material.

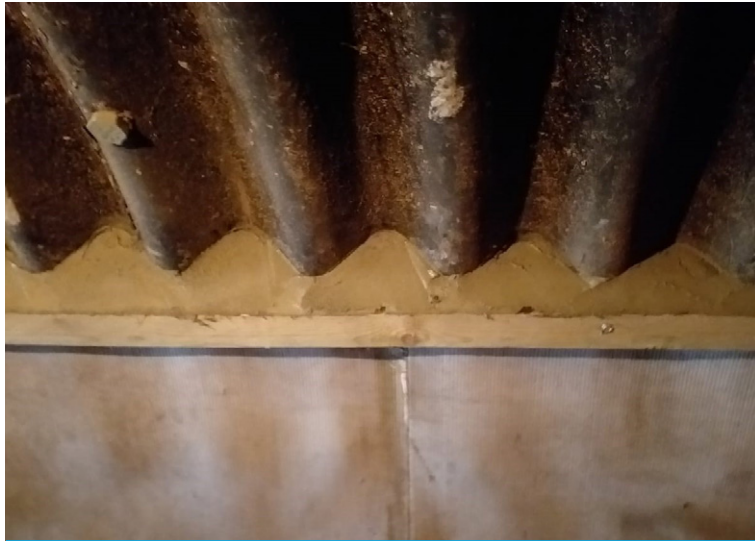
Grout used to fill voids behind material edges to prevent ingress

Once the material had been fixed and jointed it was hydrated using water pumped from the upstream dam via a lay flat hose. 24 hours later, the inverts behind the set material edges were backfilled with a grout slurry mix to fill the voids and prevent ingress behind the material. The edges and sides of the CC had an additional layer of grout applied as further ingress prevention and to ensure the waterflow of the stream could not undermine and lift the CC.

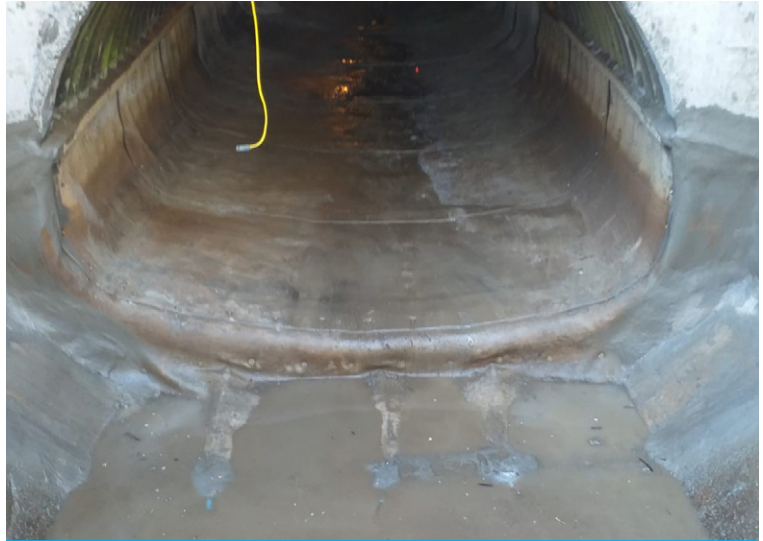
Termination of CC edges outside culvert
