CC8™ Batched Rolls

Near Southwaite,  
Cumbria, UK

Network Rail

Masonry culvert lined  
using CC8™ to prolong  
its working life and  
prevent erosion

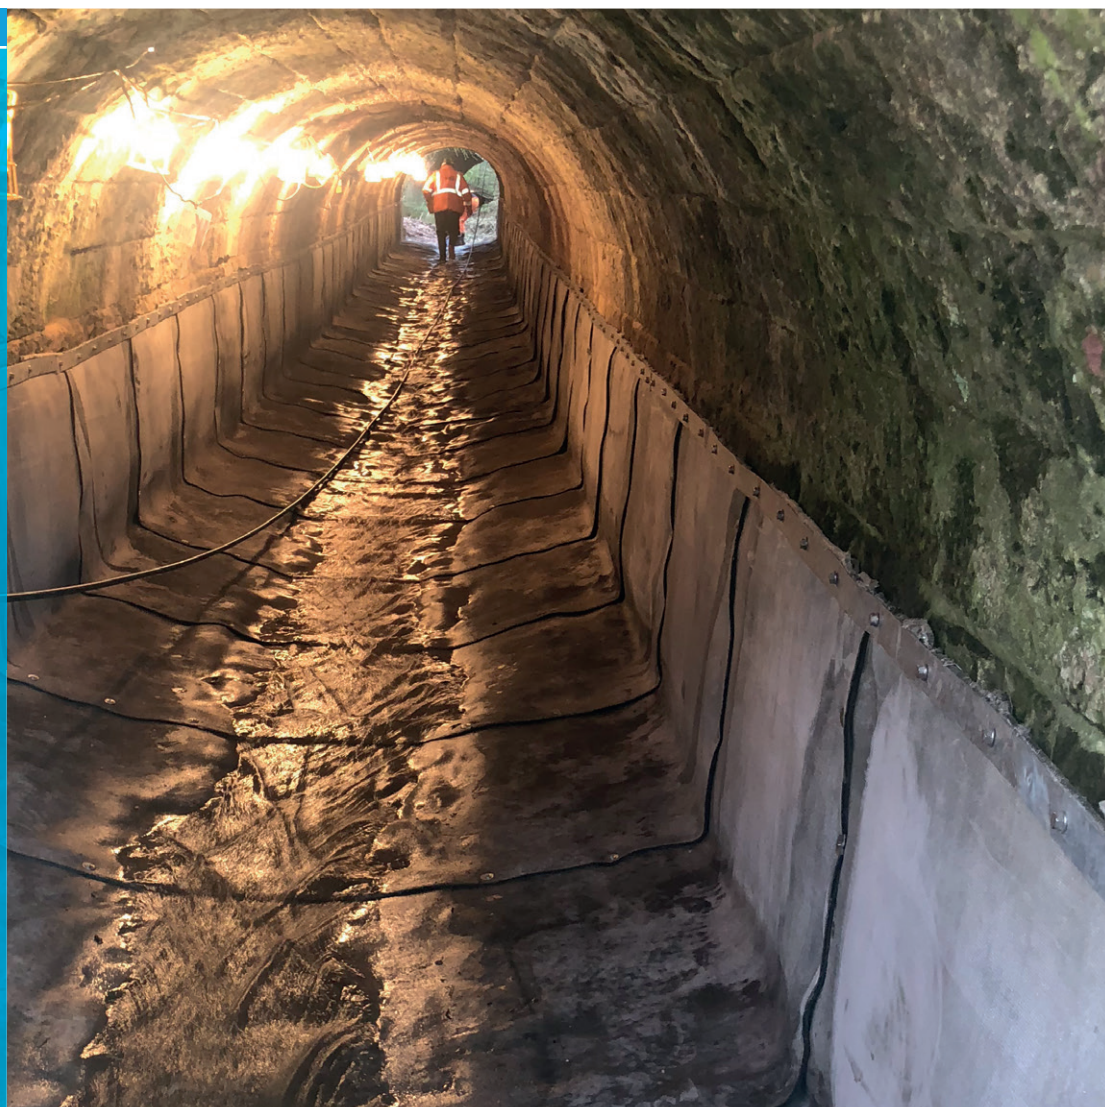
Completed installation

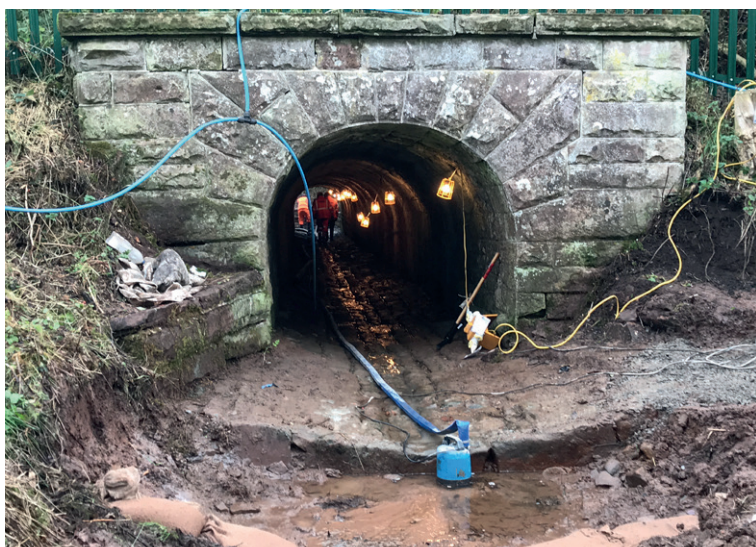
*Water overpumped*

The material was hydrated in accordance with CC's hydration guidelines. Water from the upstream side of the culvert was used with a sump pump to hydrate the material, with buckets used to hydrate CC on the culvert walls.

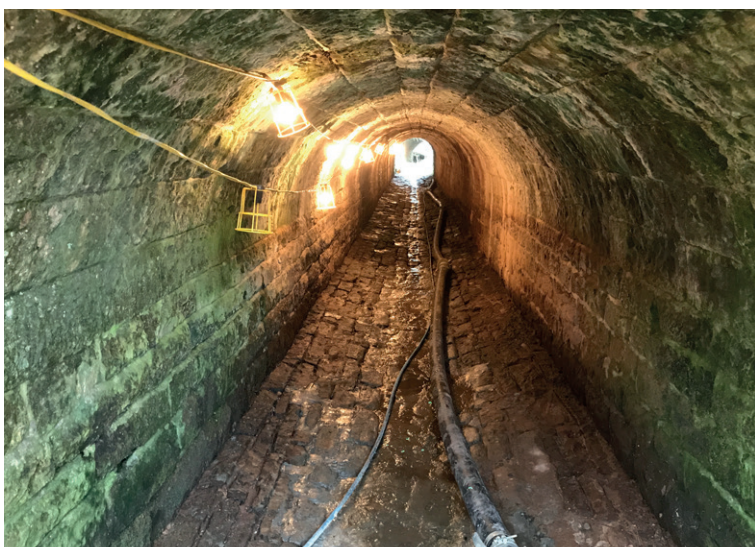
While the culvert was in a fair condition prior to the works, it was a masonry structure which had become overgrown with weeds and was in need of a lining solution to prevent erosion of the masonry floor and walls, and prolong its working life.

*Culvert prior to works*

Prior to installation, any missing sections of masonry or large voids were filled to prevent water ingress below the CC material. Vegetation was removed, and sections of a wall were repaired and repointed where required.

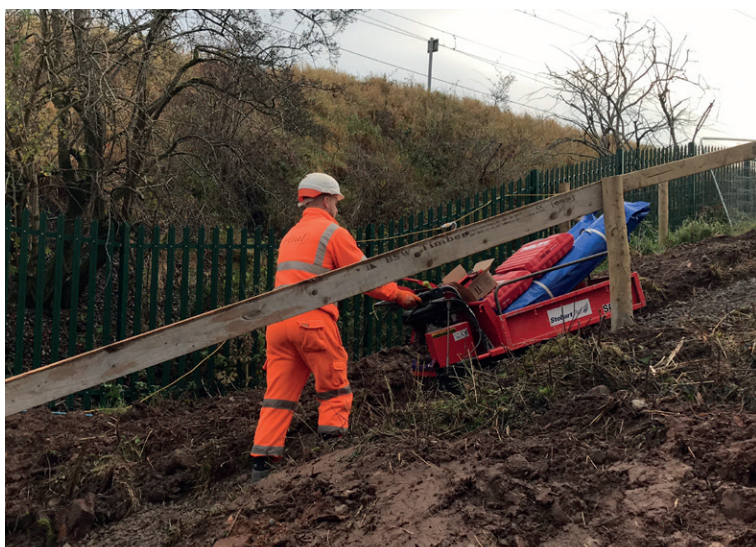
*CC batched rolls transported by trolley*

Working with the design engineer and Site Agent, the batched rolls of CC were cut to 3.5 linear metre lengths which covered the invert of the culvert and the return up the walls on each side to a height that would be above a high-water line. Batching the material to the exact required lengths allowed for minimal wastage and made the material easier to handle in the culvert.

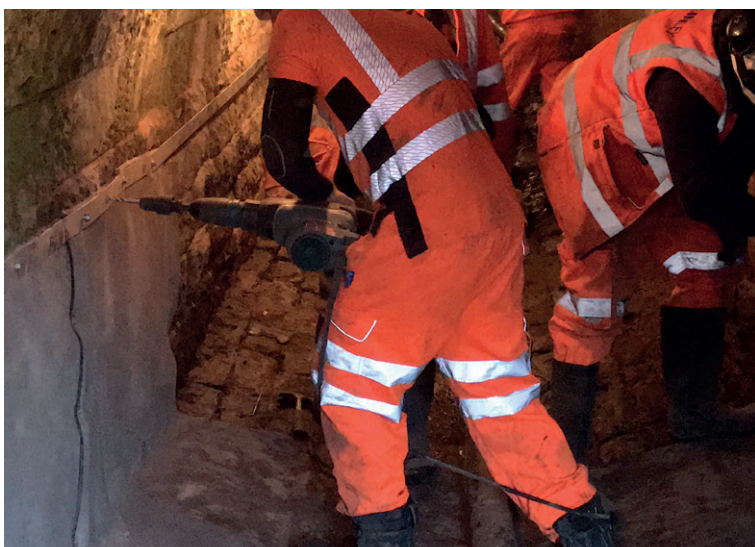
*Fixing CC to masonry wall*

The material was fixed to the masonry culvert with a mixture of shot fired nails and masonry bolts at 200mm centres on each overlap. The termination detail on the wall of the culvert was a galvanised steel strip securing the edge of the canvas to the wall and the galvanised strips were secured at 300mm centres. At the end of the installation a small bead of grout was then added to the top of the strip to neaten the edges and further prevent ingress of water.

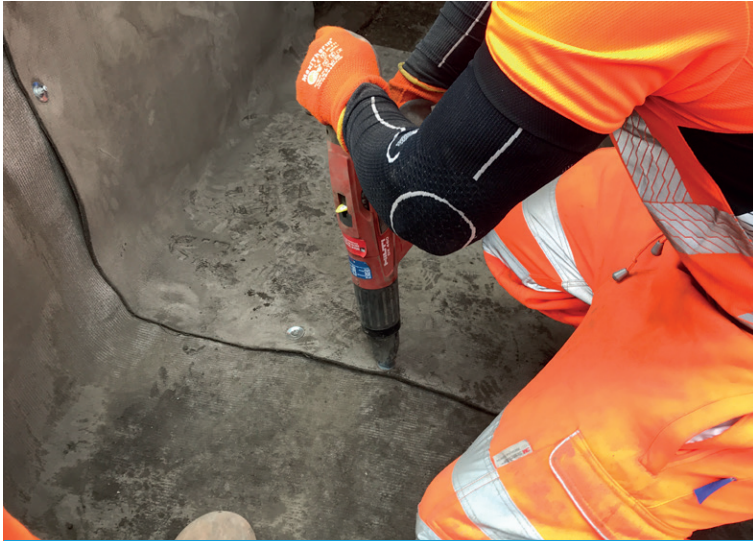
Jointing overlaps using shot-fired nails

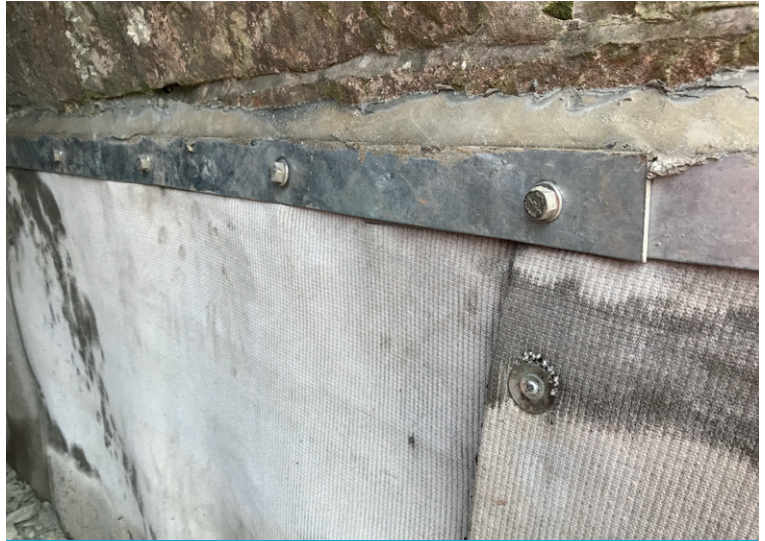
Termination of CC edges using steel bars and grout

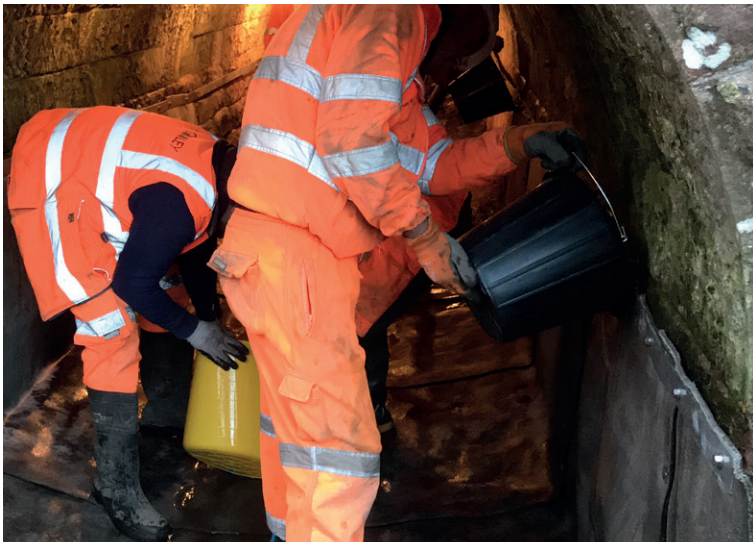
Hydration of CC on walls

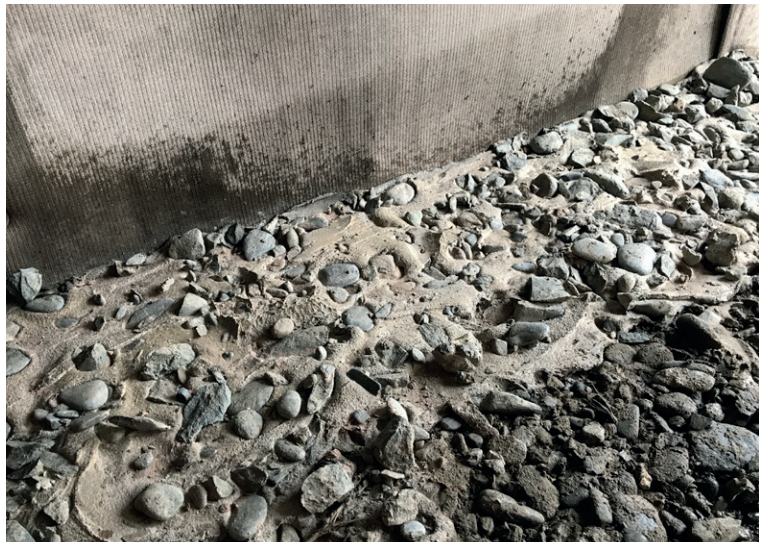
Grout & stones applied to CC floor to provide rocky surface for fish

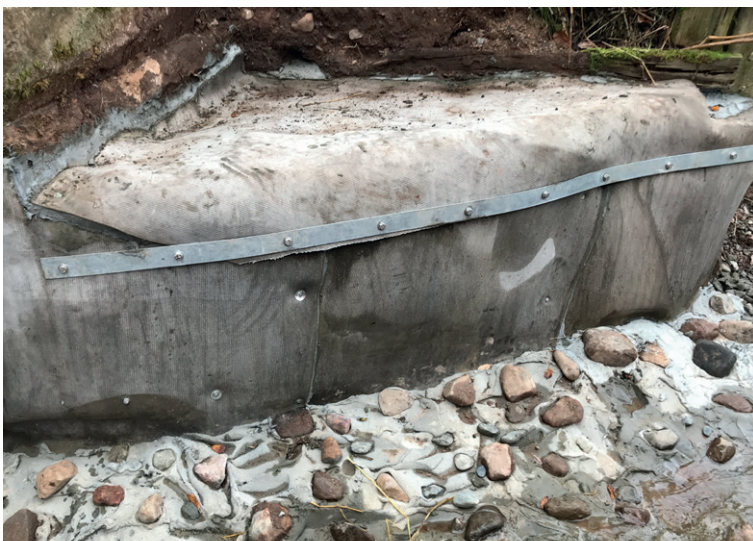
Termination details on wall outside culvert

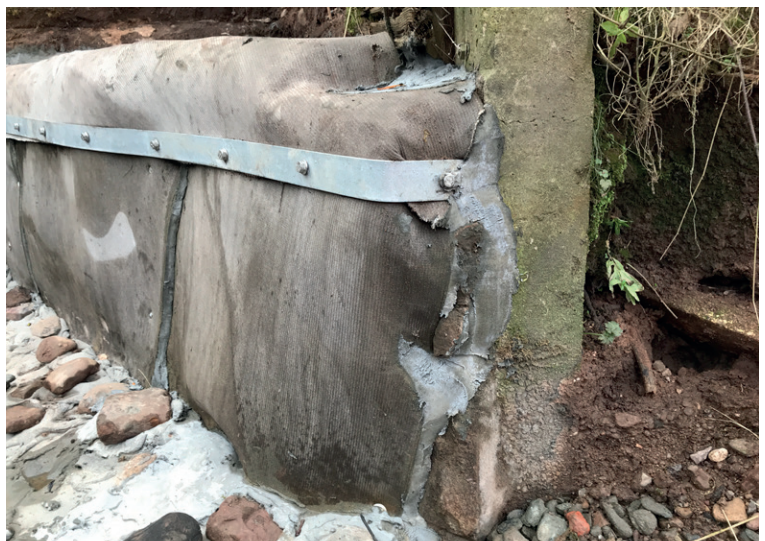
CC edges grouted to prevent ingress at wall

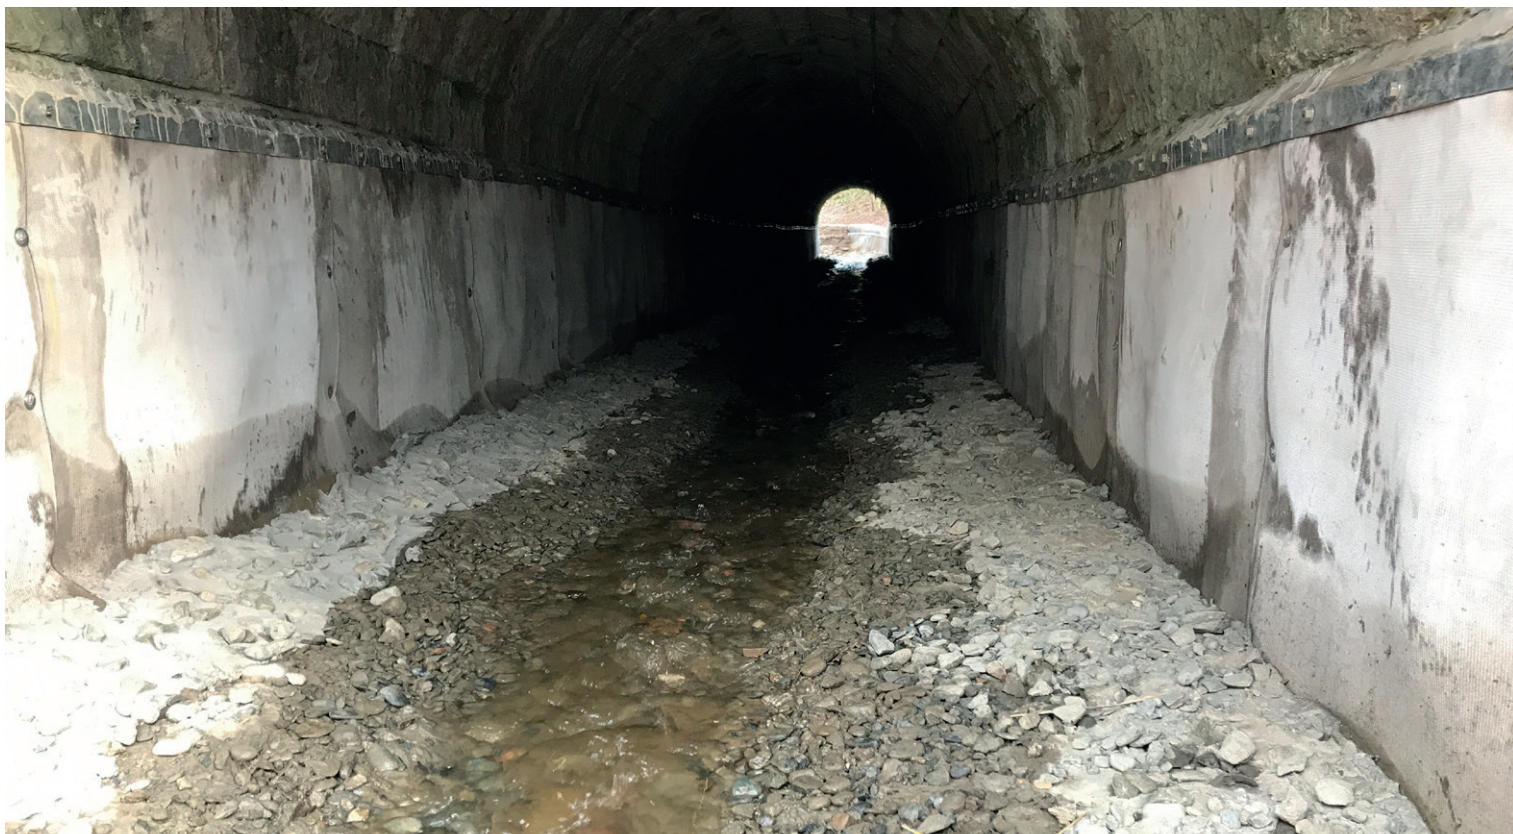
*Completed installation, with additional stone floor*
