CC5™ Bulk Rolls

Rustenburg,  
NW Province,  
South Africa

CC5™ used to line a 50  
year flood dam in the  
salvage yard of Impala  
Platinum Mines in South  
Africa

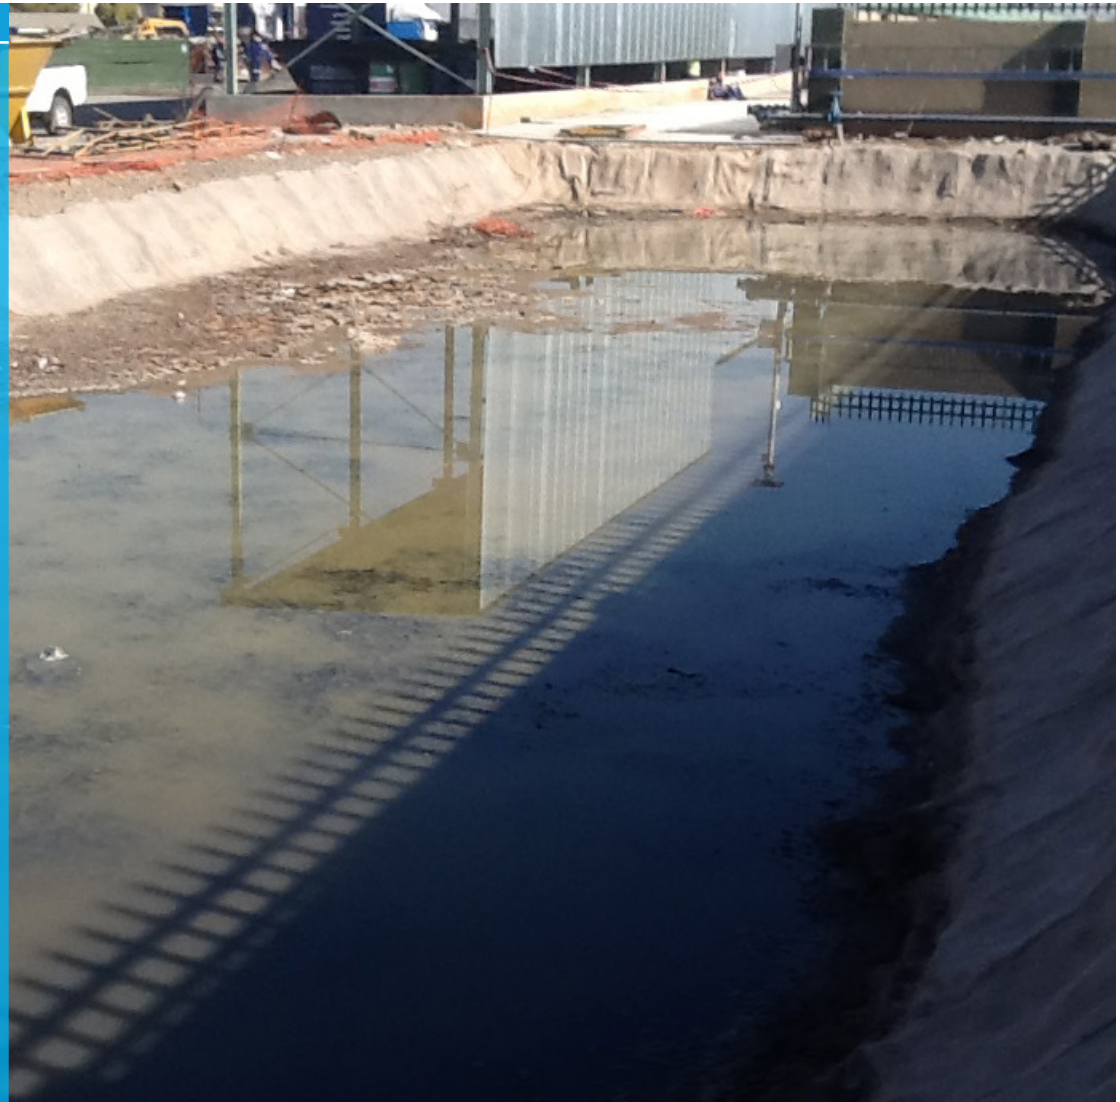
Completed dam lined with CC5™

The installation was very successful. CC was able to be installed in high temperatures of 40°C+, by a team of 10 in just under two days, using basic tools and with very little training. The dam has now been in operation for over a year and has continued to operate efficiently with no leaks or failures. Impala Platinum have noted that CC was easy to handle and install, and provided a far more cost-effective alternative to traditional concrete linings.

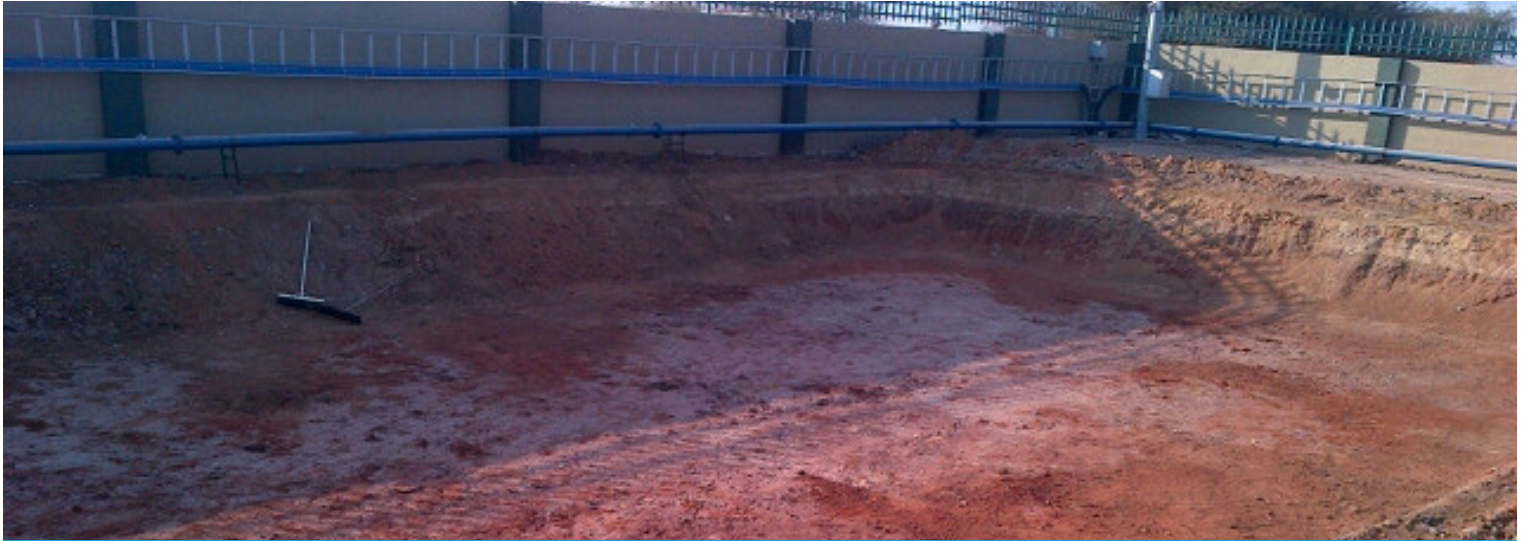
*The dam site was excavated and cleared by an on-site team prior to installation of CC*

After the preparation team had excavated the dam, 500m<sup>2</sup> of CC5™ was supplied to the project site in bulk rolls. Basic, readily available hand tools were used on site to cut the CC to the required length, before adjacent layers were taped along the joint on the impermeable side using Very High Bond (VHB) Tape. The CC sections were then laid in place in the dam, pegged along the outer edges, and the joints along the concrete side sealed with Hybriflex, a UV-resistant, waterproof sealant. On-site equipment was then used to hydrate the CC.

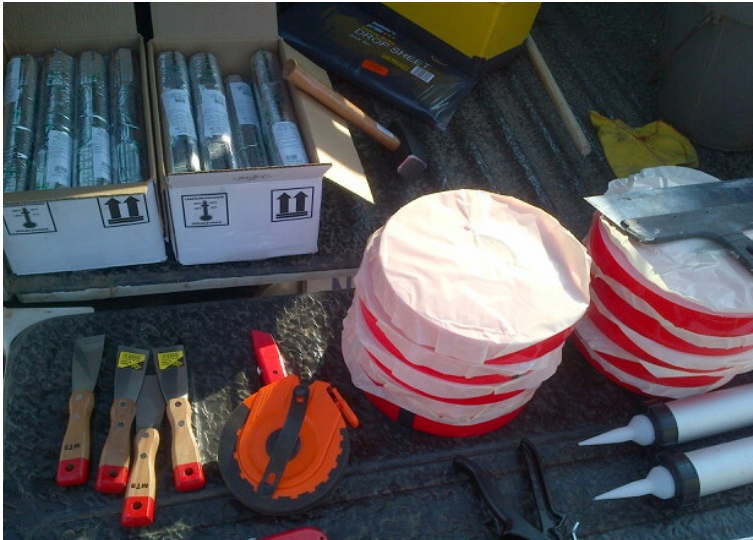
*The project was completed using readily available hand tools*

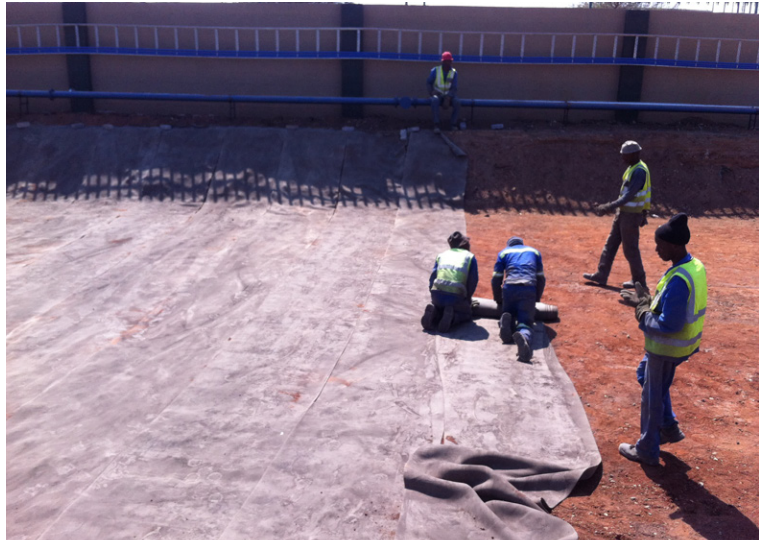
*Joints between layers of CC were sealed with a VHB tape underneath*

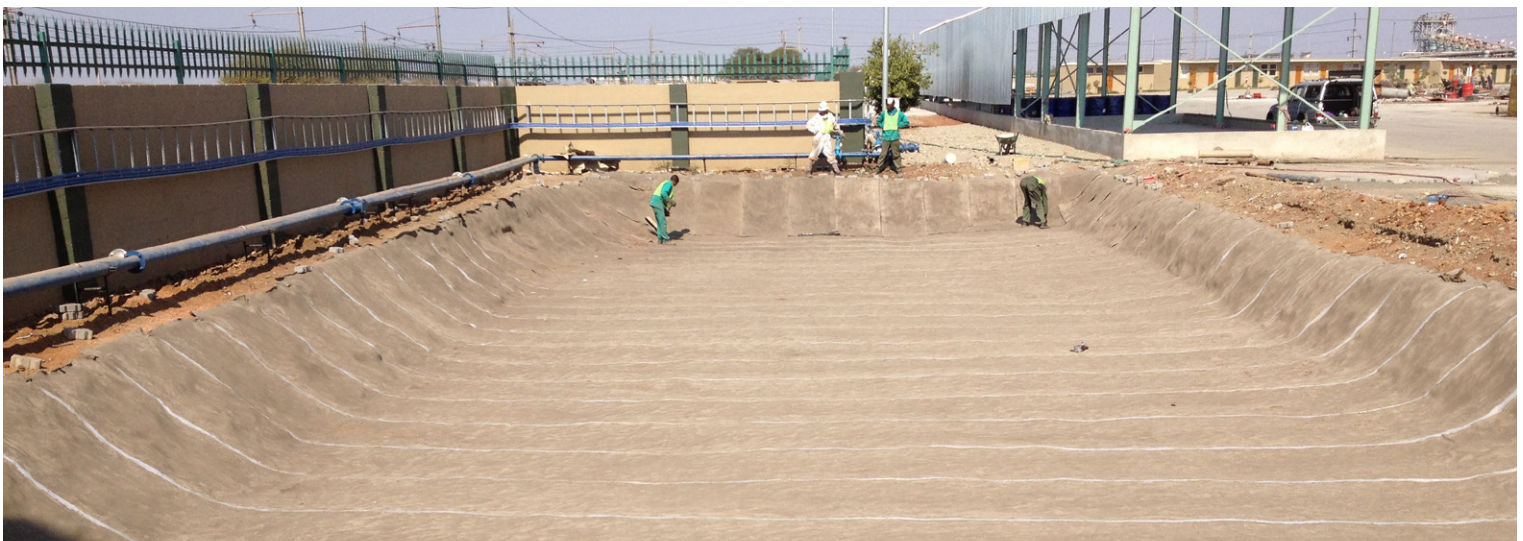
*A UV-resistant, waterproof sealant was used to seal the joints on the concrete side*
