## GABION PROTECTION

In October 2019, 30m<sup>2</sup> of Concrete Canvas® (CC) GCCM\* material was installed by Northern Divers Ltd, on behalf of National Grid, to provide long term protection to gabions walls along the River Almond in Lothian, Scotland.

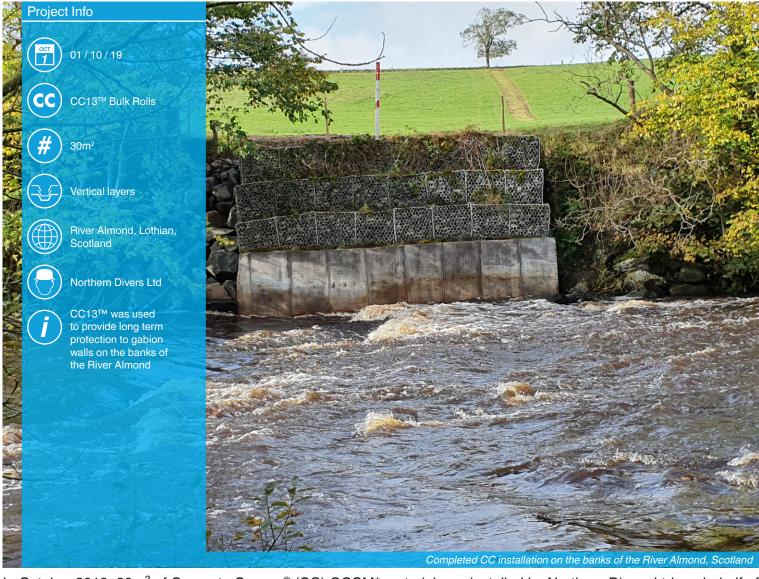
The River Almond is 28 miles long, rising at Hirst Hill in Lanarkshire near Shotts and running through West Lothian, draining into the Firth of Forth at Cramond, Edinburgh. The existing gabion stepped walls were installed for flood control and erosion protection but had degraded over time and sustained damage from heavy water flows. CC13™ was used to reline the first tier of gabions to provide long term protection and increase the operational life of the gabion structure.

The first tier of gabions measured 10m in length and 2m high with a 0.5m step to the second tier. Prior to the works, the contractor positioned bulk bags upstream of the works to help reduce the river flow and divert water away from the work area. The installation began at the downstream end of the gabion structure and the perimeter edges secured to the baskets using pneumatic hog rings. The CC layers were overlapped by 100mm in the direction of water flow and joined together using 30mm stainless steel screws at 100mm intervals.

CC was chosen due to its ease and speed of installation. The CC13™ bulk rolls could also be cut to length on site, minimising wastage and allowing installation with simple hand tools on a site with restricted site access, steep banks and high water flows. CC13™ is BBA certified with a durability in excess of 120 years.

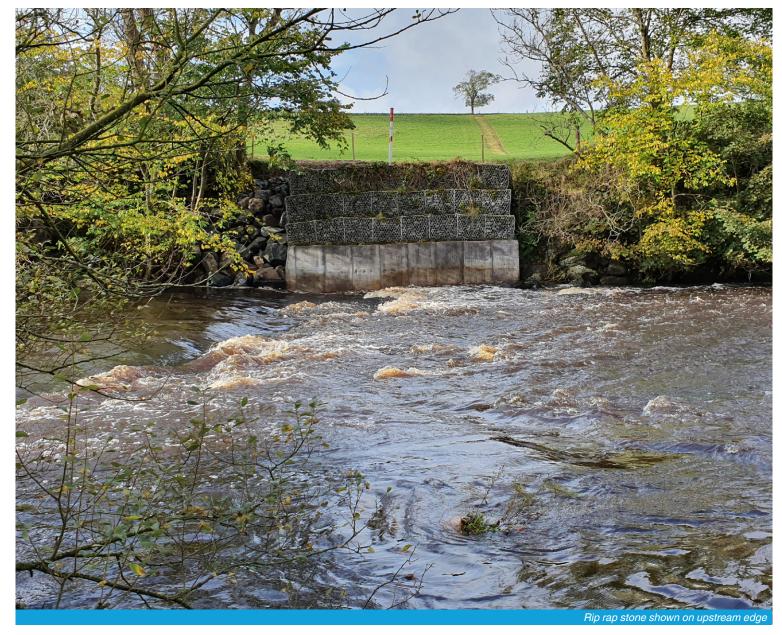
On the upstream and downstream side sections, CC was terminated into the existing bank profile and fronted with rip rap stone. The CC was then secured to the gabions along the bottom edge using stainless steel lacing wire and then hydrated using river water. CC has a low alkaline reserve and does not adversely affect watercourses. As a result, the hydration water was allowed to discharge in the river.

30m² of CC13™ was installed by the contractor in two days by two people. The client was impressed with the ease and speed with which CC was installed, along with its minimal environmental impact and will consider CC for future projects.

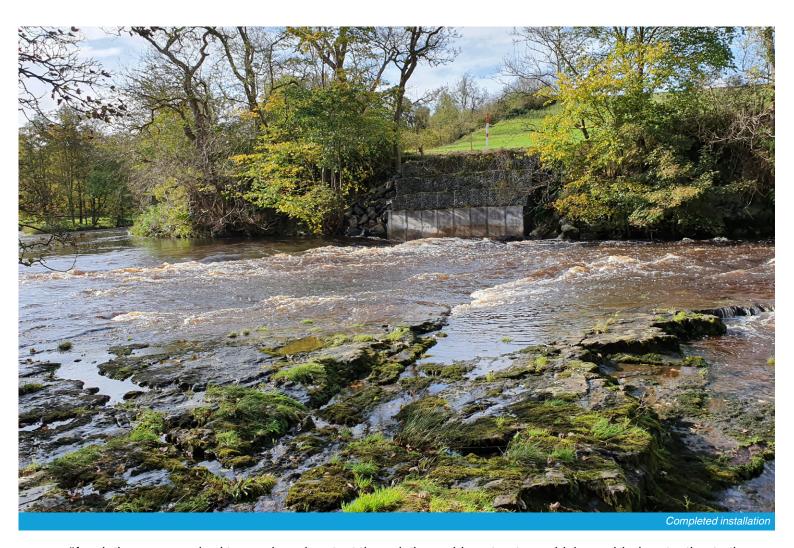
"A solution was required to repair and protect the existing gabion structure which provided protection to the gas pipeline crossing the River Almond. Due to the river being very fast flowing in winter and flood conditions, and also the probability of the carriage of water bourne debris, trees etc, a solution had to be applied that not only provided long term protection but also did not encroach on narrowing the water course and possibilities of trapping debris. [CC] was chosen for these reasons; its low profile and smooth facing meant that water flow and possible debris could pass unrestricted and with its strength and durability it would more resilient to strike damage."
