CC8™ Batched Rolls

Tattenhoe, Milton Keynes

Provide scour and erosion control beneath an outfall

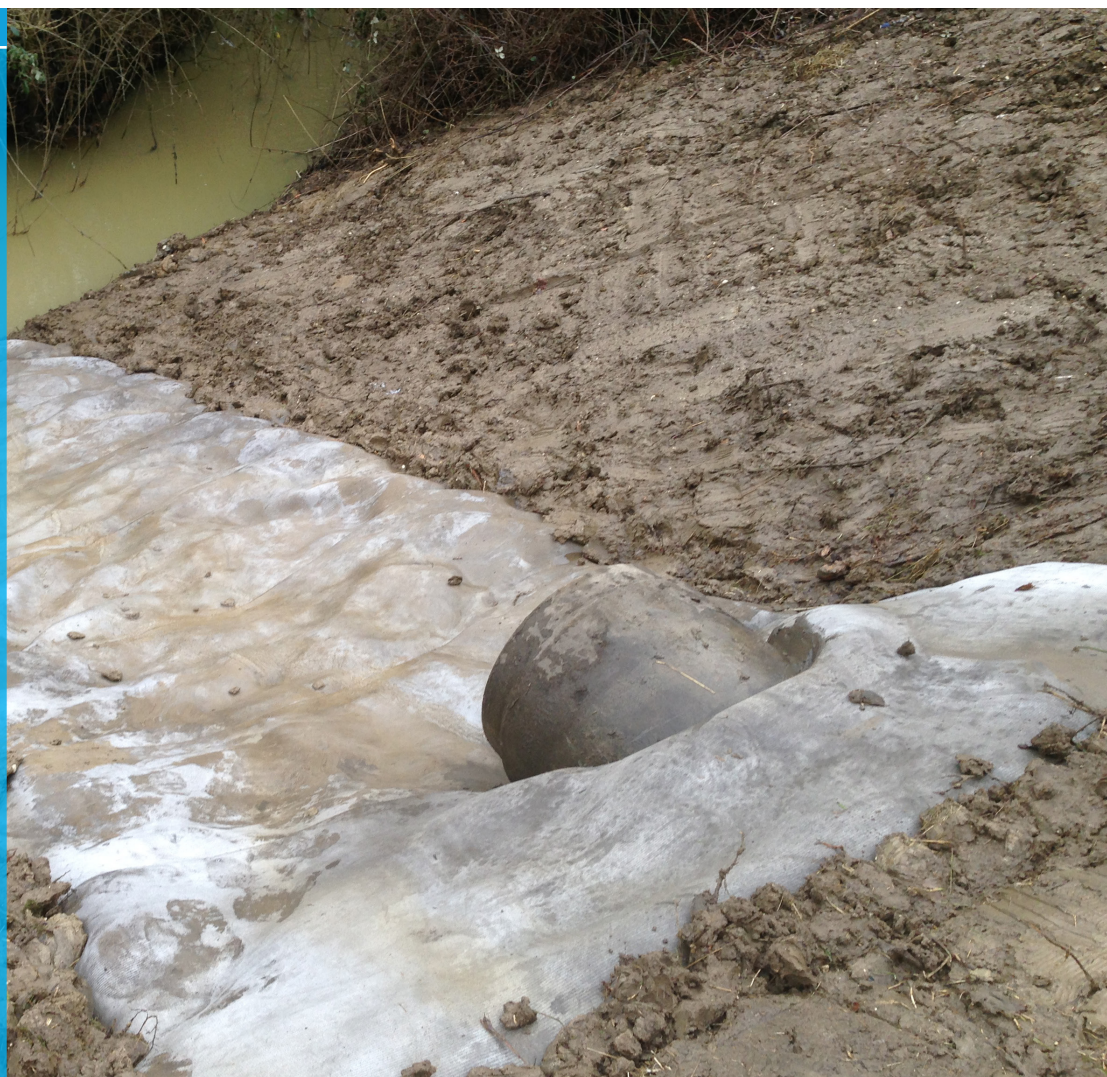
The installation took just 1hr and 15 minutes from delivery to completion

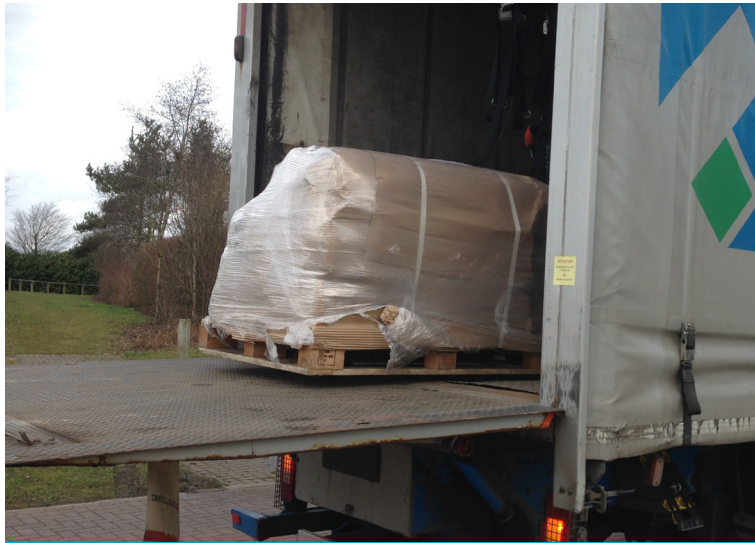
Delivery was at 1pm

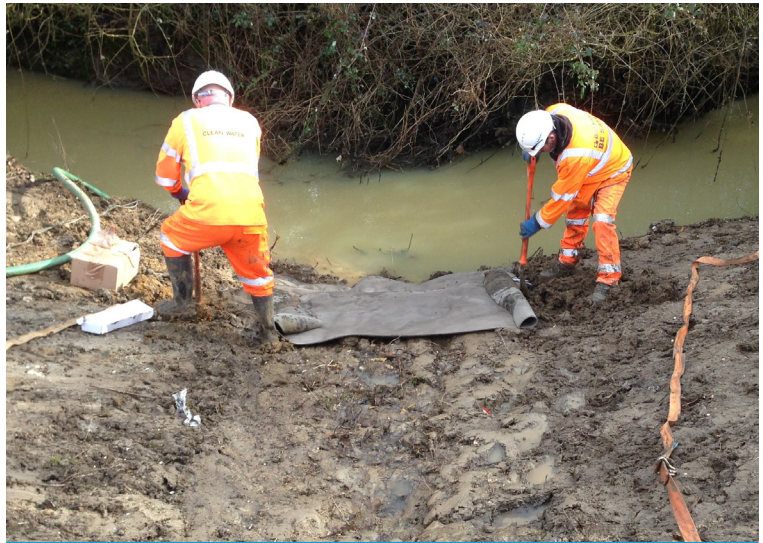
CC was cut to length and installed in a transverse layup working upstream

The installation took place in dry weather, but the ground was very damp and muddy, making working conditions more difficult. Vegetation was removed from the 60° slope with an excavator, then re-graded, with anchor trenches being dug by hand during the installation. The CC was installed in a transverse layup, anchored with 250mm steel pegs at 1m intervals, jointed with stainless screws at 200mm centres and grouted around the existing pipe. The anchor trenches were backfilled by hand with hydration taking place via a pump utilising water from the adjacent stream.

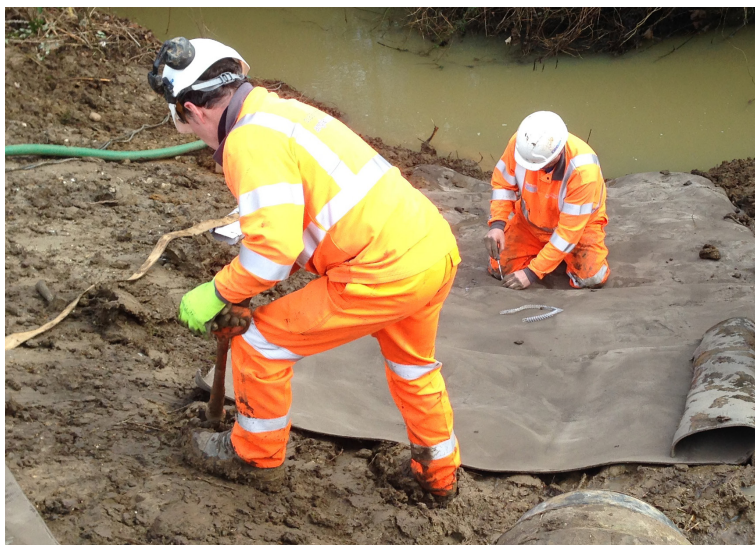
All work was carried out by hand

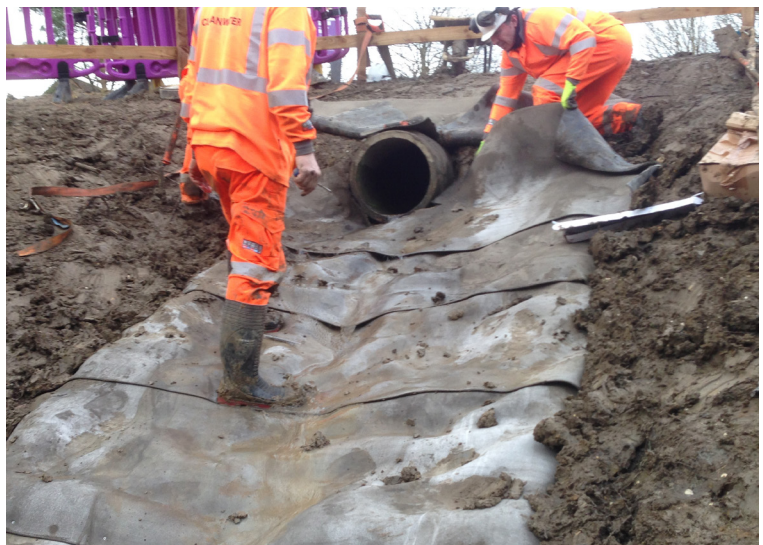
Weather conditions were dry, but the ground was saturated

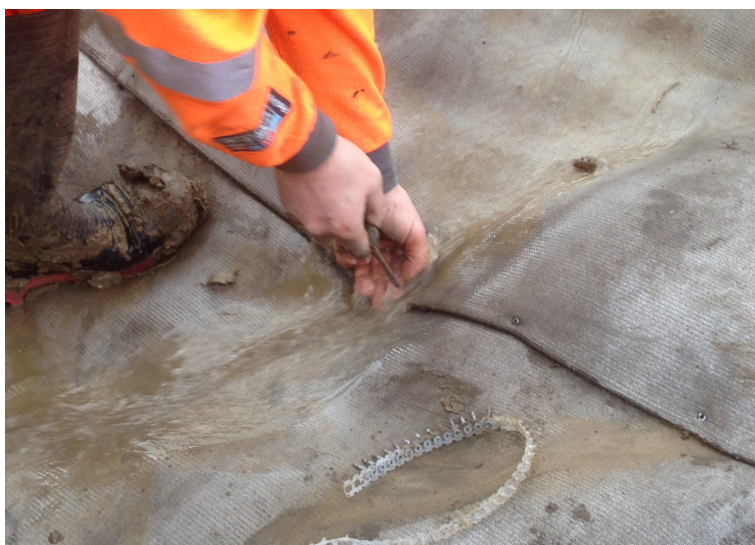
The CC was jointed with stainless screws at 200mm centres

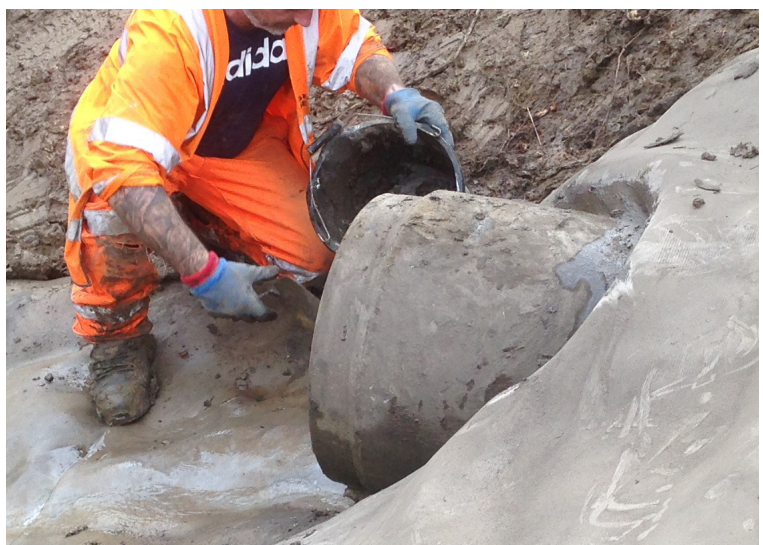
The CC was grouted around the existing pipe

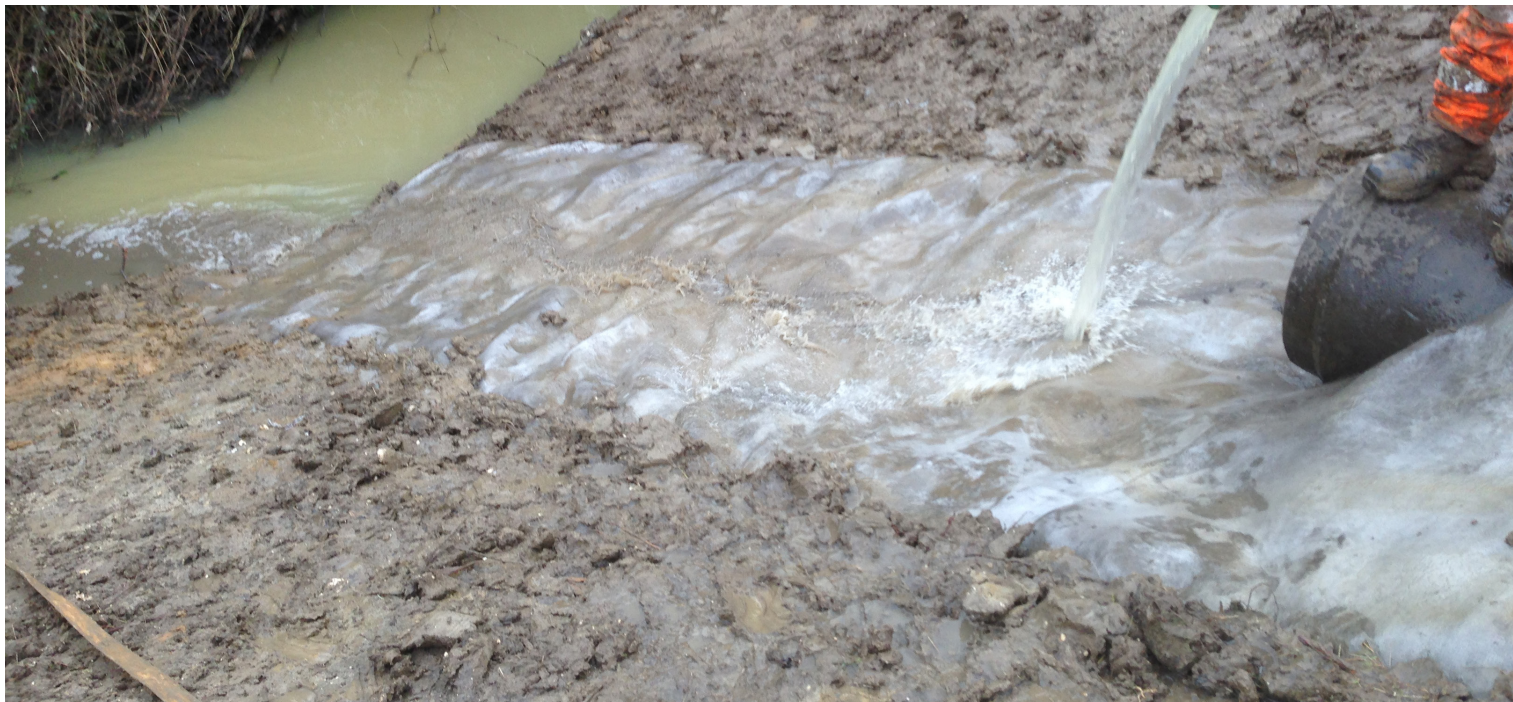
Hydration took place via a pump linked to a nearby stream

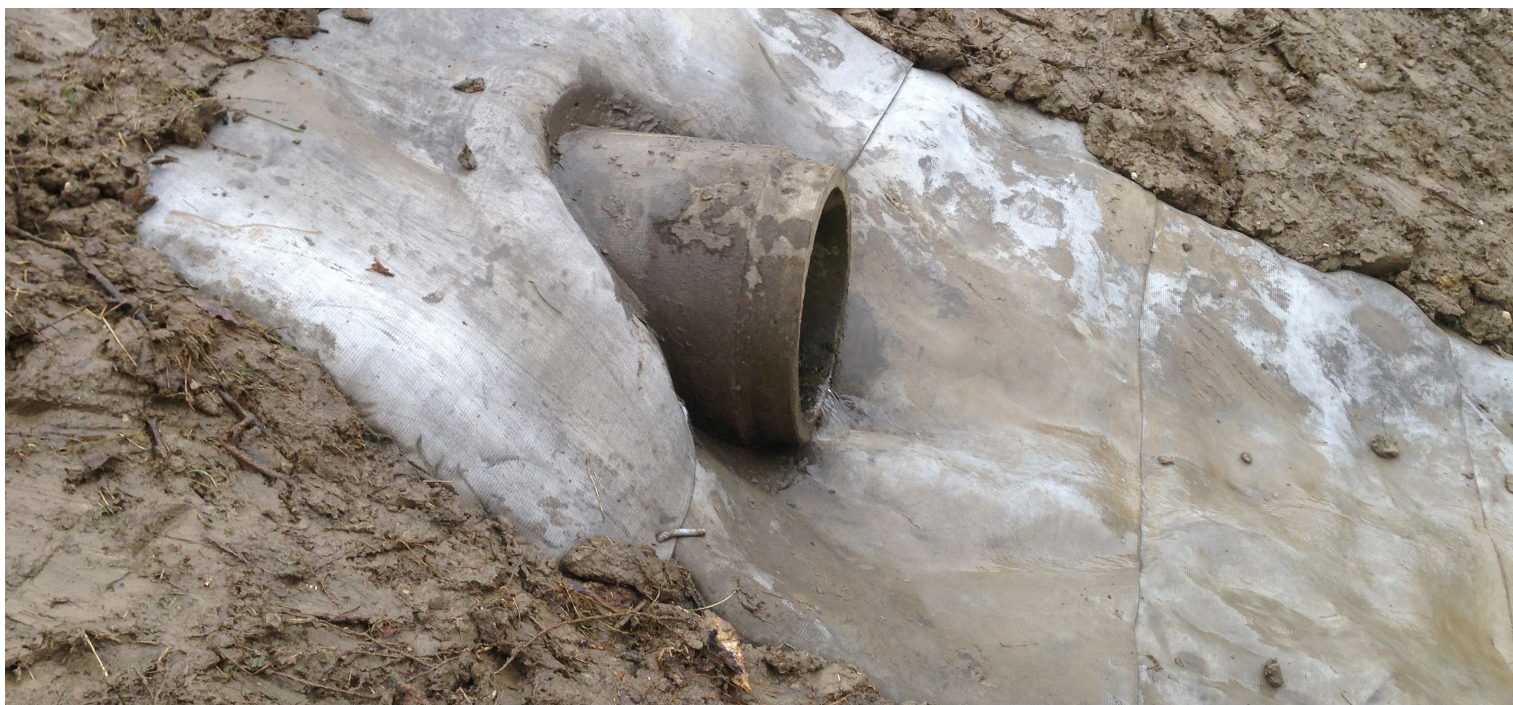
From delivery to completion, the install took just 1 hour and 15 minutes

20m² of CC8™ were installed in 1 hour and 15 minutes by 3 people, from delivery of the batch rolls at 1pm, the installation was complete by 2.15pm including off-load time and other work such as digging anchor trenches, grouting around the existing infrastructure and hydration. The speed and ease of installation made this project a success.
