CC8™ Batched Rolls

West Devon

CC8™ installed to  
prevent erosion beneath  
an outfall

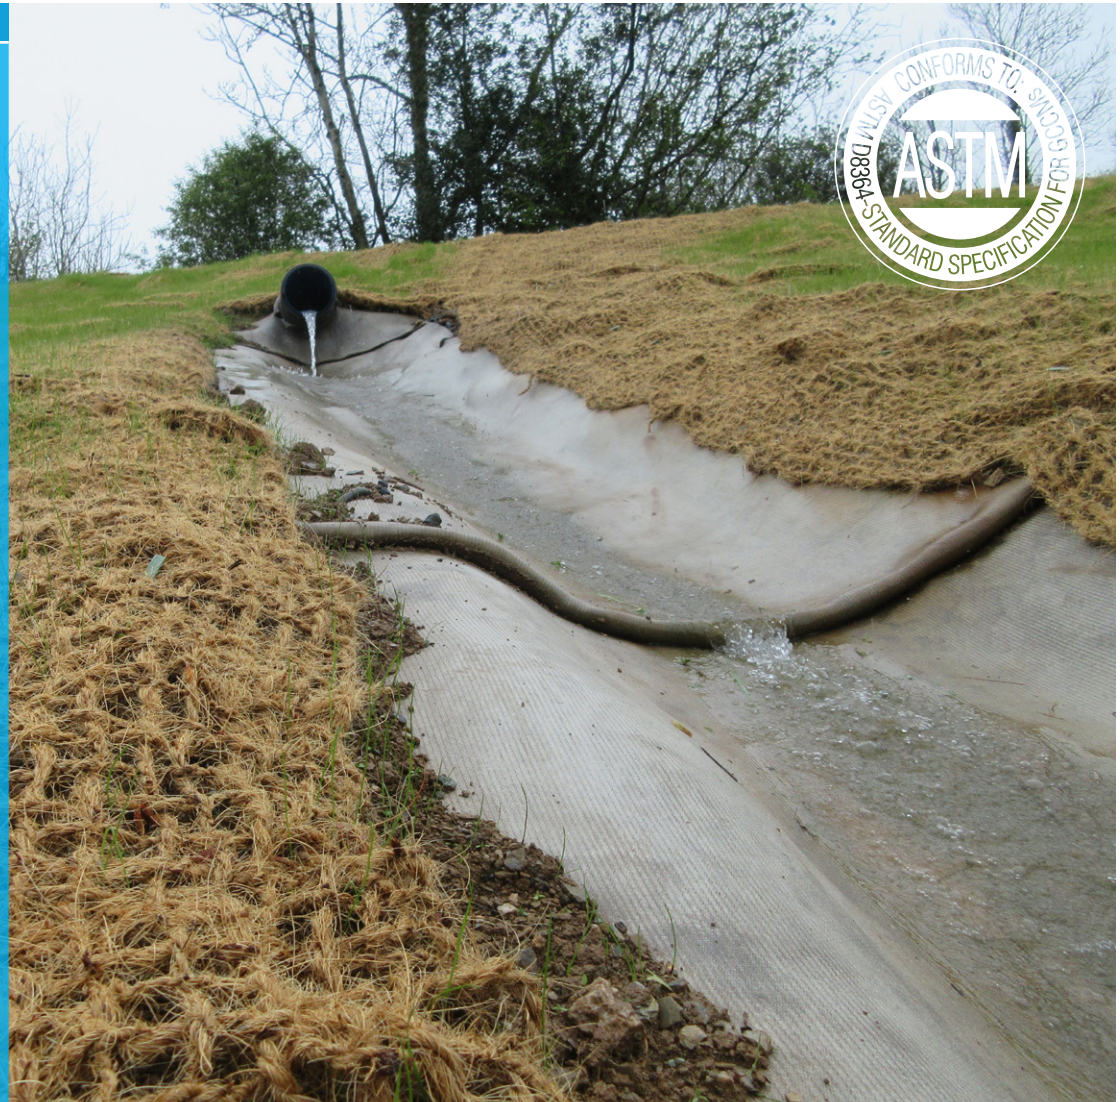
Completed Installation

As a result of installing CC8™, Devon County Council and Mac Plant Ltd provided a long-term erosion control solution that would prevent future degradation of the slope. The CC8™ material effectively controlled the flow of water down the slope, whilst preventing further saturation and potential instability.

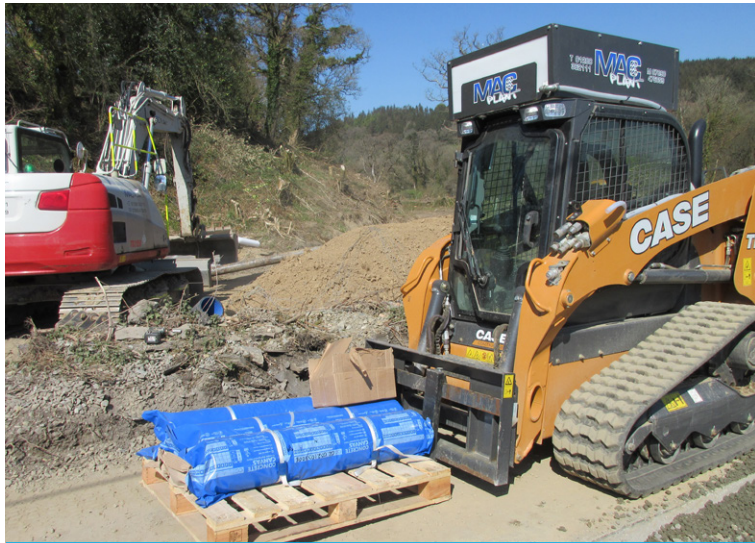
*CC8™ Batched Rolls being transported to the top of the outfall*

It was decided that due to the steep slope that CC8™ batched rolls were required (instead of standard bulk rolls). CC8™ batched rolls weigh 60kg's each and could be carried into place by hand. They were installed longitudinally along the channel meaning there would be little to no requirement for plant or machinery during installation.

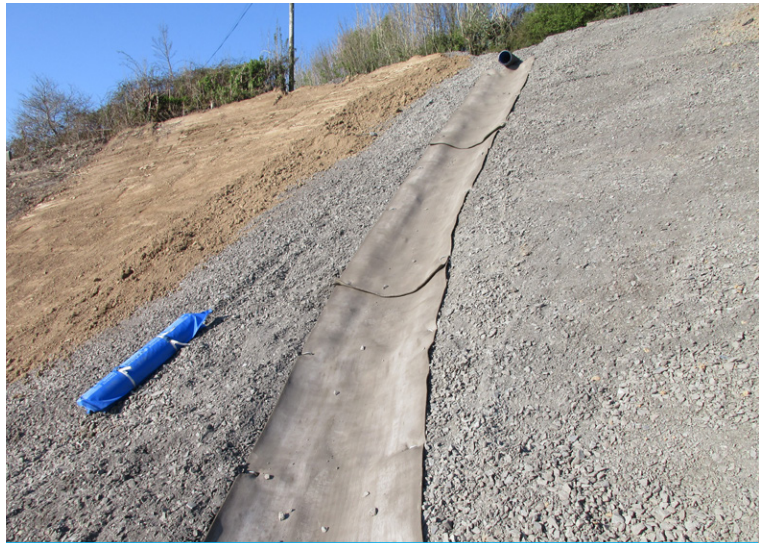
*Batched Rolls installed longitudinally down the outfall*

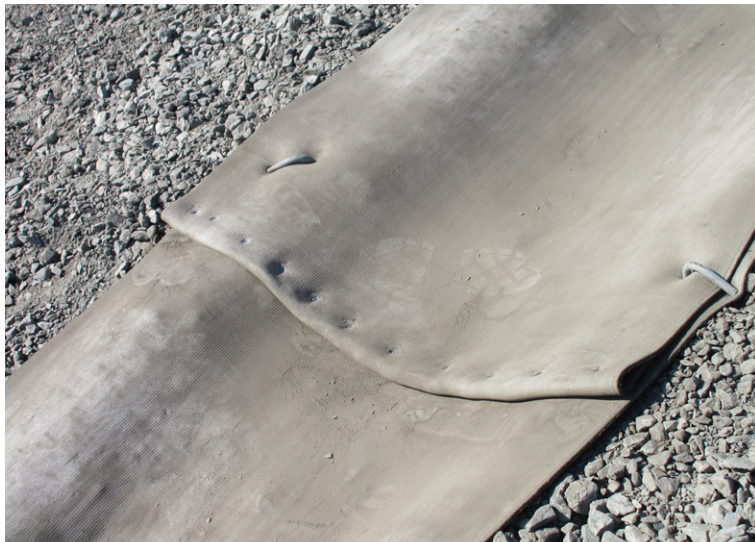
*Screwed lap joint detail*

The ground was made of re-graded and compacted fill material and the outfall channel was cut into the slope using an 8-tonne excavator. All debris and loose rock were removed from the channel to give a smooth surface for the CC8™ to be placed on. It is important that the PVC backing of the Concrete Canvas material is in direct contact with the soil substrate. Once the CC8™ had been placed along the channel it was jointed using a simple screwed joint. 30mm stainless steel screws were driven along the 100mm wide lap joints at 200mm centres. This provided a mechanically secure joint but still allowed a natural weep path for groundwater to seep into the channel. An auto-fed screw-driver was used to insert the screws to reduce the installation time.

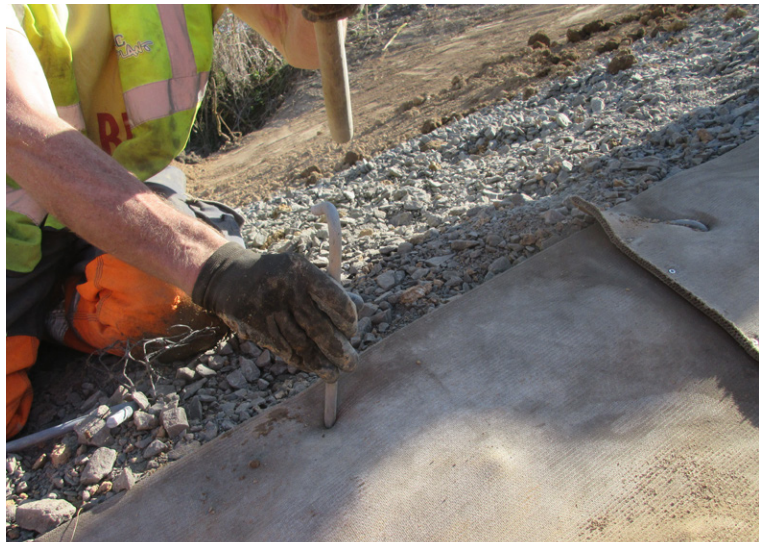
*Galvanised steel pegs used to fix the CC8™ to the ground*

Galvanised steel pegs (250mm long) were inserted along the edges of the CC8™ material at 1m spacings using a 4lb lump hammer. This ensured that the material was fixed to ground and would not slip down the steep slope. The edges were backfilled with soil to provide a neat termination and prevent undermining.

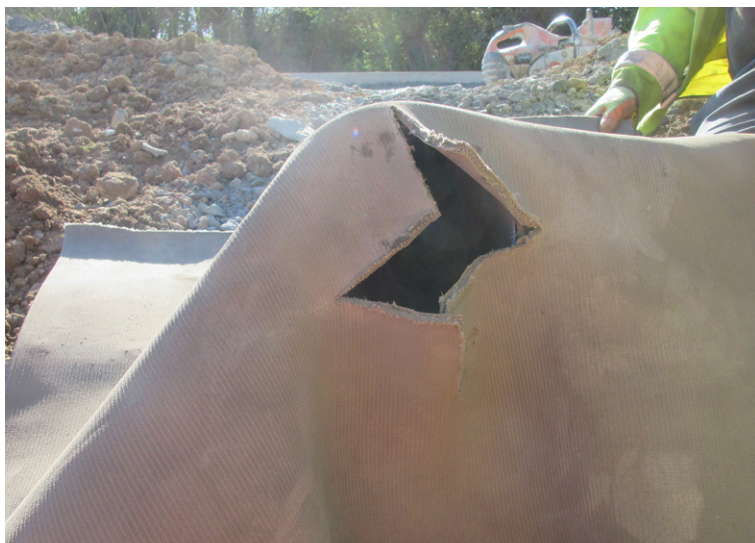
*Opening cut into CC8™ material for 250mm dia twin wall carrier pipe*

A 250mm diameter twin-wall carrier pipe was situated at the top of the outfall and was easily accommodated into the CC8™ lined outfall. Prior to hydration CC is flexible and can easily be cut to incorporate pipe penetration details. At the trailing edge, rocks were placed over the CC to slow the water flow and prevent erosion and scour as the water entered the adjacent stream.

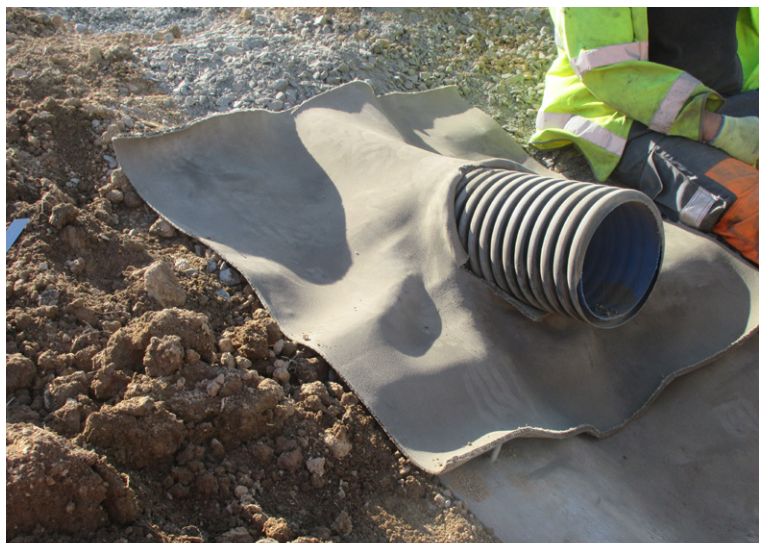
*Twin wall carrier pipe installed into outfall channel with a overhang detail*

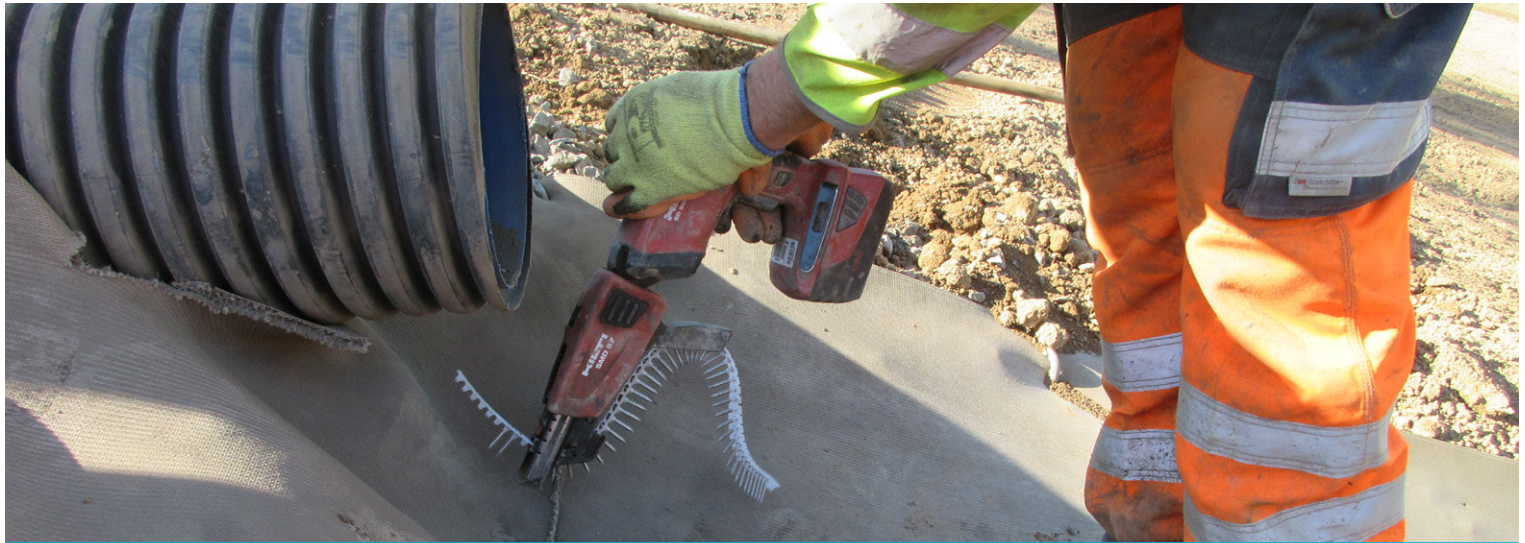
*Auto-fed screwdriver being used to joint the CC8™ using 30mm stainless steel screws*

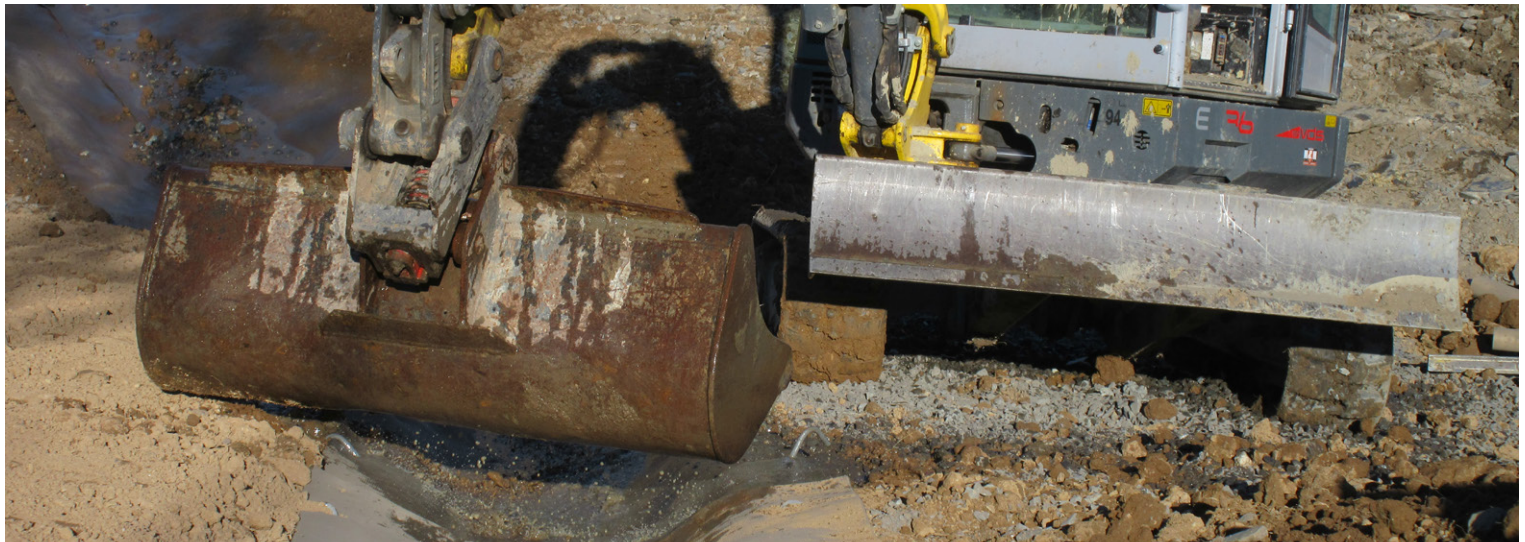
*An excavator bucket was used to collect water from a nearby stream to hydrate the CC8™*

The water required to hydrate the CC8™ was sourced from the stream at the toe of the embankment. CC does not require potable or clean water for hydration and the material has a very low alkaline reserve. This meant that during hydration the surface water run-off could be discharged directly into the stream and did not negatively affect the flora and fauna. Unlike poured in-situ concrete, the washout from CC does not typically need to be treated. This was a crucial consideration because the stream joined the River Lyd 50m from the outfall. Pollution of the River Lyd would have resulted in potential fines for the contractor. A team of two groundworkers lined the 20m long outfall over an 8-hour shift. One key benefit of using CC is it offers time and cost-saving opportunities due to significantly reduced installation times.

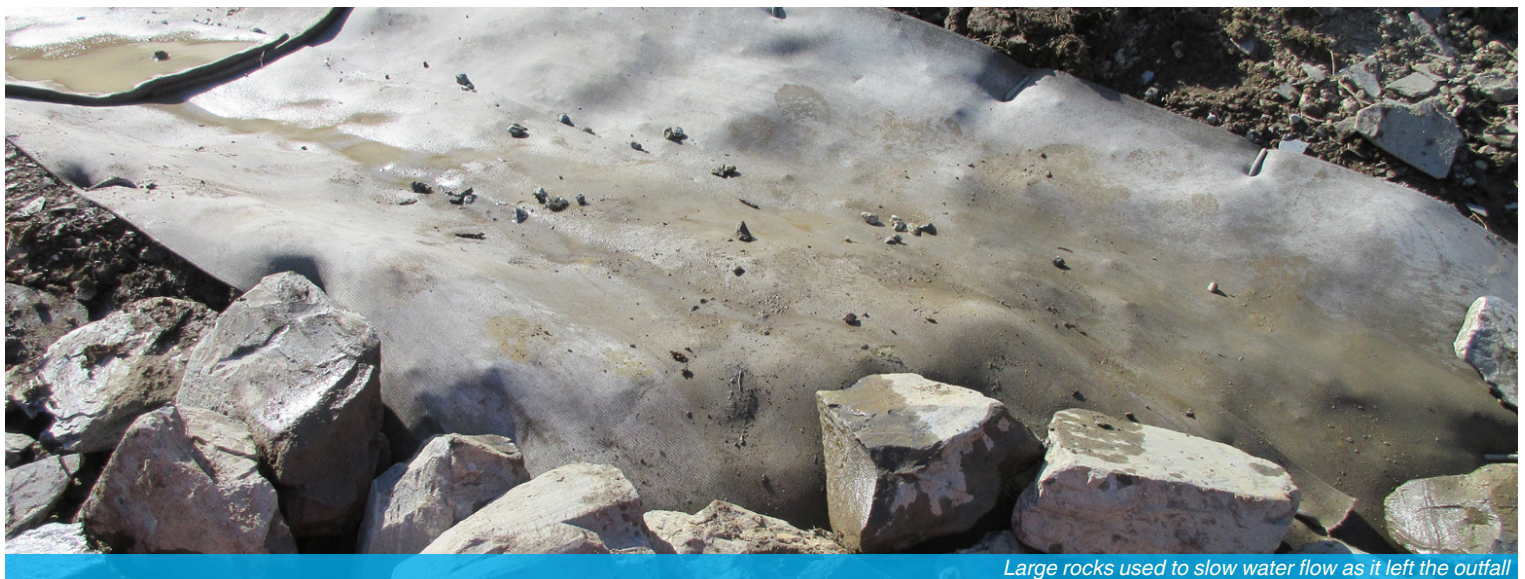
*Large rocks used to slow water flow as it left the outfall*

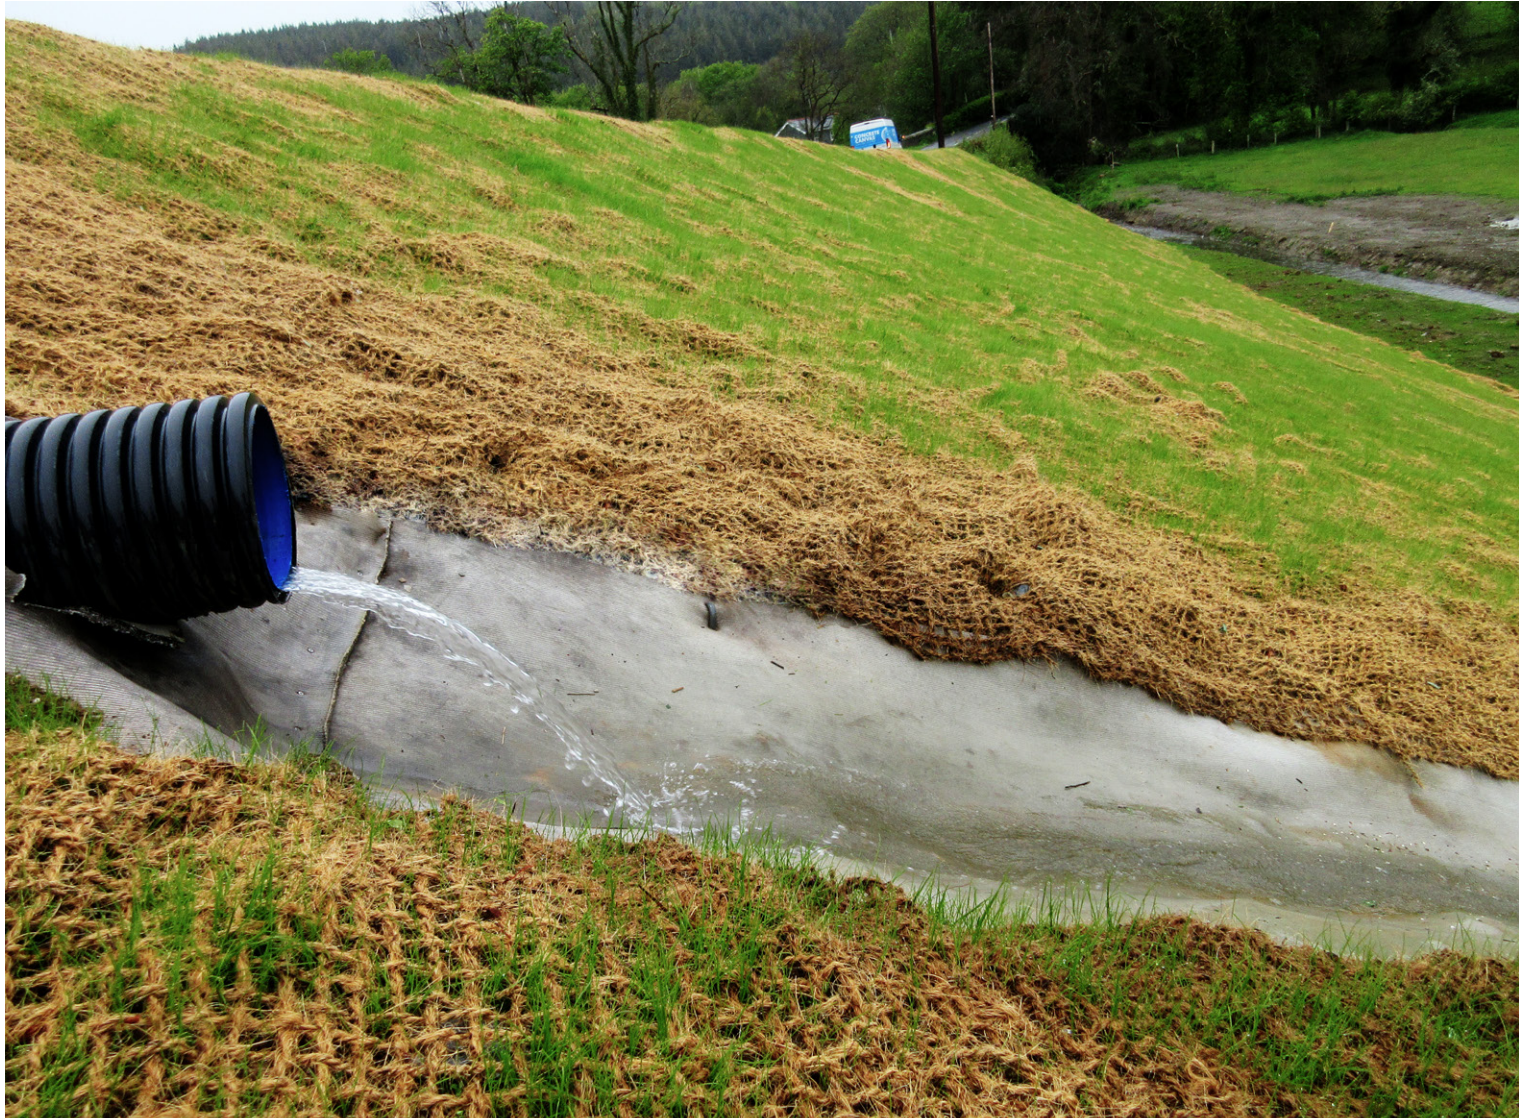
*Completed and lined channel with water flowing from the outfall*

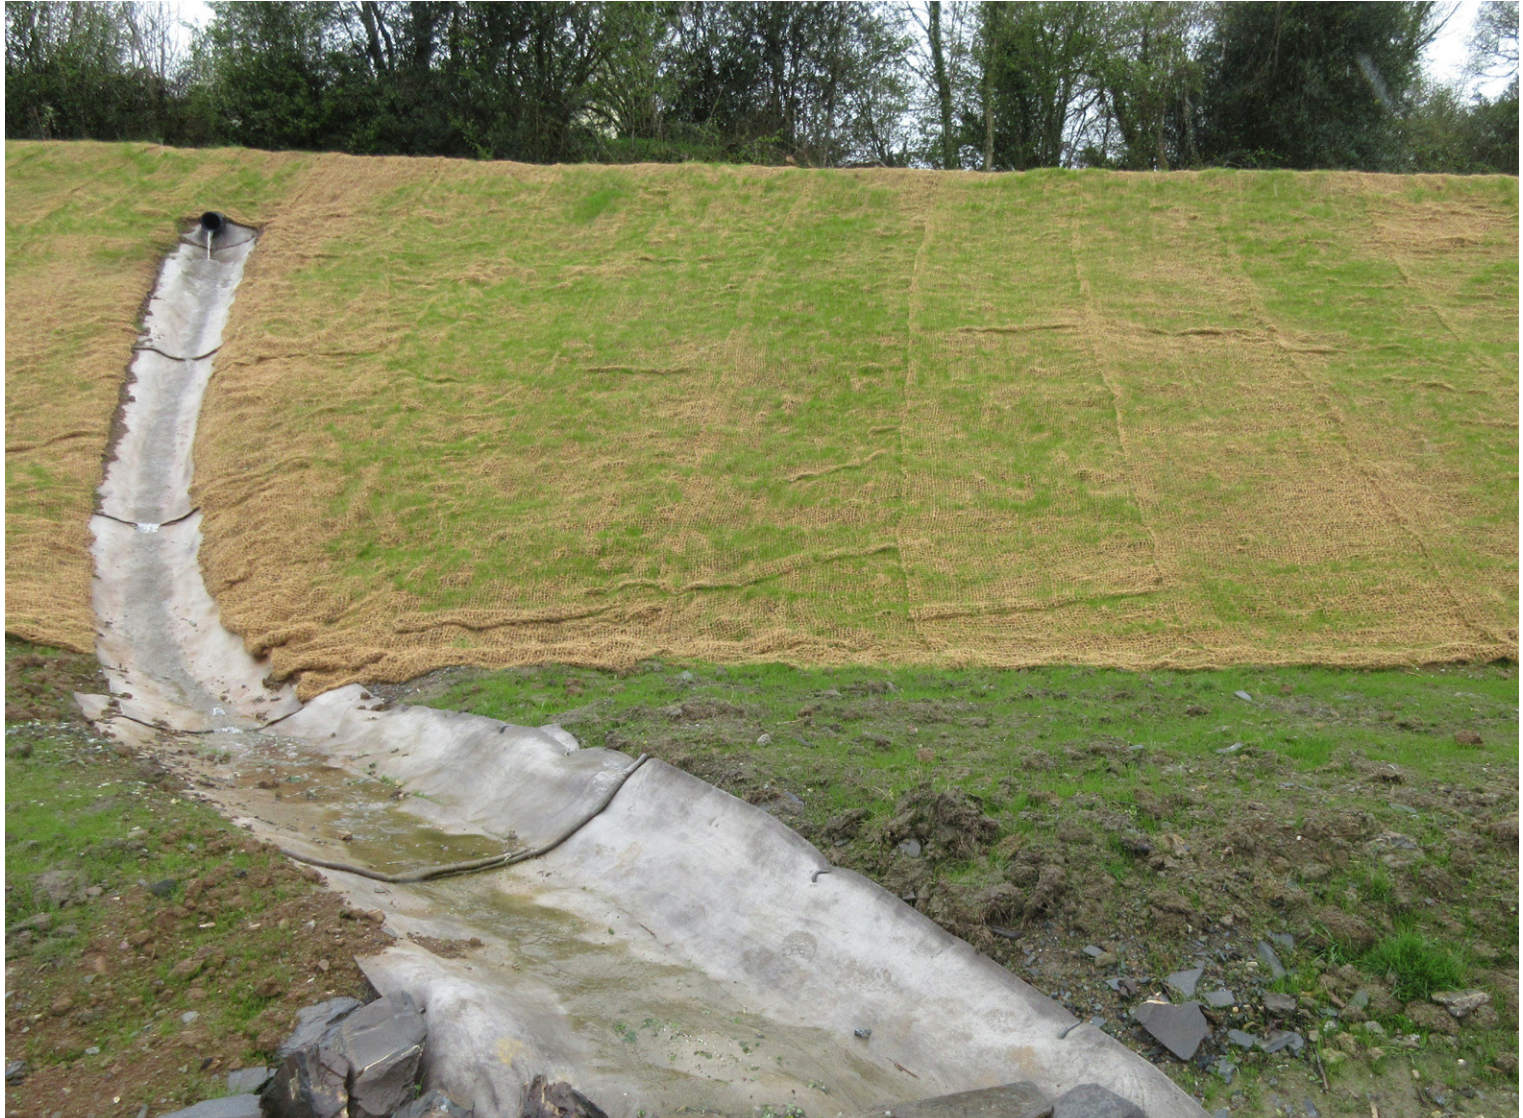
*Completed lined channel*
