CC5™ Bulk Rolls

Bowburn Flume, Dumfries & Galloway, Scotland

Cubby Construction on behalf of Scottish Power

CC5™ used to remediate a dilapidated concrete flume forming part of a hydro-electric system

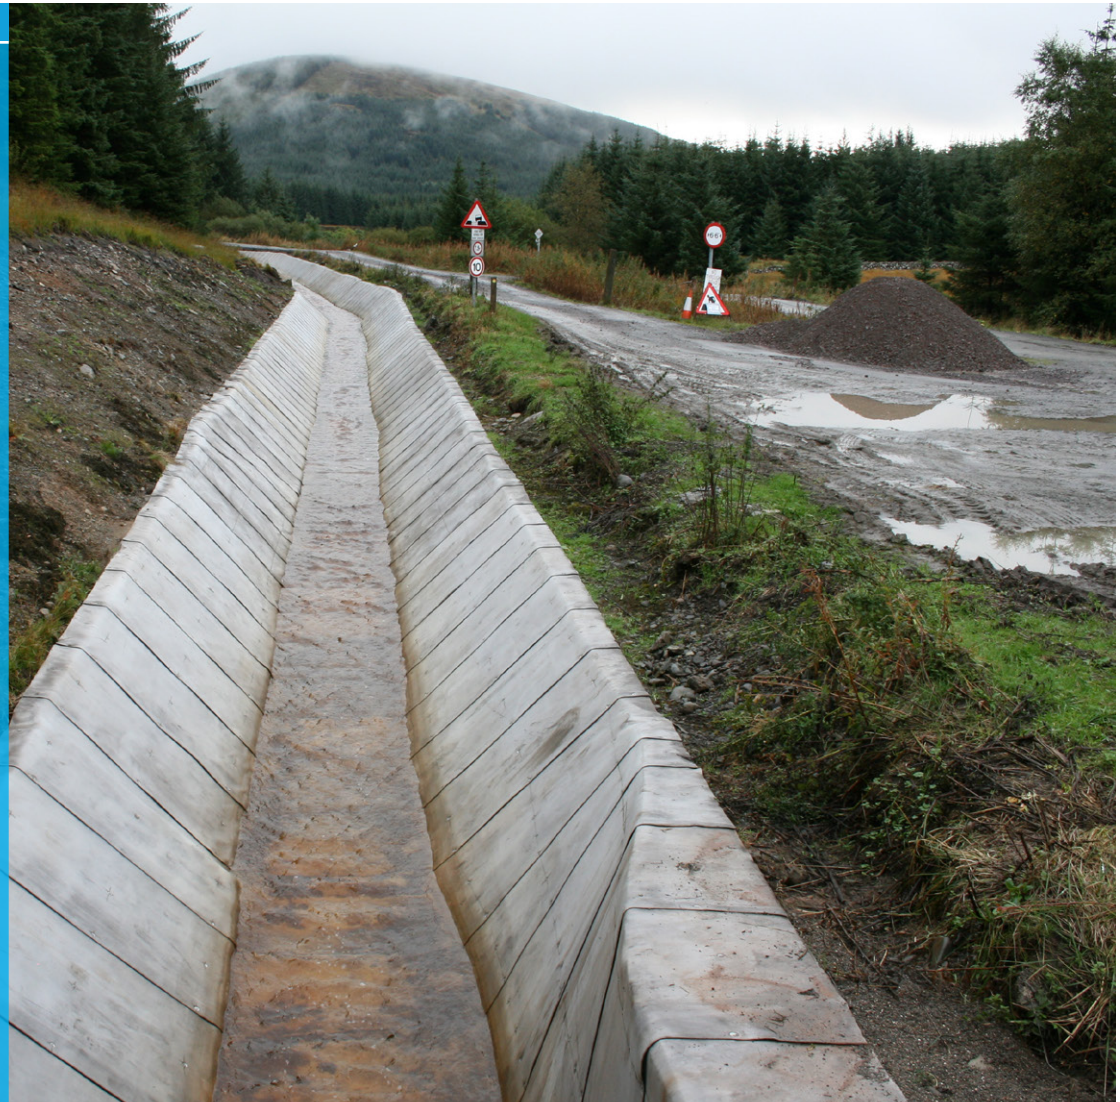
Section of completed flume

In October 2013, Concrete Canvas® GCCM* (CC) was used to remediate a 1.5km concrete flume, forming part of a hydro-electric scheme operated by Scottish Power, in Dumfries and Galloway, Scotland.

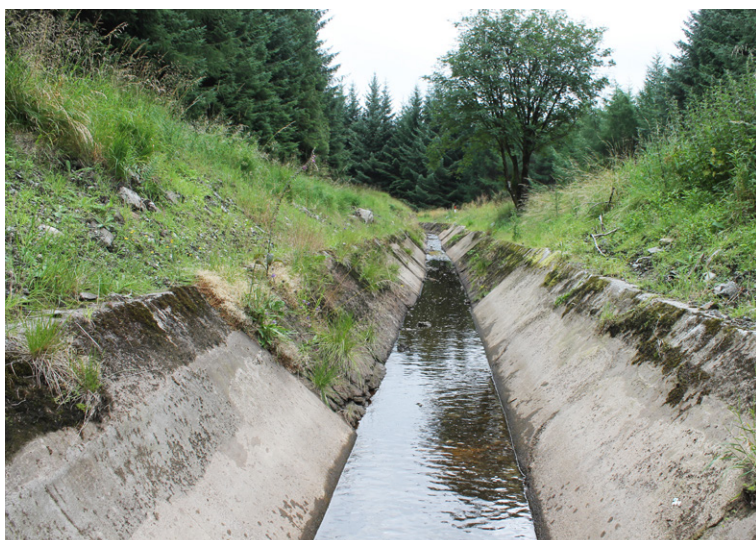
1.5km dilapidated concrete slabbed flume prior to installation

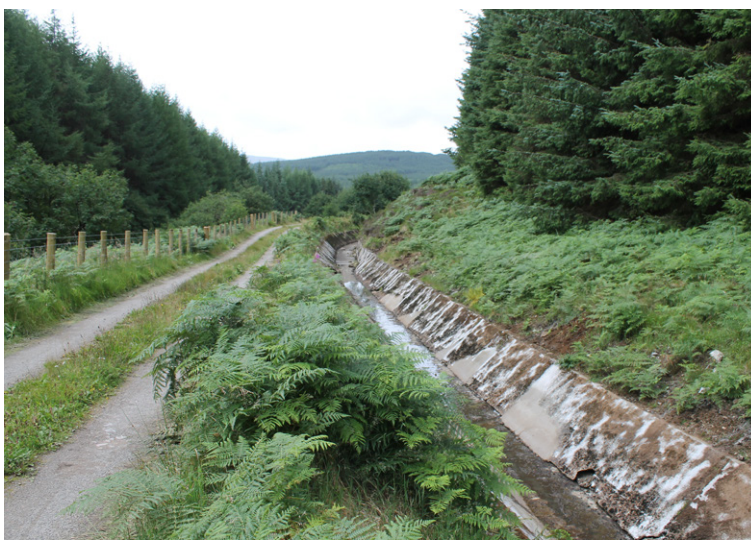
Various inspections and repairs of the flume had been undertaken over the last 10 years. The inspections had revealed several areas which were in need of refurbishment. The surveys highlighted that the whole length of the flume had algae, moss and grass growth, covering a varying amount of the top surface. There was a substantial build up of gravel and detritus at certain locations and the condition of the concrete panels was variable. Rather than using conventional concreting techniques, CC was proposed to significantly mitigate the need for costly periodic repairs. Traditional options previously used had included sprayed concrete and removal and replacement of sections of existing concrete.

Algae, moss and vegetation growth within flume invert

Prior to the installation of Concrete Canvas, the flume was pressure washed to remove vegetation and minor repairs were carried out using a semi-dry grout mix to fill any voids in the concrete larger than 50mm. Bulk rolls of CC5™ were delivered to site and cut to specific profile lengths eliminating any wastage. Each length of CC was laid transversely and fixed in place using 34mm Hilti nails with 25mm diameter washers shot fired at centres not exceeding 600mm. Adjacent layers of CC were overlapped by 100mm in the direction of water flow. End sections of CC were cut with an angle grinder post-set to provide a neat finish.

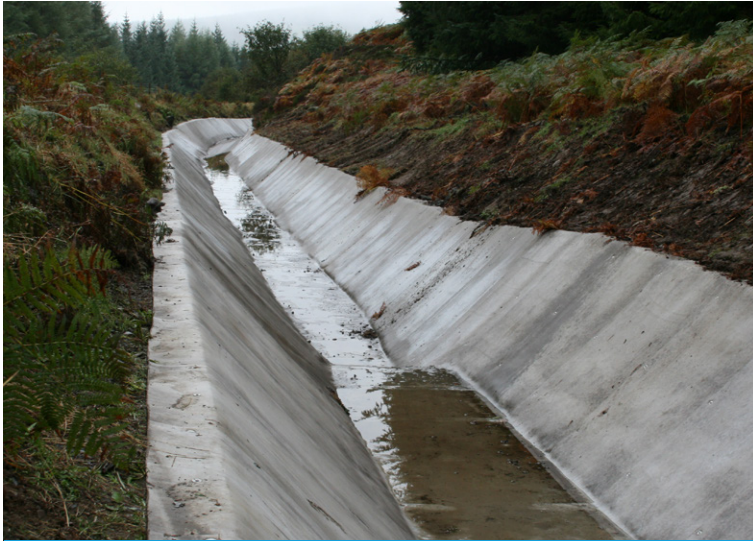
Remediated flume lined with transverse layers of CC5

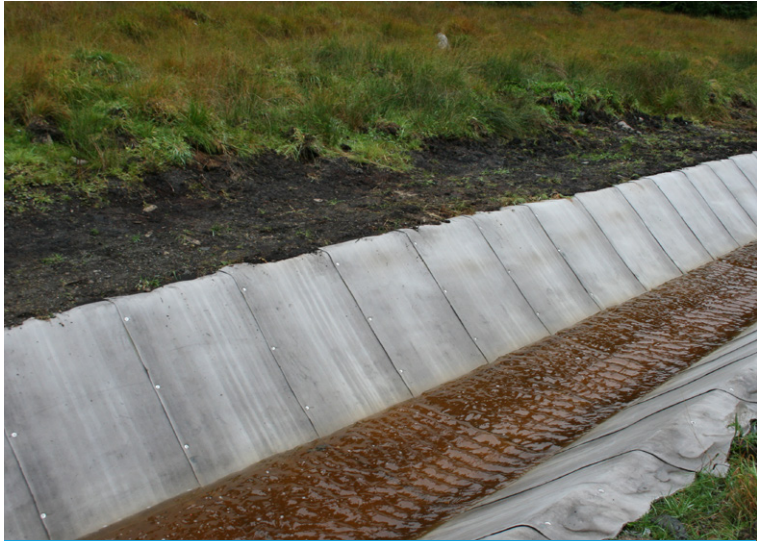
Anchor trenching of far crest

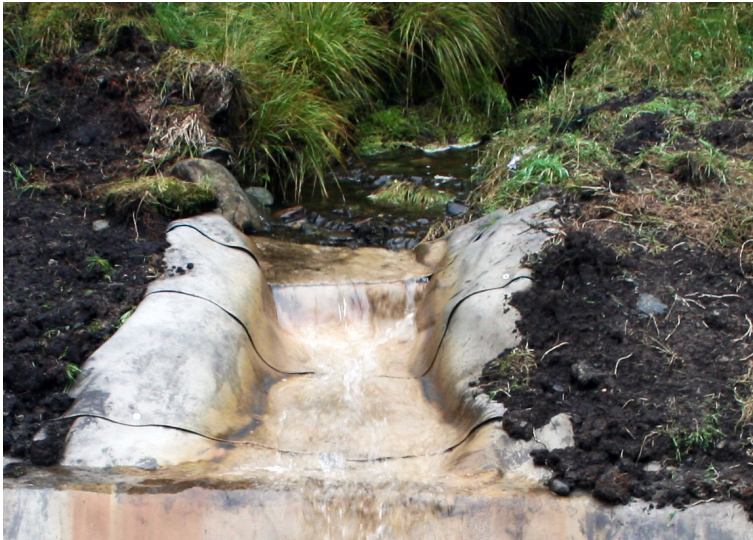
Inlet channels lined with CC to direct bank runoff into flume

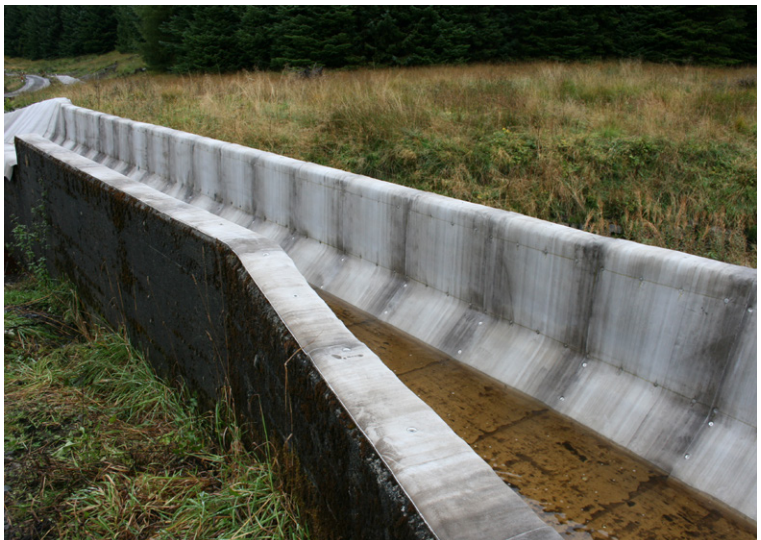
CC lined cascade section

The CC was able to accommodate sharp bends, junctions and terminals, interior and exterior pipe protrusions and a series of cascaded steps. In future projects, flume sections likely to experience very high turbulence and eddy forces (also known as Foucault currents) would be lined with CC13™ with additional fixings for further reinforcement. It was originally considered to seal the overlapped layers of CC using a beaded polyurethane sealant or thermally bonding the joints. However, it was determined that it would be beneficial for the joints to be free draining. The free draining joints would create natural weep paths to allow water ingress into the flume, preventing build up of hydrostatic pressure between the original concrete slabs and the CC.

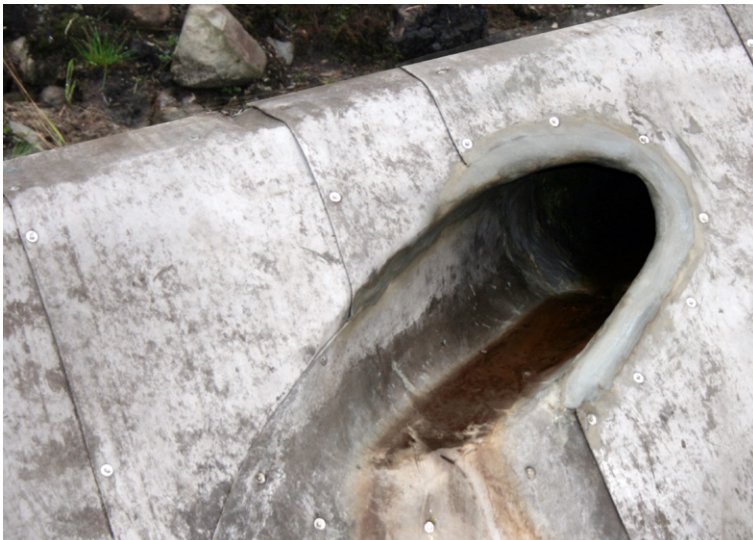
Intermediate intake pipe lined with CC and finished flush with grout

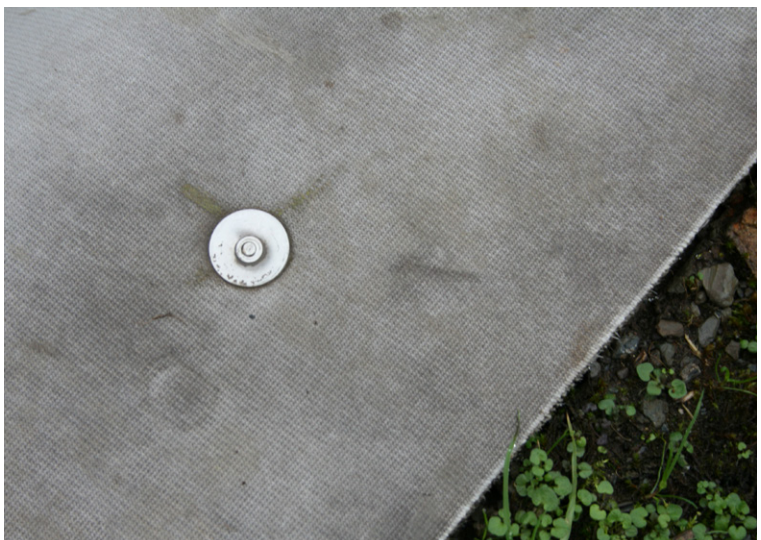
CC5 fixed using 34mm Hilti nails with 25mm diameter

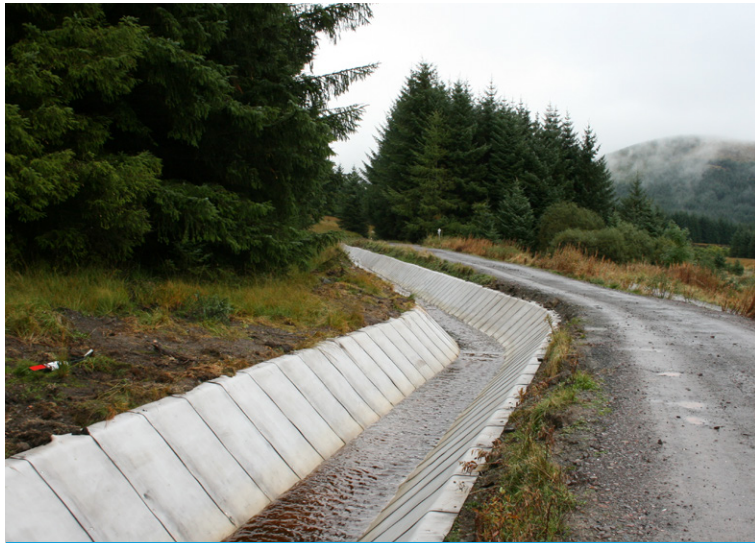
Remediated flume lined with CC5 transverse layers

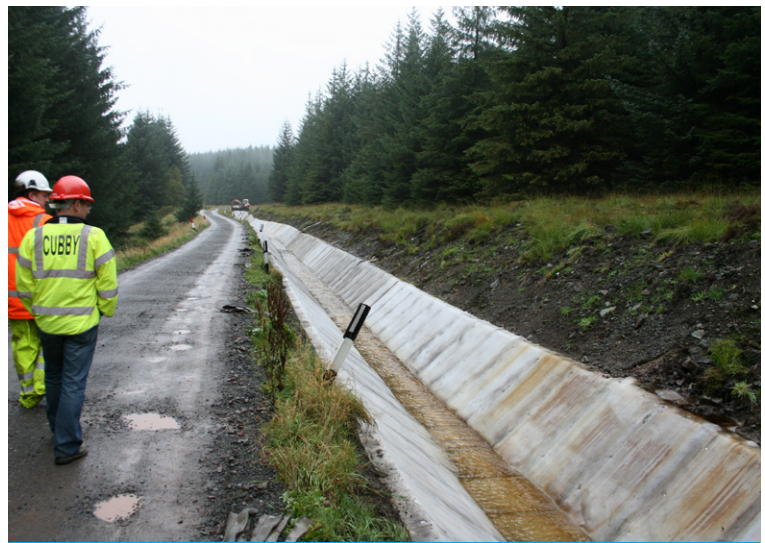
CC installed at rates of up to 600m² per day

A total of 7500m² of CC5™ were installed over a 6 week period at rates of up to 600m² per day in inclement weather and in a remote location. The performance of the CC will be reviewed by half yearly inspections of the flume in relation to abrasive nature of the water on the CC. The use of CC allowed Scottish Power to line the entire length (1500m) of the flume encasing all the concrete defects, thus negating the requirement to carry out concrete repairs every 2 years, saving the client time and money.

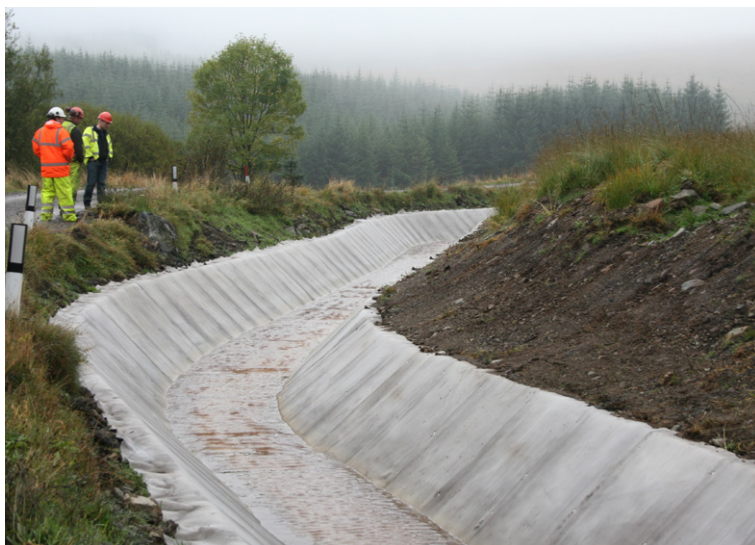
CC able to accomodate sharp bends

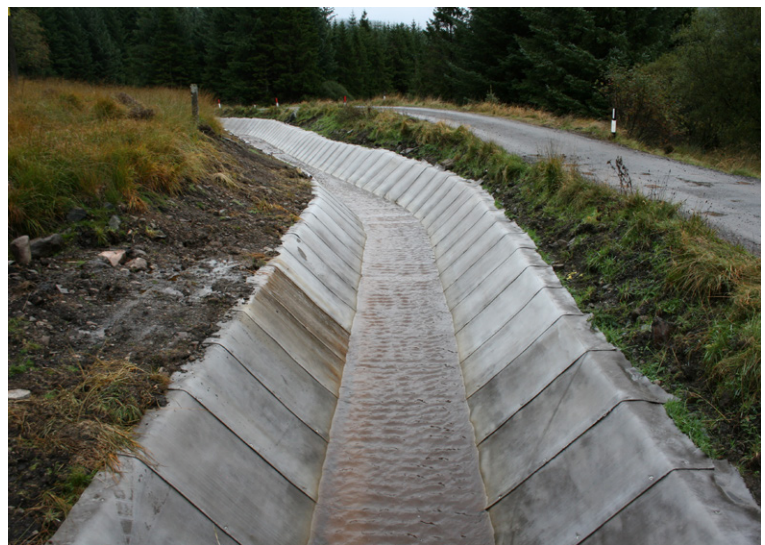
CC layers overlapped in direction of water flow providing natural weep paths

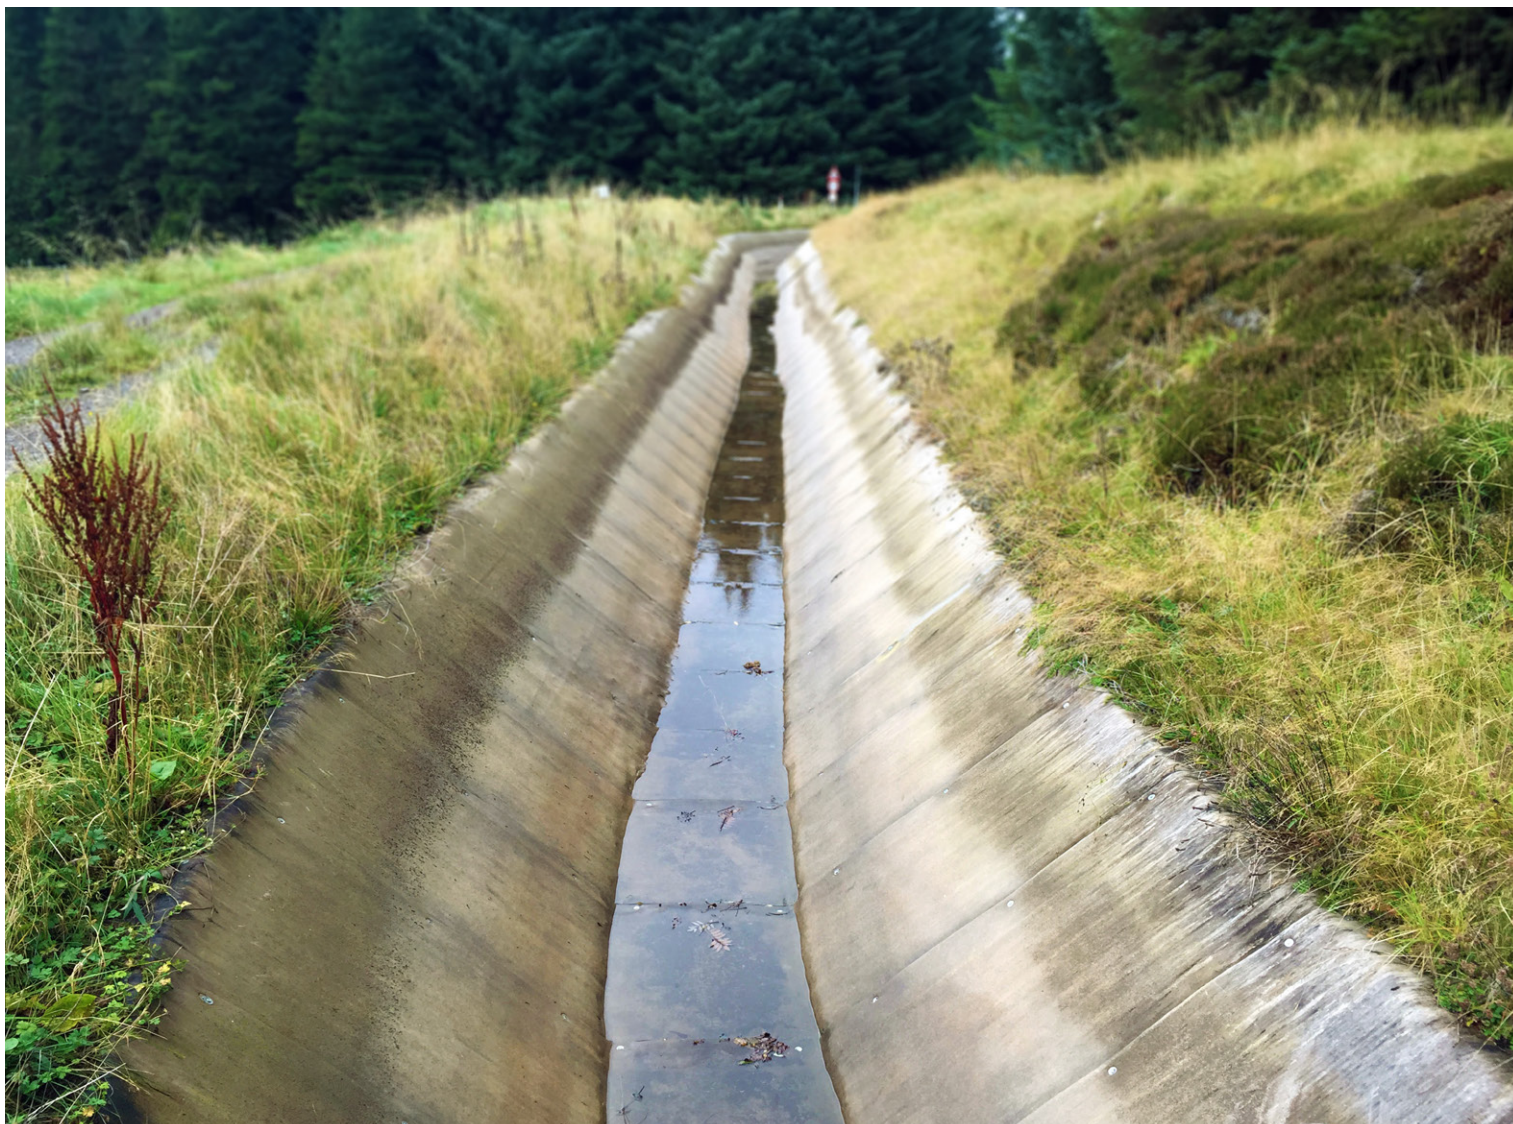
Bowburn Flume 4 years on

Four years after installation, a return visit to the site found that CC is performing as expected and has begun to blend in with the environment. Moss and algae have begun to grow on the surface of the material, creating a 'greening' effect. Concrete Canvas® is now certified by the BBA with a durability of 120 years and as such is expected to considerably extend the working life of the flume.
