CC CC8™ Bulk Rolls

Kenyar Dam, Hulu Terengganu, Malaysia

i CC8™ was installed as a channel lining solution at a roadside near Kenyar Dam in Malaysia.

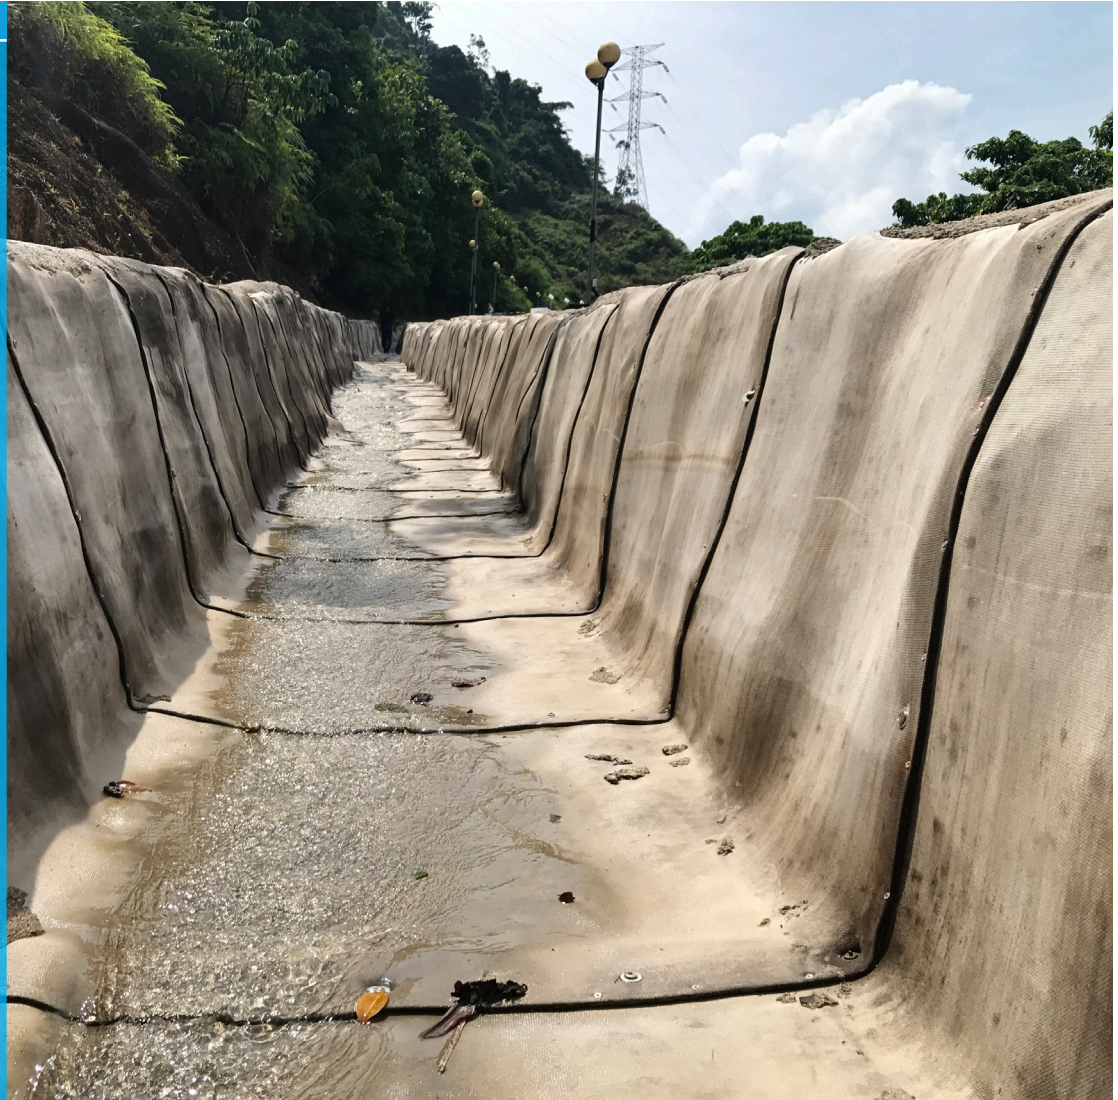
Completed installation near Kenyar Dam

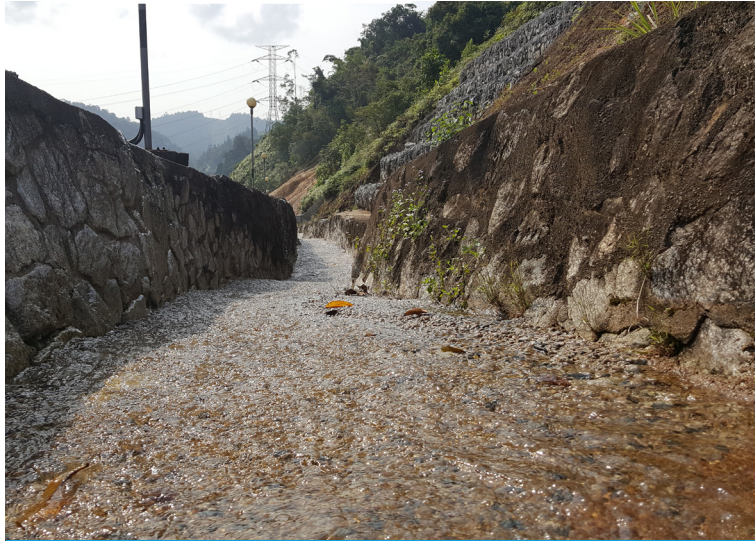
The channel prior to installation

The channel had previously been lined with rubble pitching and poured concrete, but over time water had seeped from the old concrete and got underneath the road beside it. Precast concrete or reinforced concrete were considered, but would have involved a lot of traffic disruption, as well as being much more time consuming. Due to its quick installation times, ease of installation and, therefore, limited disruption to traffic, CC was chosen for the project instead. The works were carried out by Daengco Sdn Bhd.

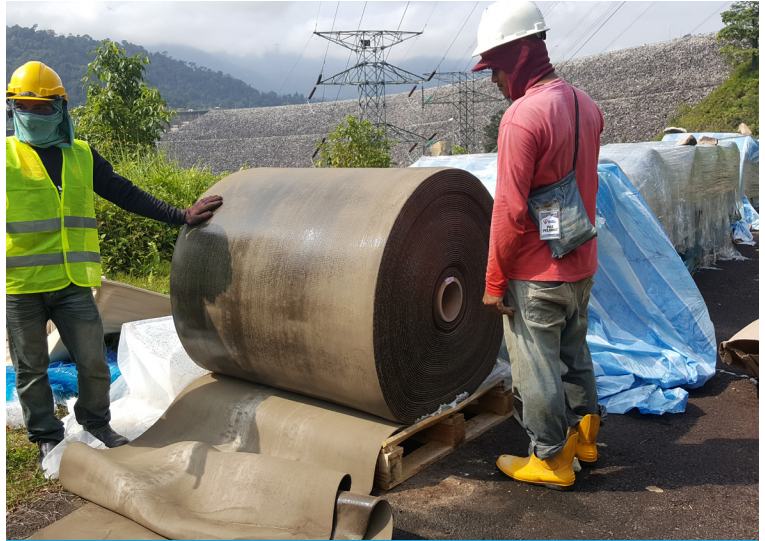
The CC was delivered to site in bulk rolls

The CC8™ was delivered to site in bulk rolls, laid longitudinally across the profile of the channel in the direction of water flow and cut to length. The CC was then fixed to the surface using anchor wedges at intervals of around 200mm along the overlaps of material. Following installation, the edges of the CC were terminated in concrete grouting, and the CC was hydrated; however, water continued to flow through the channel during installation (as CC is capable of being installed underwater) and assisted in the hydration process.

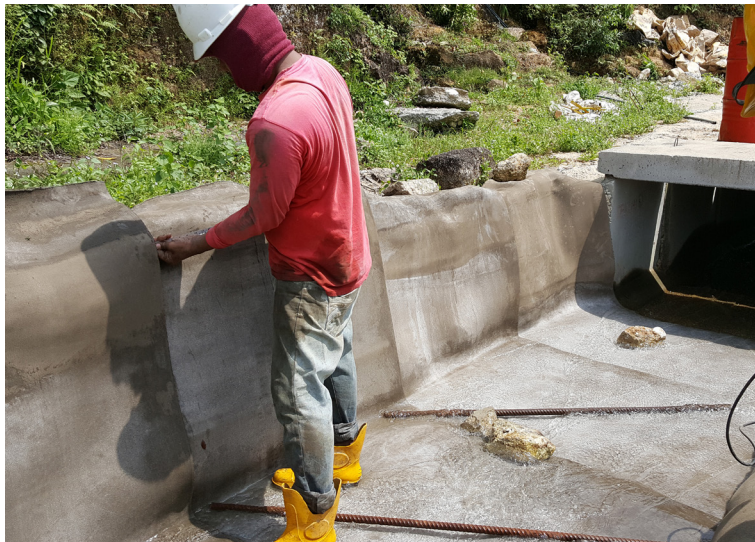
The CC was laid transversely in flowing water

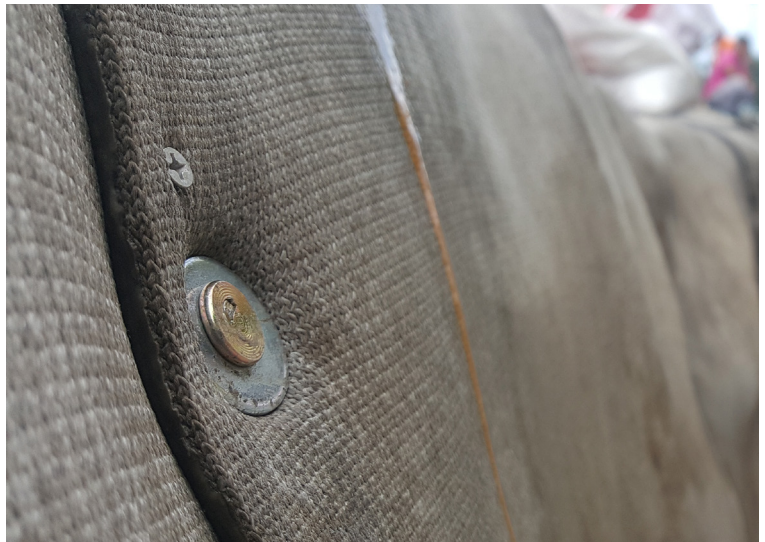
Anchor wedges were used to fix the CC to the channel walls

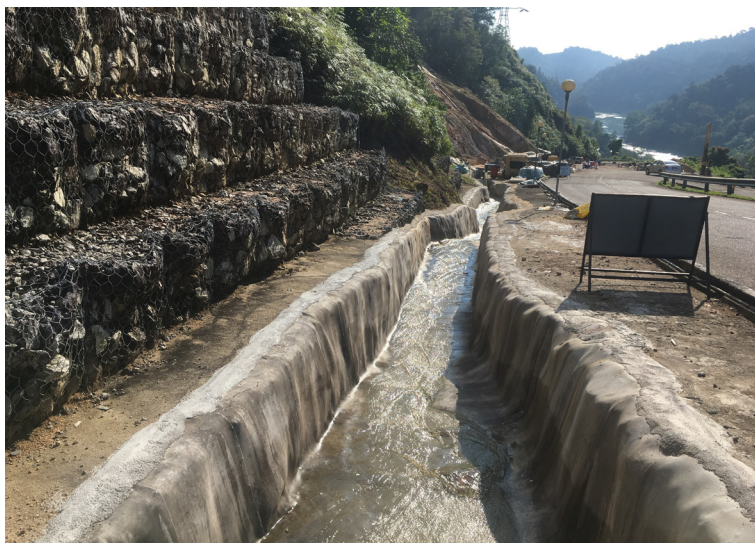
The completed installation

The CC8™ provided a waterproof lining which is capable of withstanding the high velocities of waterflow that are typical for the channel. The flexibility of the CC meant that installation was easy and much quicker than conventional concrete methods as it was able to contour to the channel profile and the team were able to prevent the formation of any voids underneath the material.

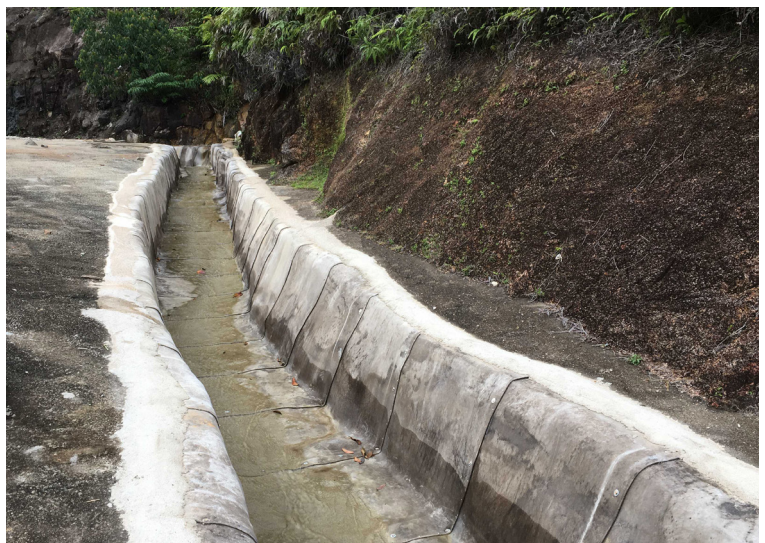
The channel in use

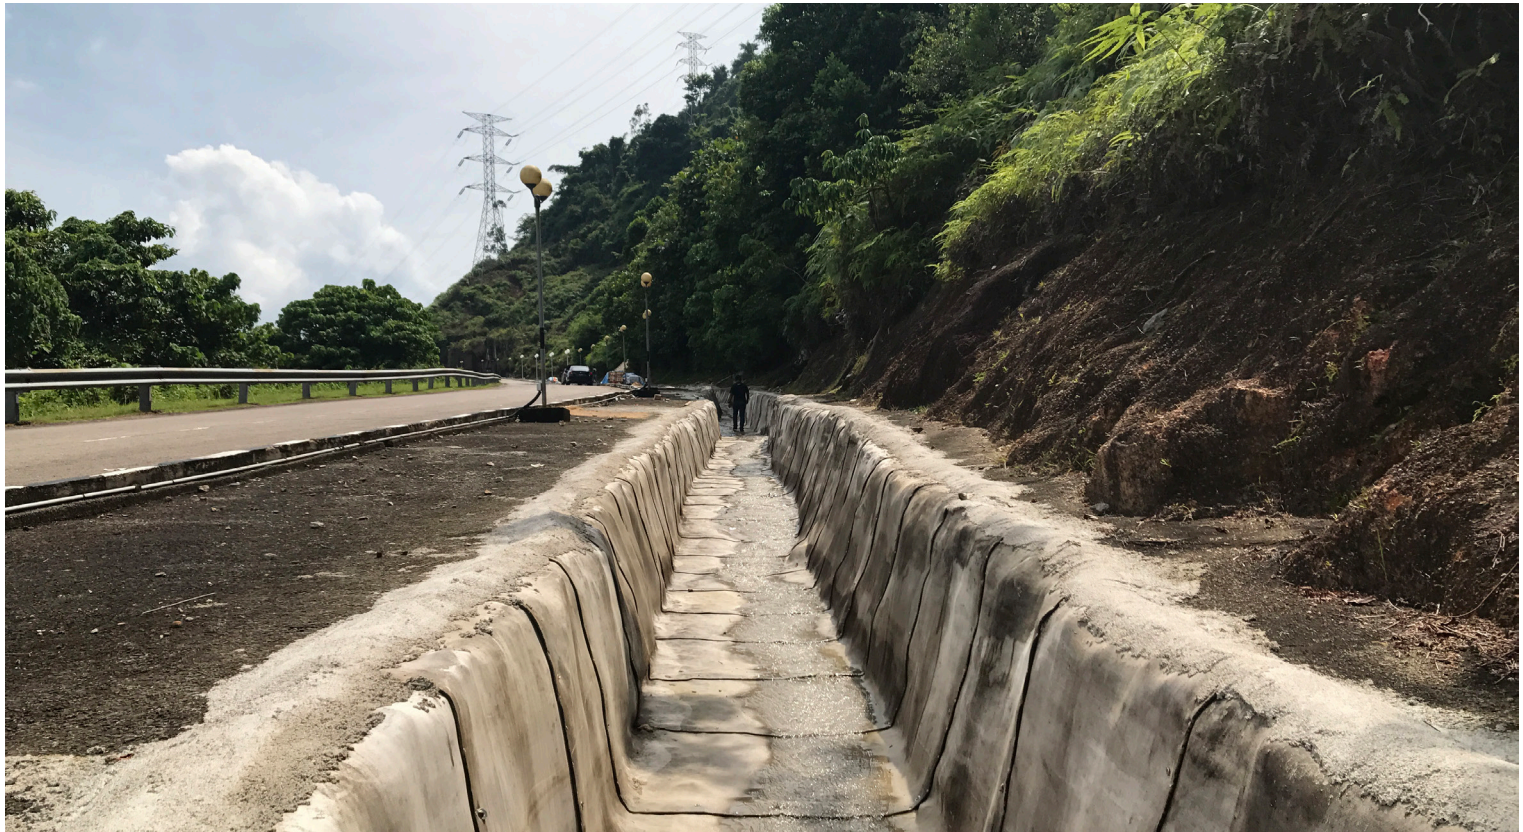
Completed installation

In total, 1,463m² of CC8™ were installed in 2 weeks in very wet weather conditions, which slowed progress as the work could only be carried out when the channel water levels were low. Both the client and contractor were impressed by the ease of install, and pleased with the outcome.
