CC5™ Bulk Rolls

Mooi River irrigation canal, Muden, South Africa

CC5™ was used to remediate a failing irrigation canal

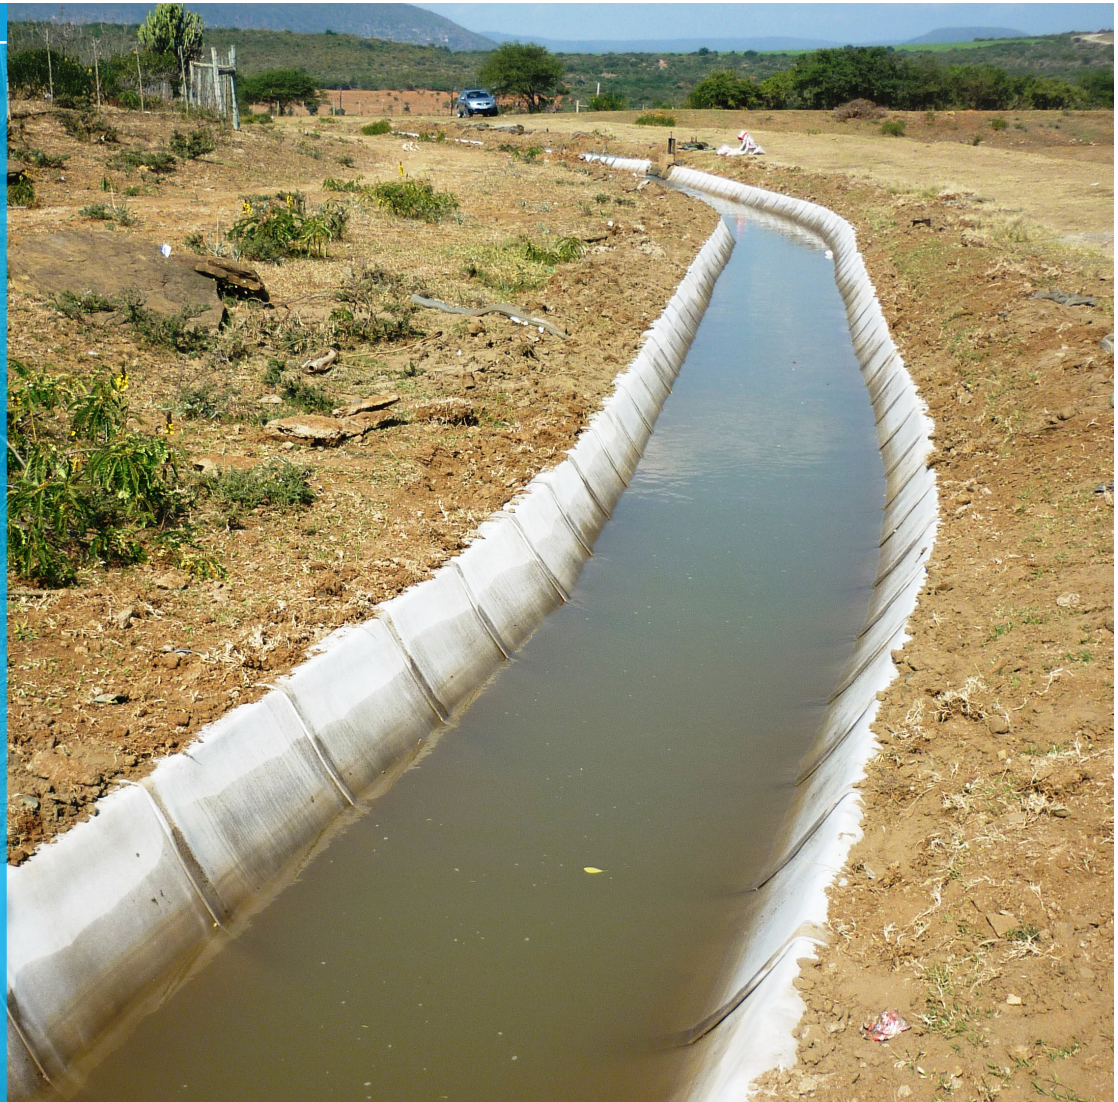
Completed installation

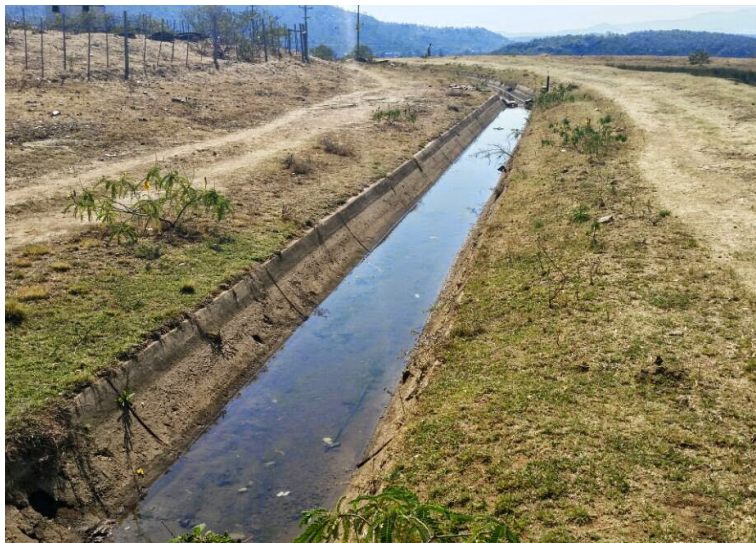
The canal was badly cracked leading to large amounts of water loss. Poured concrete was considered for the project, however some areas of the canal were only accessible by foot, which would have made a poured concrete installation difficult. In addition, CC minimised the interruption to the water supply for the residents along the canal who depend on it. The works were carried out by Medina Engineers and Dwenga Trading in a joint venture, with consultation from Element Consulting Engineers, for The Department of Rural Development and Land Reform.

Site prior to works

Due to the profile varying between 2m and 3m a transverse layup was used to minimise wastage. To prepare the canal, any debris or vegetation was removed, crumbling concrete was removed from cracks and voids before they were filled, and anchor trenches were excavated along the shoulders of the canal. The CC5™ was mounted onto a spreader beam hung from a JCB 3DX Backhoe Loader and batched to specific profile length on site. The CC was unrolled across the channel, with the open edges placed into the anchor trenches. Subsequent lengths overlapped the previous by 100mm. Following installation, hydration was achieved with a 5000L water bowser and hose. 30 minutes after hydration knuckle joints were formed by folding the material back under itself, creating a 50mm wide knuckle. These joints were then hydrated again and compressed with sandbags. Once the material had set the anchor trenches were backfilled.

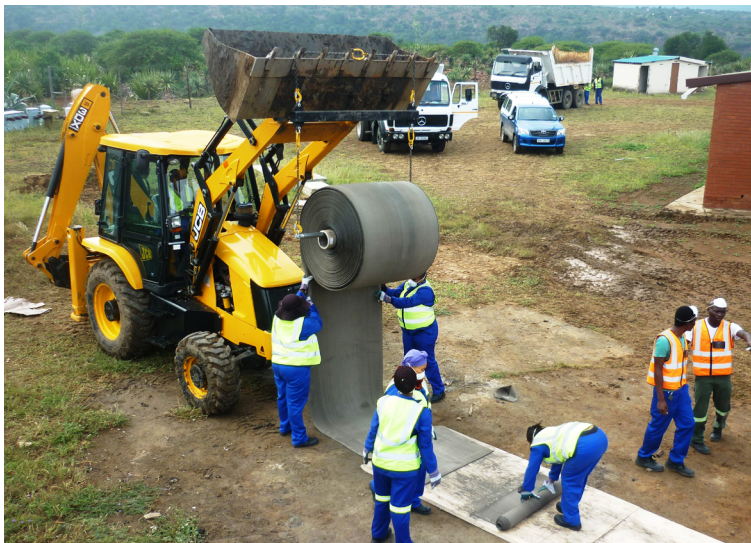
CC bulk rolls dispensed and cut to length on site

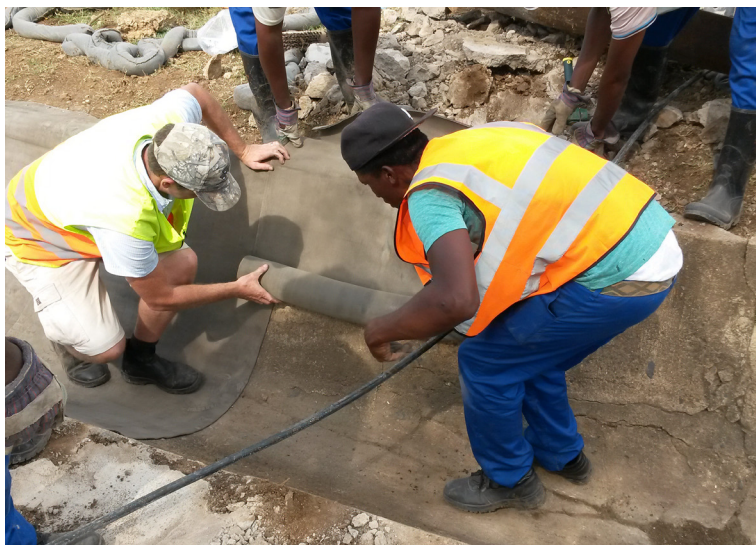
CC was laid transversely across canal width

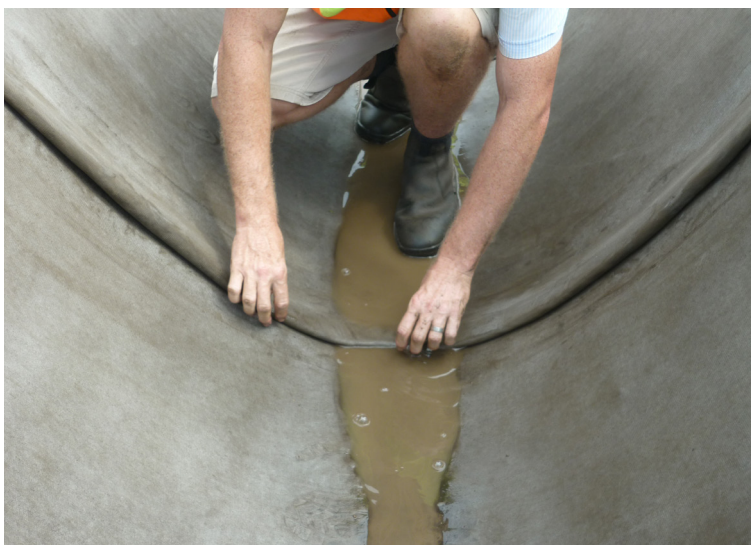
Creating knuckle joints

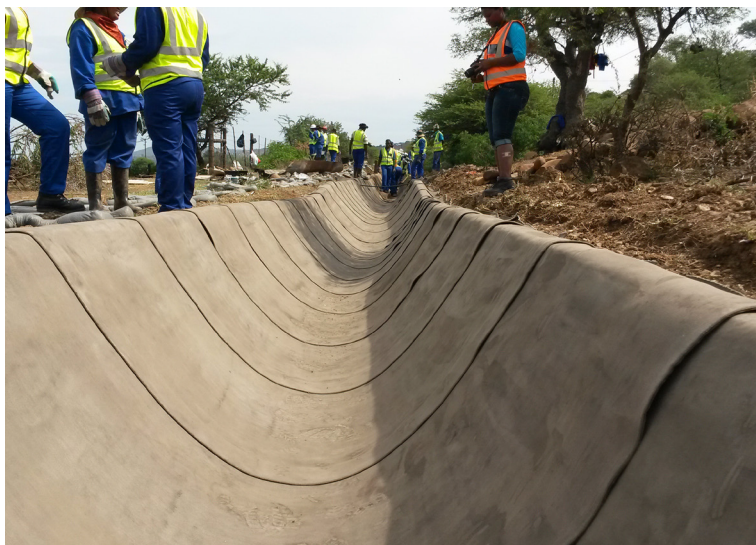
Completed layout

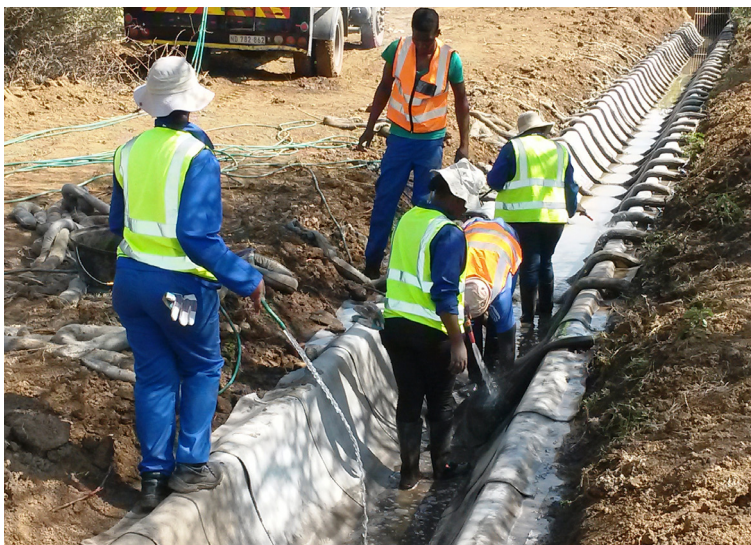
Hydration and compression of joints

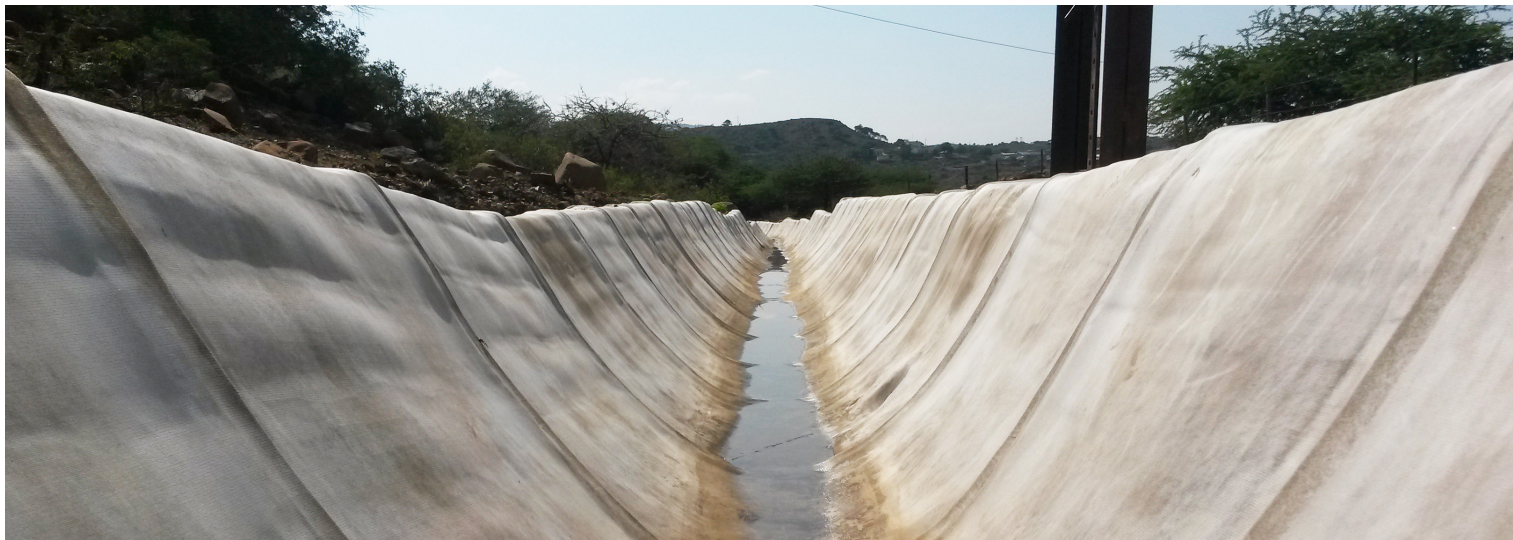
*Completed canal*

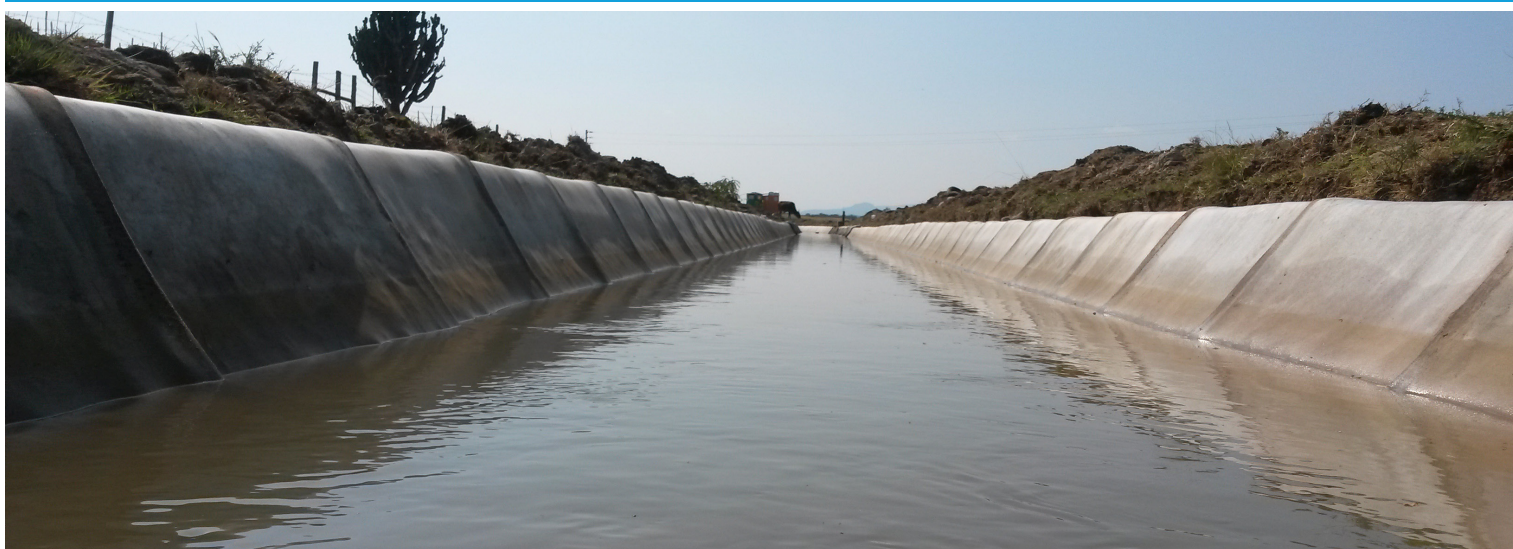
*Completed canal following reintroduction to water flow*
