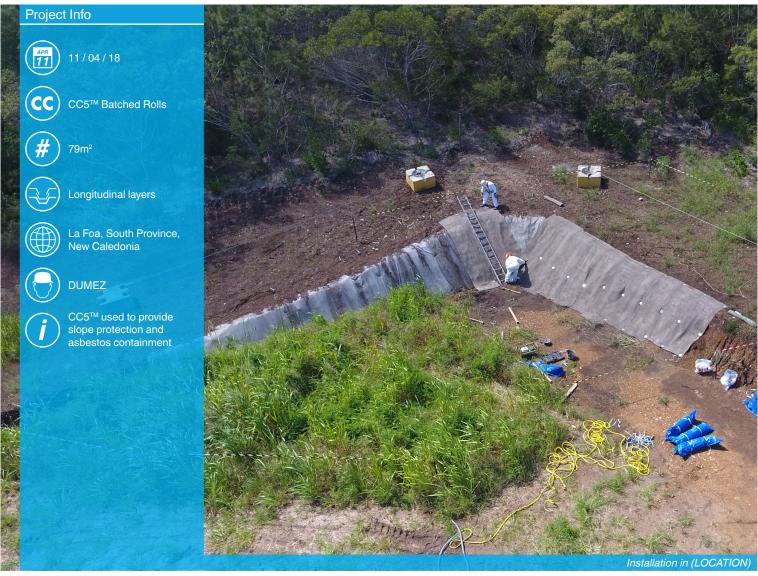
In April 2018, Concrete Canvas® GCCM* (CC) was used to provide slope protection and asbestos containment in La Foa, South Province, New Caledonia. Known as the 'Agrisolar project', the installation was carried out on an agricultural/ solar farm site.

A non-woven geotextile had previously been installed as a temporary solution, but required replacement due to environmental degredation. Both shotcrete and CC were considered, but CC was ultimately chosen due to its ease of installation. Unlike shotcrete, CC was also not prone to cracking under hydrostatic pressures, making it the preferred option. The works were carried out by the client, DUMEZ.

Prior to installation, anchor trenches were created at the toe and crest of the slope. CC5™ batched rolls were specified and unrolled and laid vertically down the slope. Subsequent layers were overlapped by 100mm, and ground pegs used to secure the material at 2m intervals along the crest. A combination of CT1 sealant and 20mm screws placed at 200mm intervals were then used to joint the overlaps. This process was repeated along the full section of the slope, which covered a corner section of varying heights. The CC was then hydrated using a 1,500L bowser and pressure hose, allowed to rest for 1 hour and hydrated again to ensure sufficient hydration.

79m² of CC5™ were installed in just 8 hours, in temperatures of 25-30°C. The client was satisfied with the installation and has enquired into using CC for a second project, where the material would be used for channel lining.

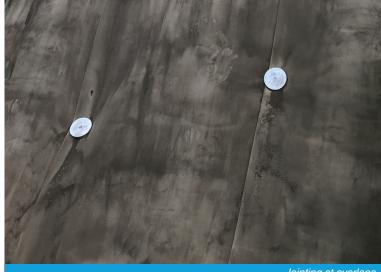
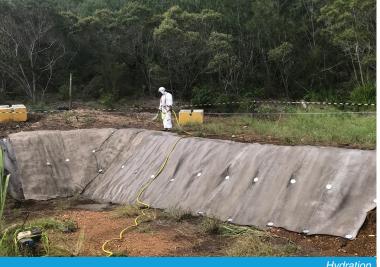
Jointing at overlaps
