CC5™ & CC8™ Bulk Rolls

Kariangau Substation,
Balikpapan, East
Kalimantan, Indonesia

CC™ used to provide
erosion protection to
slopes and channels
adjacent to the
substation

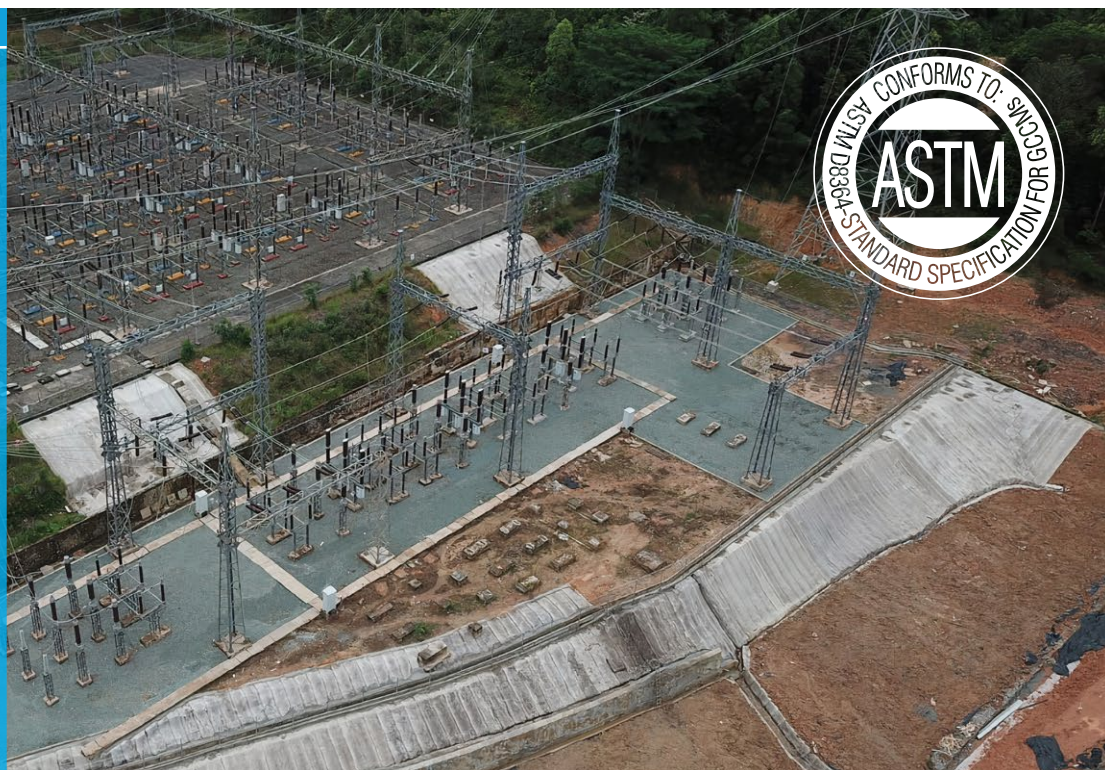
Completed CC Installation

Anchor trenches were excavated around the entire perimeter of the slopes and channels. Due to the limited access, the CC was cut and transported into position by hand. The CC5™ was installed vertically down the slopes, whereas the CC8™ was installed transversely across the channels, lapping in the direction of water flow. The CC was pegged in the anchor trenches to hold the material in place, and the overlaps were jointed using stainless steel screws at 200mm spacings. Once both CC5™ & CC8™ were installed, the material was then hydrated using a portable bowser and hose. Then the anchor trenches were back filled with the excavated soil.

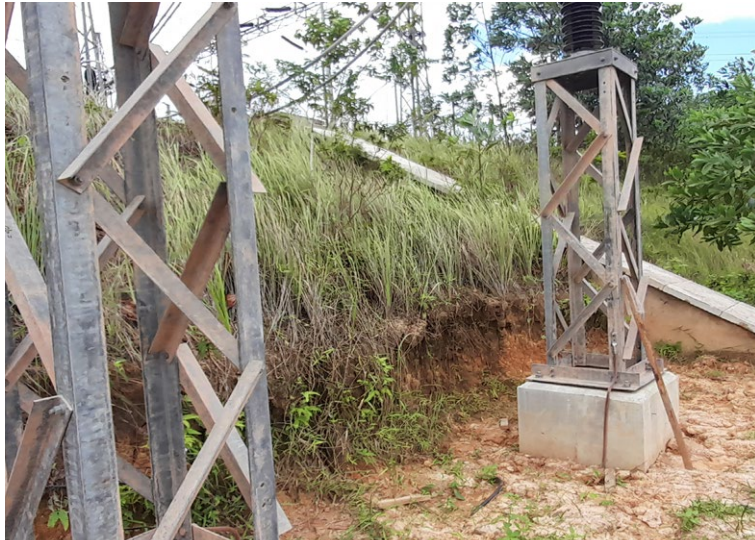
Slope before work commenced

The slopes near the substation were becoming increasingly unstable due to erosion caused by heavy periods of rainfall within the area, so an erosion control solution was needed to protect the substation. Shotcrete was considered as a method to line the slopes and prevent further erosion, but also line a channel at the toe of the slopes to take the rainwater runoff away. However, due to the location having poor access for heavy plant machinery, CC was chosen because of its speed and ease of installation and ability to be installed during the rain.

Prior to installation, sharp rocks and protusions were removed from both the slope and channel to prevent damaging the PVC backing. Once removed, both the slope and the channel were re-graded with any voids filled in to create a smooth and uniform surface.

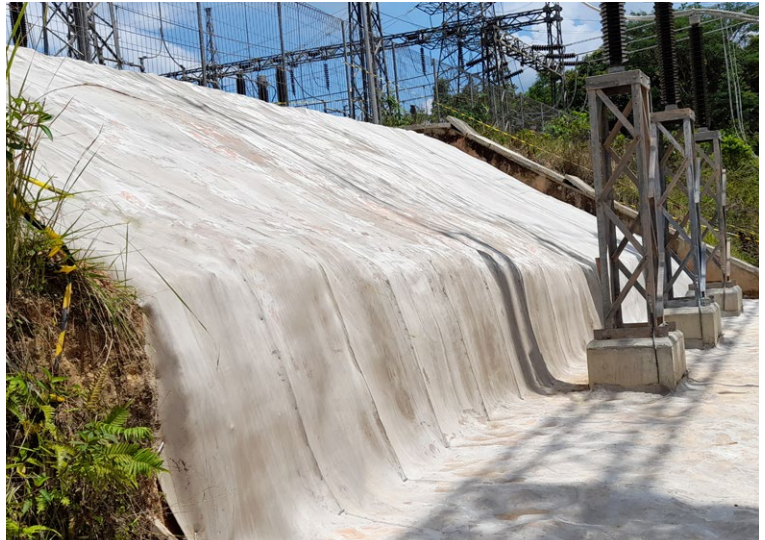
CC fully hydrated

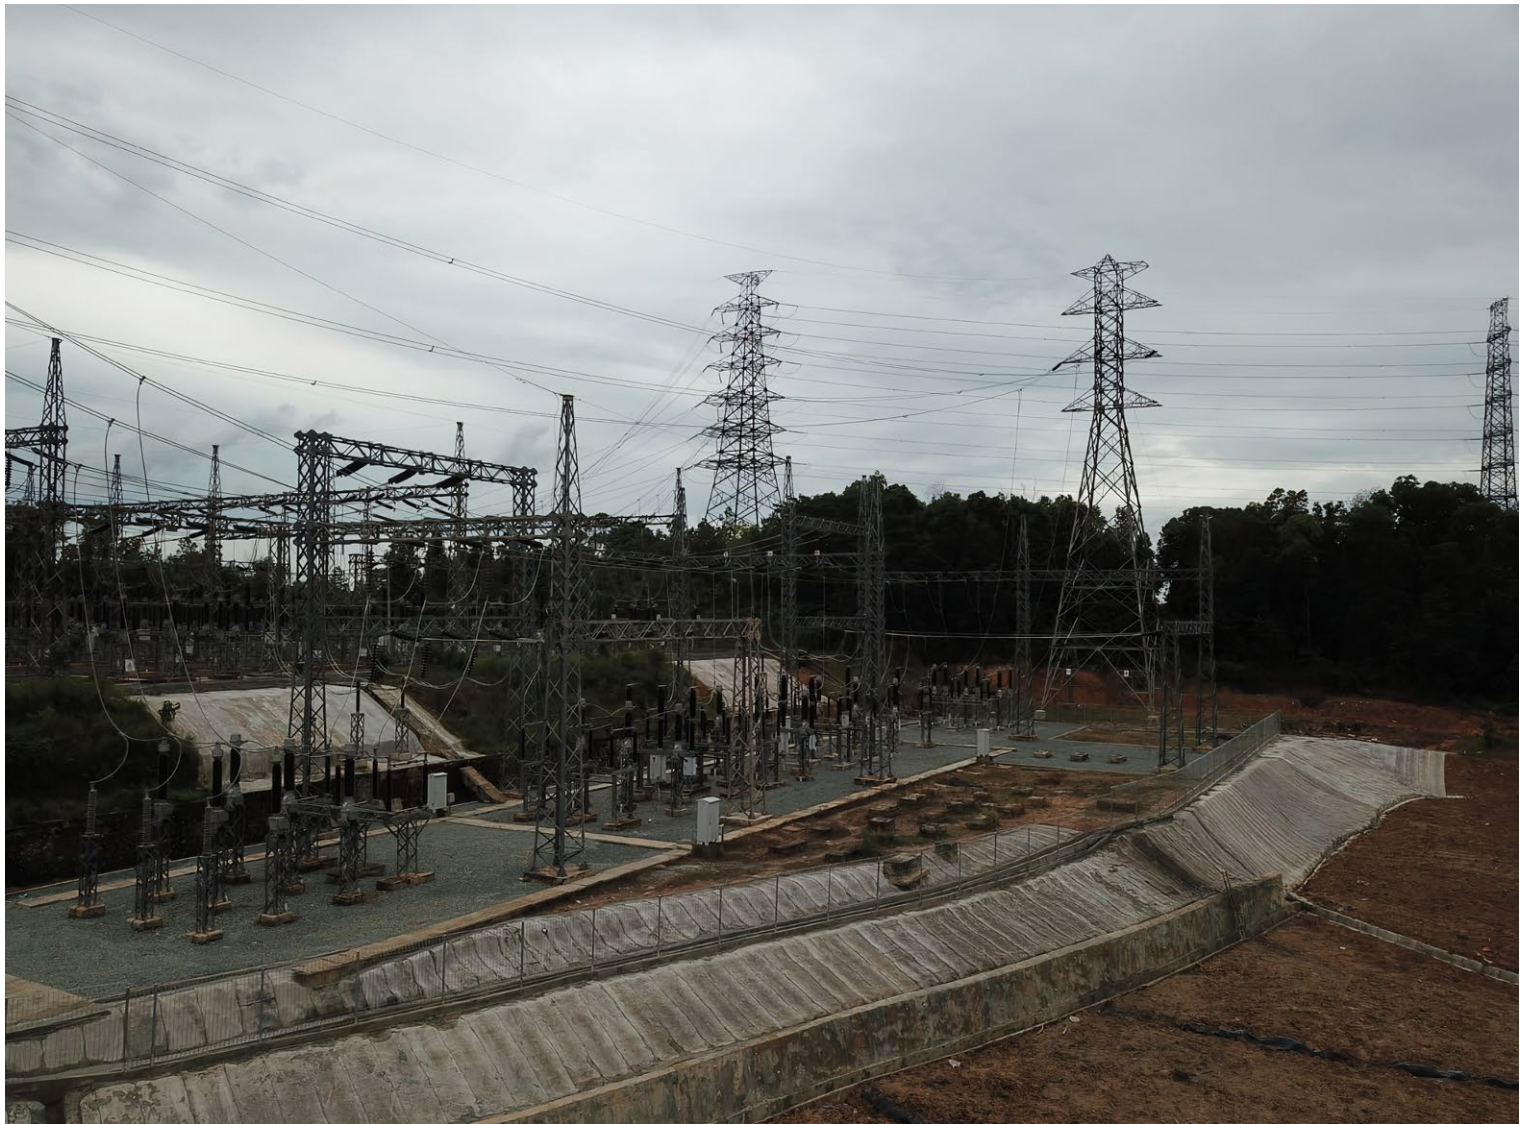
Completed channel and slope protection works
