CC CC8™ Batched Rolls

Globe icon Palm Oil Plantation, Selangor, Malaysia

i CC8™ was used in a trial to establish whether CC could be an effective erosion protection measure on an earth-bund on a palm oil plantation.

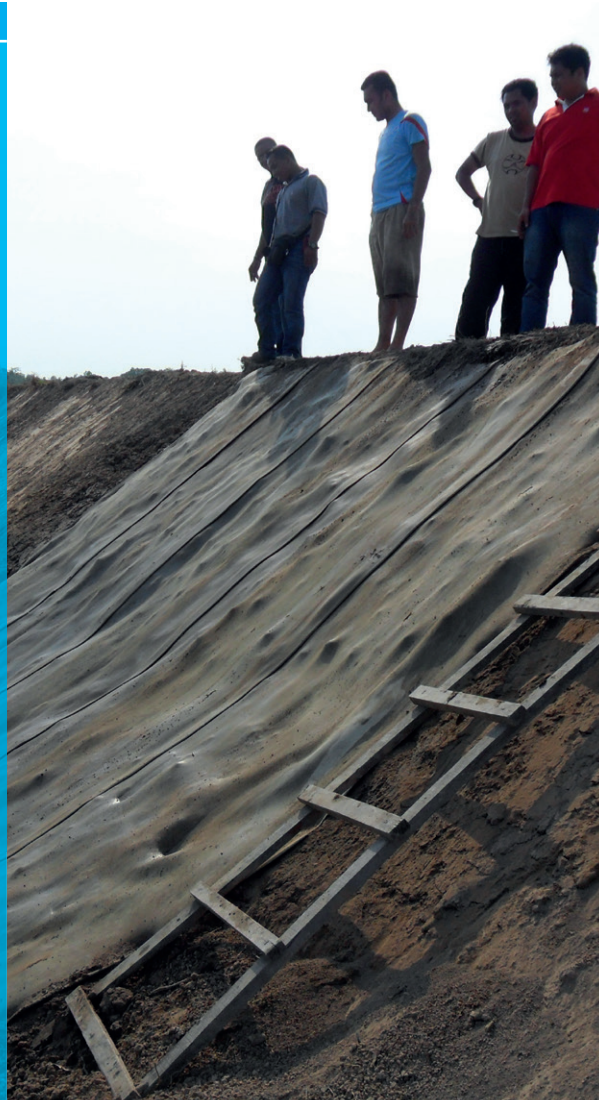
Completed installation

The CC was delivered to site in batched rolls of CC8™, unrolled and cut to specific profile length and fixed to the slope using steel pegs. The edges of the CC were then buried in anchor trenches at the crest and toe of the slope and backfilled with soil. Hydration was then given using water from the lake below.

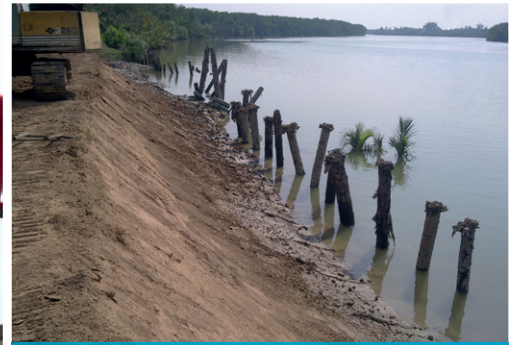
Trial site located on bank of the Langet river

The palm oil plantation is situated 2ft below high water and protected by the earth-berm in question, running around the periphery of the plantation. Maintenance of the earth-berm is of paramount importance as it is the sole flood prevention measure protecting the island from flood water and the palms from seawater contamination. Monthly maintenance is conducted on the earth-berm using a combination of measures including regrading, piling, gabion walling and vegetation growth. However, there are still regular breaches and loss of land, and erosion is exacerbated by a number of factors including high tidal flows, strong water currents and wave damage. CC was chosen for a trial installation as an erosion control measure to protect the outside face of the earth-berm in order to reduce maintenance costs, time, and flood risk levels.

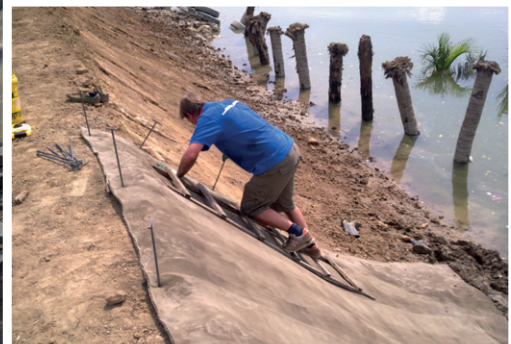
Pegging the pre-cut layers of CC to the substrate

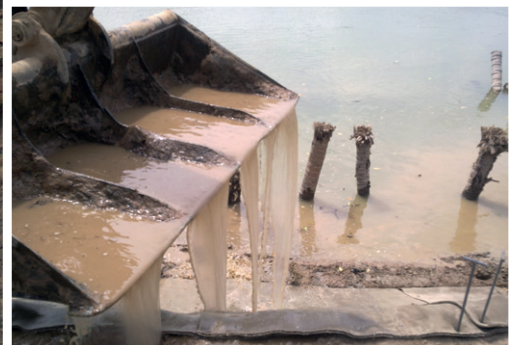
Hydration of the CC using plant site equipment
