In June 2013 Queensland Rail installed Concrete Canvas on a slope adjacent to a railway line in Wooloowin, Australia. CC was being trialled as a protective covering for the slope, allowing Queensland Rail to assess it's suitability for permanently eliminating vegetation from high-risk locations within the rail corridor. In this case, vegetation was threatening to interfere with Overhead Line Equipment and obscure vital signalling infrastructure, something which had drawn much criticism from train drivers and engineering staff. Shotcrete was also considered for the project but would require specialist labour and a lengthy line possession with the possibility of debris and rebound affecting the railway line. There was also the issue of limited access to the site, which would cause logistical difficulties should shotcrete equipment be specified.

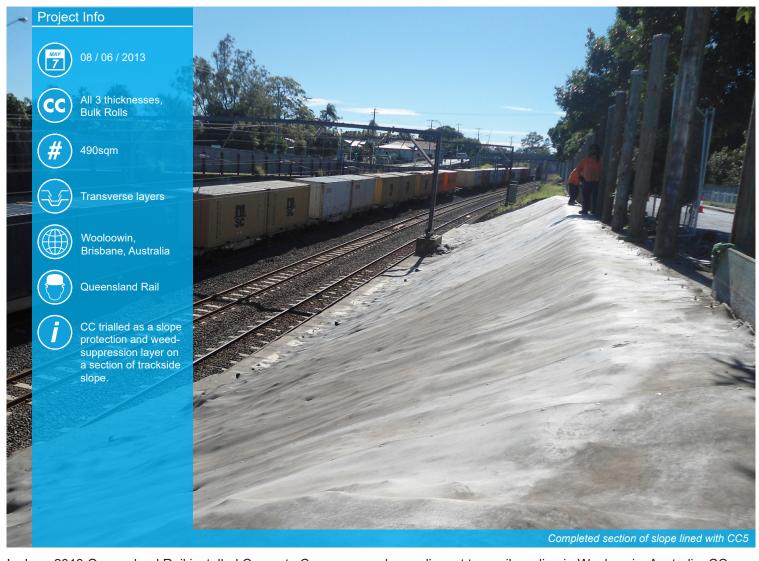
Prior to installation the project site was cleared of all vegetation and debris, subsurface drainage was installed and the slopes re-graded. Bulk rolls of all three thicknesses of CC were then delivered to site and dispensed using a crane truck and spreader beam. Once laid and cut to length, ground pegs were used to fix the CC to the crest and toe of the slope whilst adjacent layers were bonded together using Sikaflex Pro and fixed with steel screws. The CC was then hydrated using a water truck.
