CC5™ Batched Rolls

Uzsabánya, Hungary

CC5™ was used to provide slope protection beside a rail track on an industrial site in Hungary

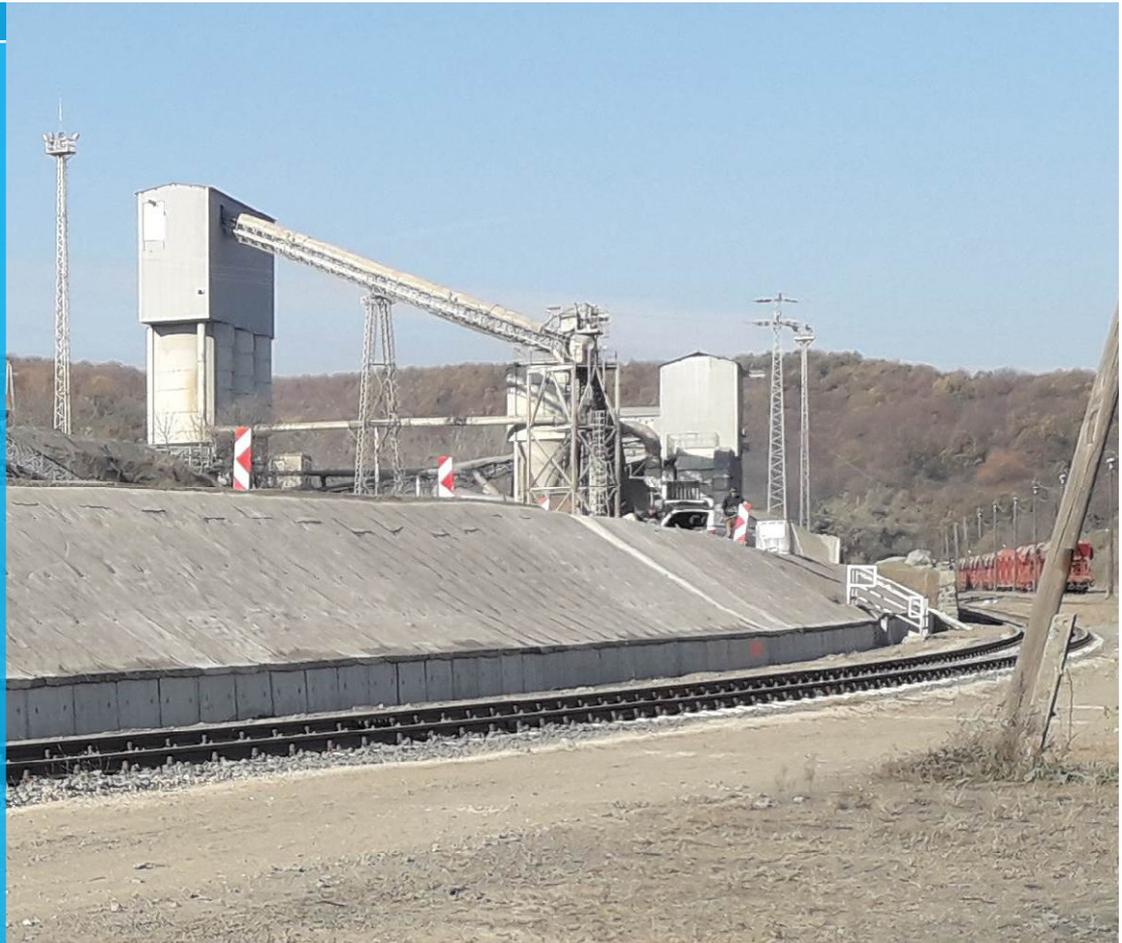
Completed installation in Uzsabánya, Hungary

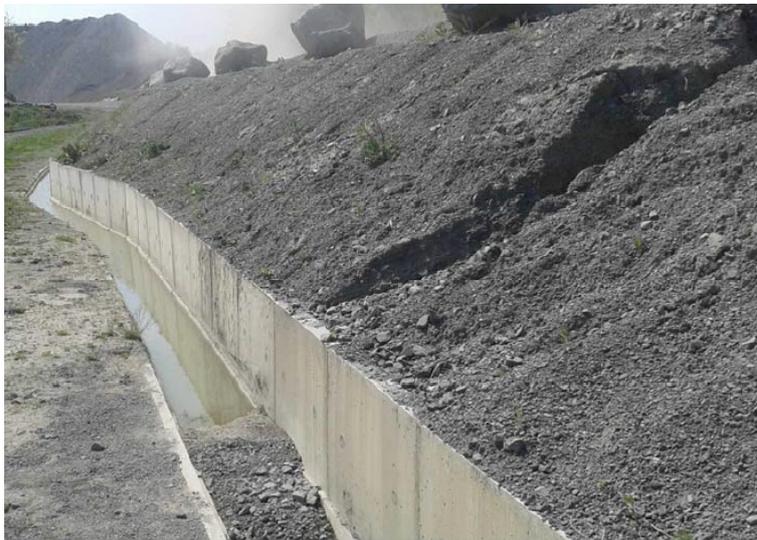
Evidence of erosion, failure and drain blockages on slope section 2

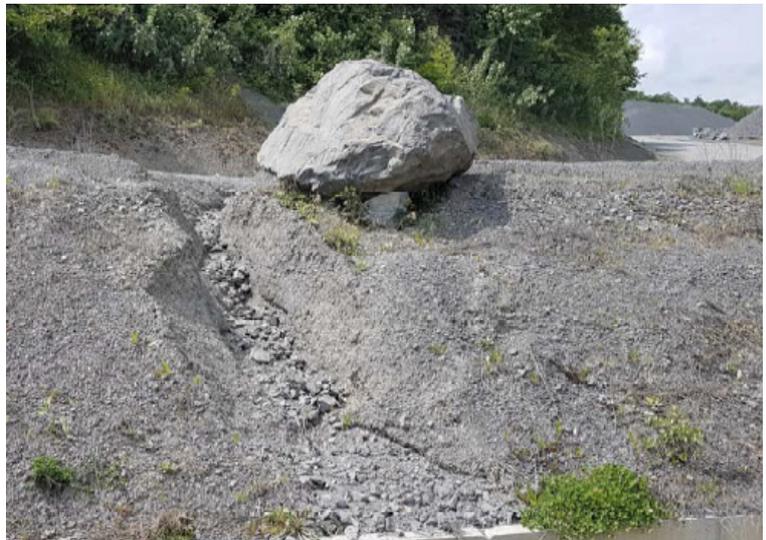
Scour of slope caused by erosion

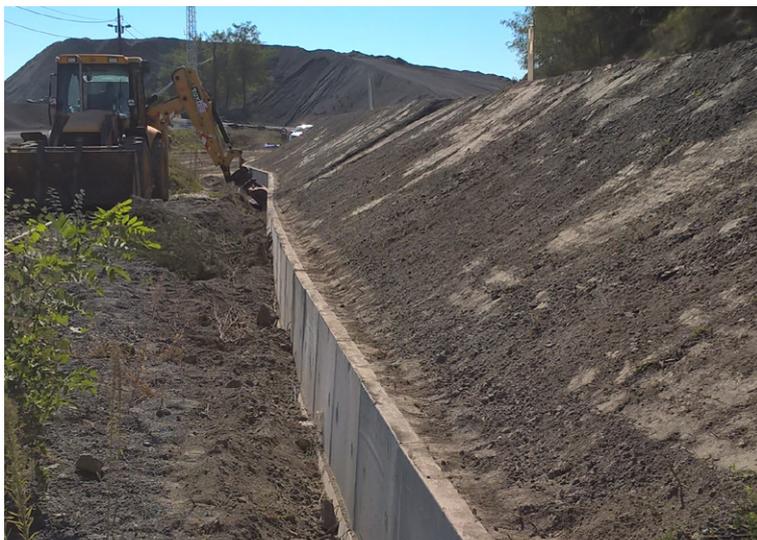
Slope section following ground works

In September 2018, works on the project began, with the installation carried out by MÁV FKG Kft. for MÁV Co. - a Hungarian Railway company. In preparation for installation, the slopes were excavated to remove vegetation and any sharp or protruding rocks, then re-graded and levelled before and after laying crushed stone. Anchor trenches were then excavated at the crest of the slopes.

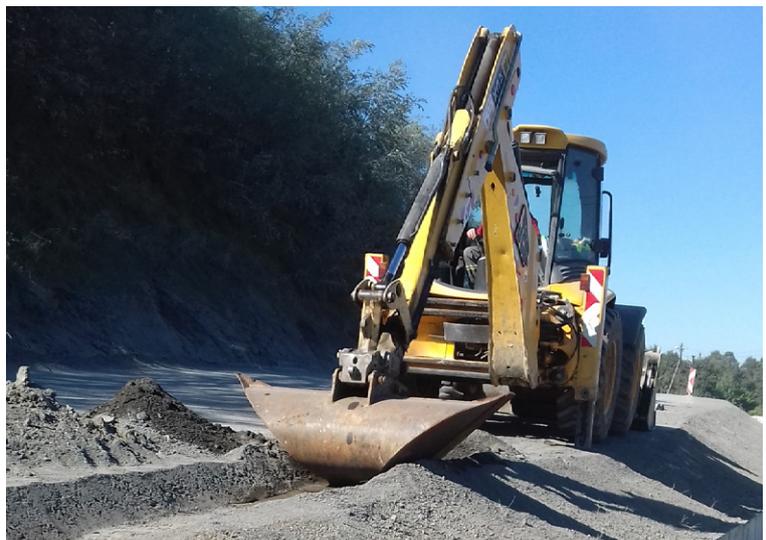
Anchor trenches created using digger and V-bucket

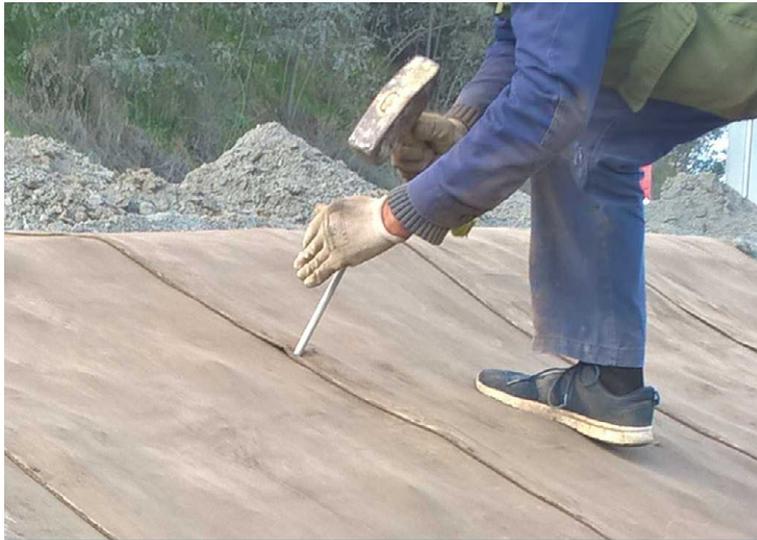
Ground pegs used to fix CC to substrate

Batched rolls of CC5™ were delivered to site, transported to the slopes by hand and unrolled down the slope faces, with the leading edge captured and secured within the crest anchor trench. Subsequent layers were unrolled and secured in the same way, with overlaps of 100mm created and jointed using screws. Each length of CC was fixed to the ground using ground pegs at 1m intervals along the edges. In some places, the material was fixed to headwalls using masonry nails while lower edges were nailed to the precast concrete elements.

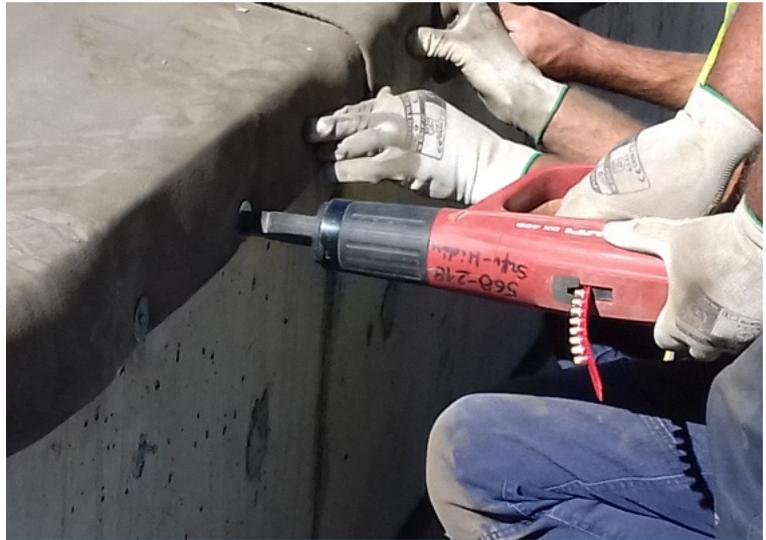
Hilti nails used to fix CC to masonry walls

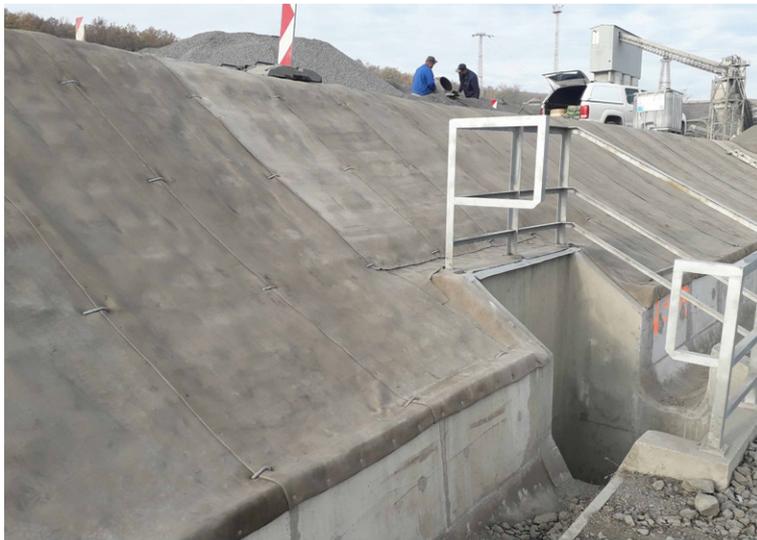
Termination detail onto concrete wall at slope toe

Following installation, the CC was hydrated using a water truck. A 1000L bowser was used to hydrate the lower layers of CC at jointed sections and smaller areas. The anchor trenches were then backfilled and the substrate compacted using a Wacker plate to prevent water ingress. In some sections, where the CC met existing concrete or masonry infrastructure, mortar was used for the backfilling.

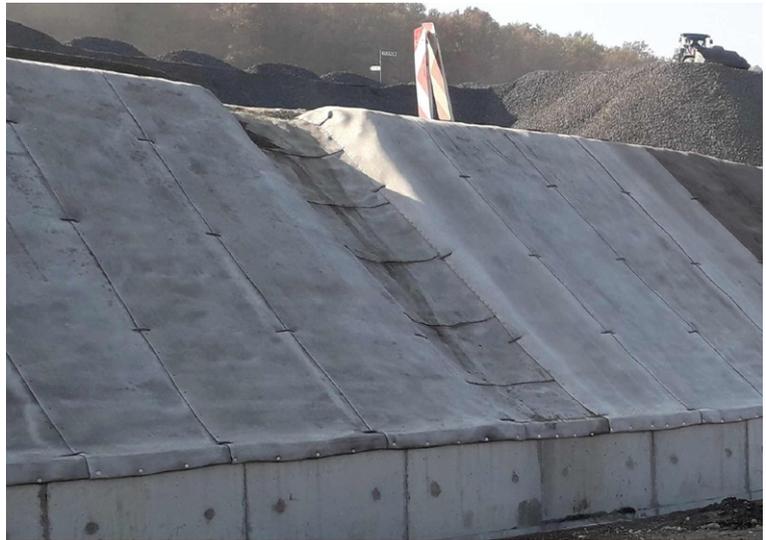
Section of transversely laid CC sections for surface runoff

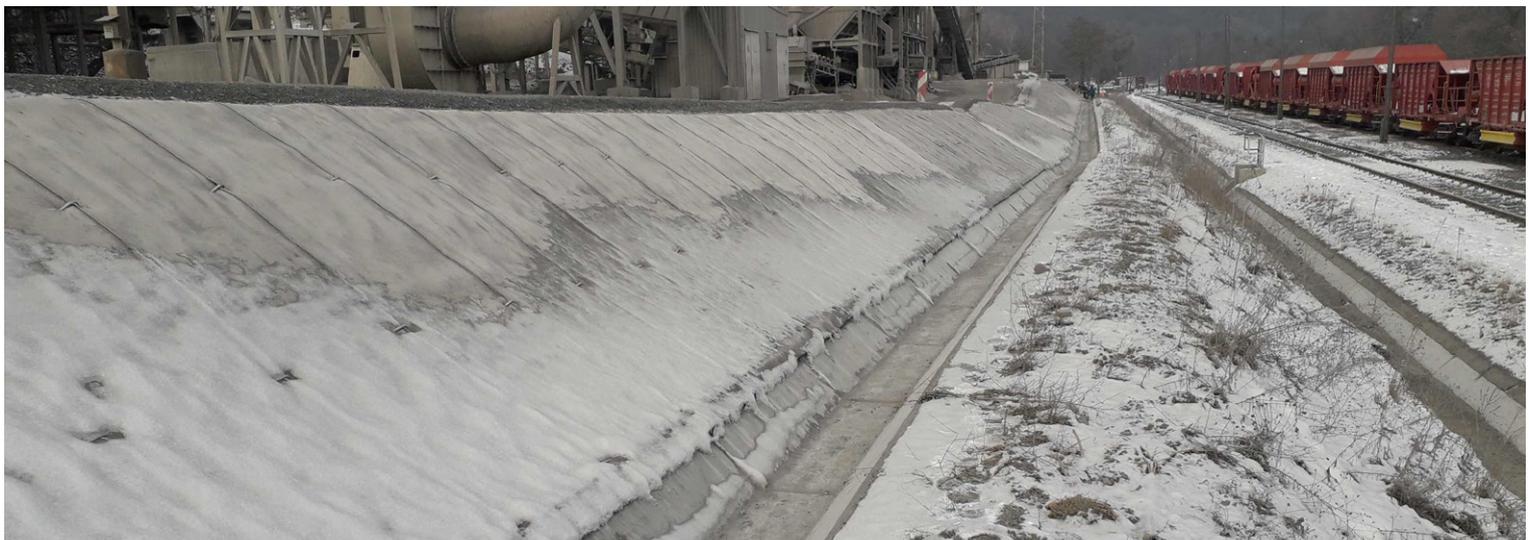
The CC slope is able to withstand freeze thaw conditions experienced during colder months in the area

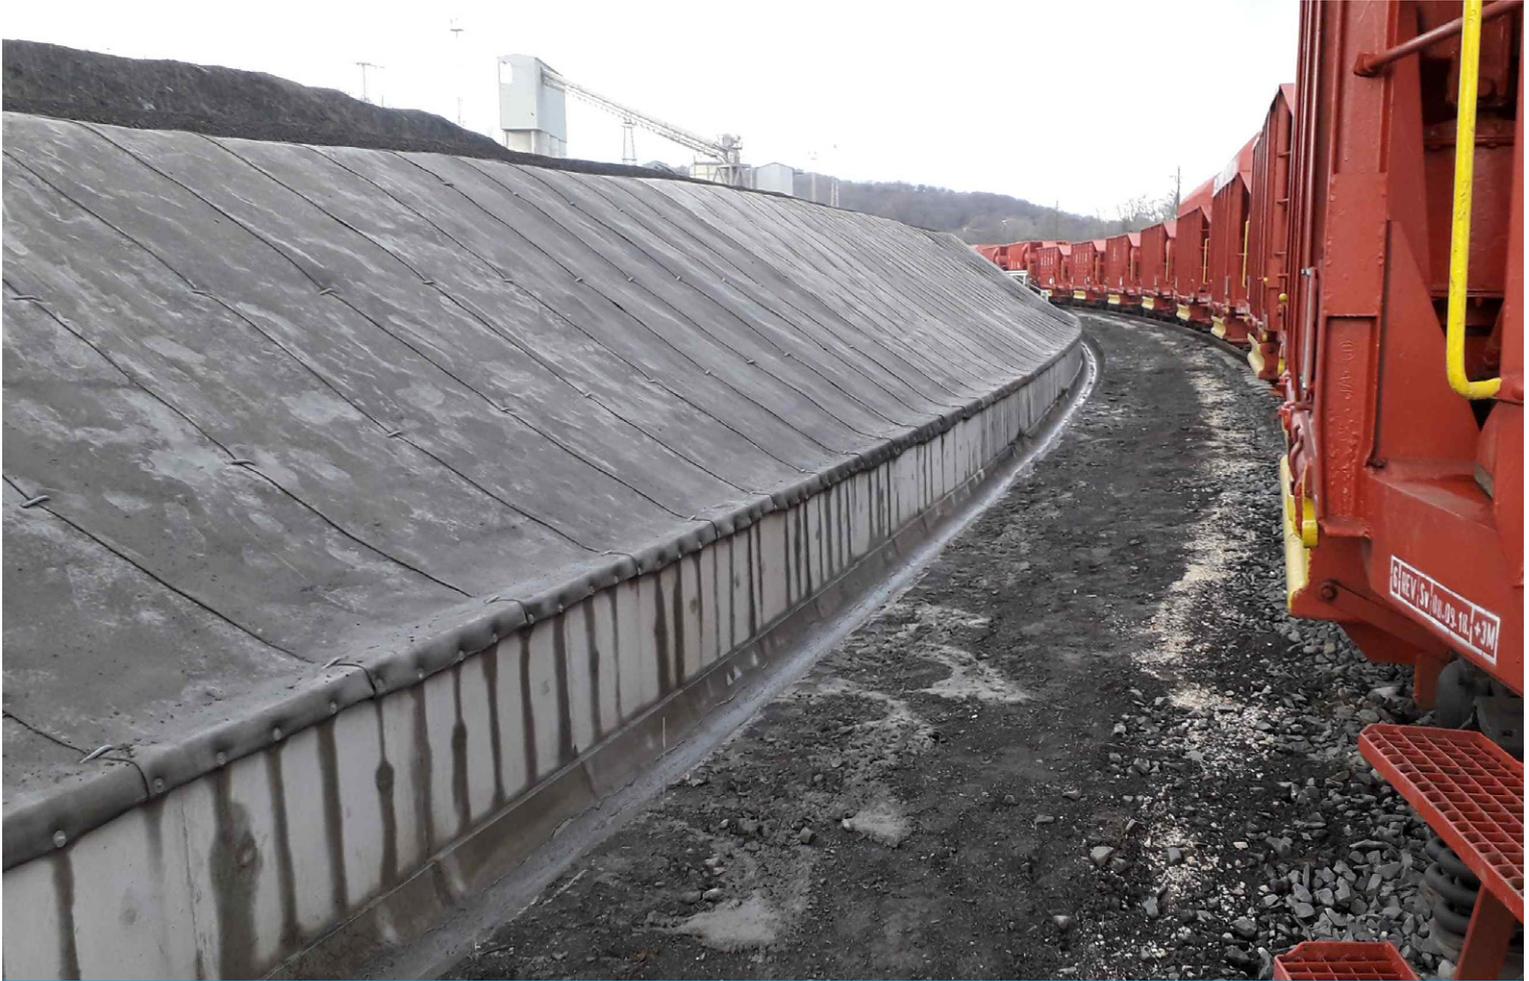
Completed section of CC slope protection installation
