CC8™ Batched Rolls

Widdop Reservoir,
Hebden Bridge, Yorkshire,
UK

CC8™ was used to
provide protection to a
drainage channel at
a reservoir in Yorkshire

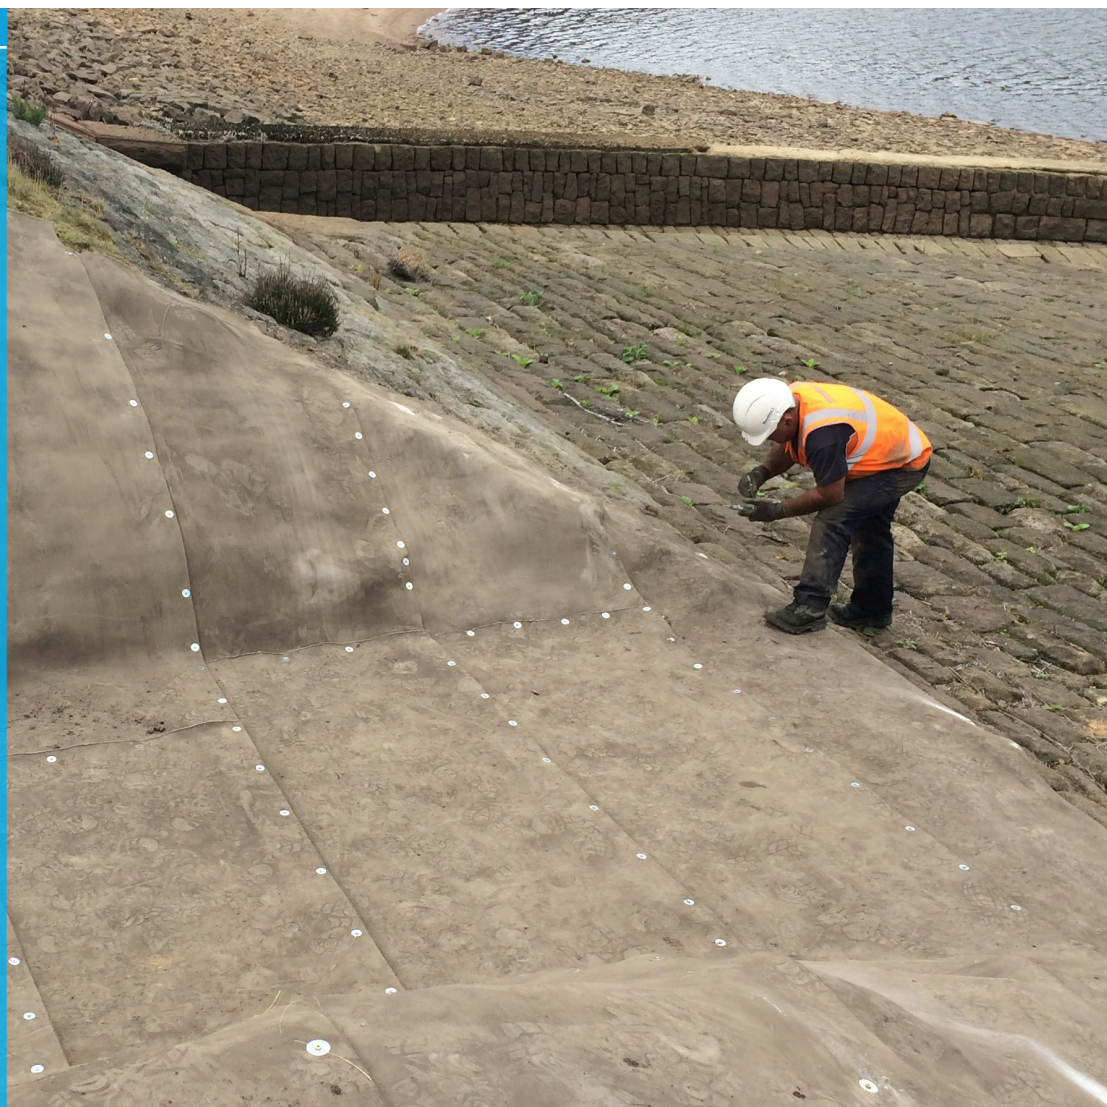
Drainage channel prior to hydration.

In August 2014, Concrete Canvas® GCCM* (CC) was used to line a drainage channel at Widdop Reservoir, Yorkshire, UK. CC provided cost savings compared to conventional concrete solutions given the speed of installation in a remote, limited access location. The works were carried out by Contractors J N Bentley on behalf of the consultant Mott MacDonald Bentley for Yorkshire Water.

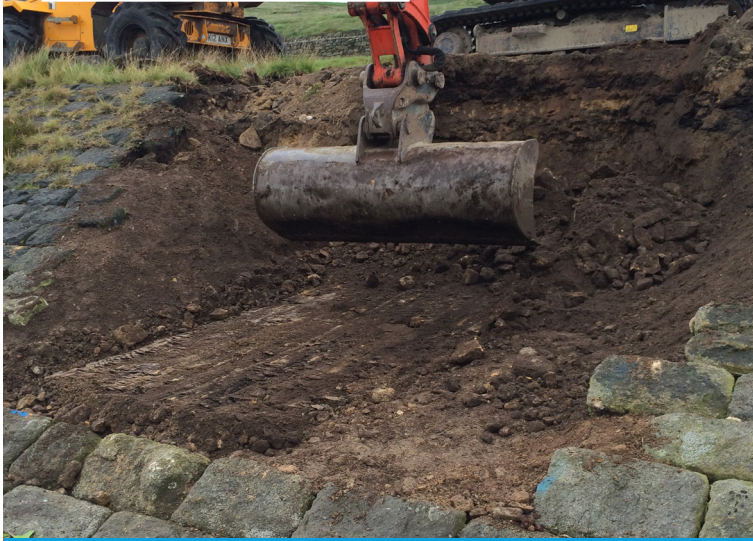
Site being cleared.

The install took place on a clear and sunny day. In order to dig out the channel, a temporary flume was built to enable a 360° digger to access the other side of the drainage channel. The wall of the channel was left in place while the channel was excavated. The wall was removed and the stones were marked and kept ready to re-build once the repair and maintenance work further down the channel had been completed.

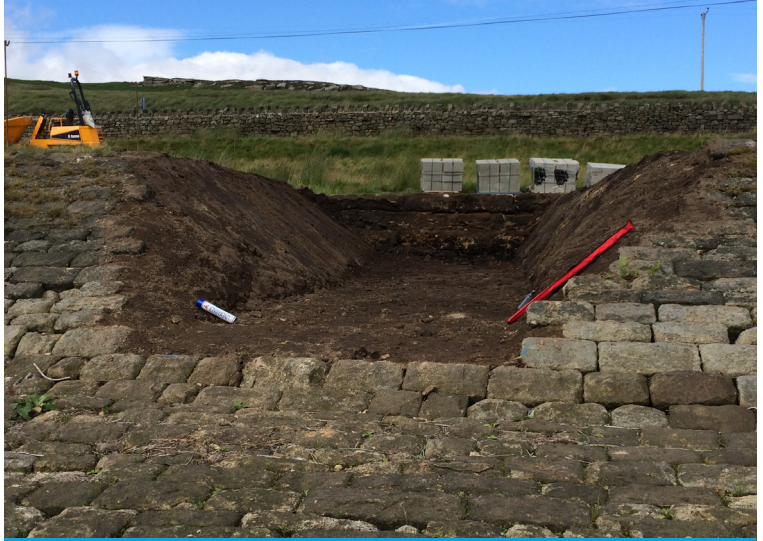
The drainage channel after being excavated.

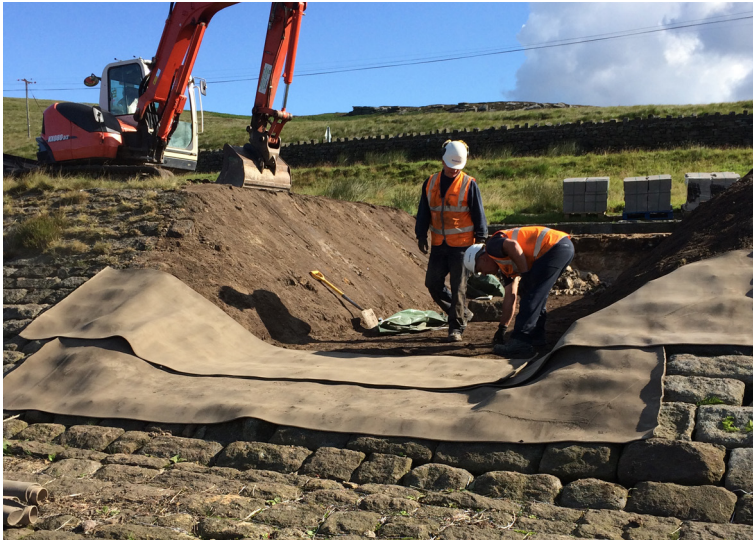
The CC starting to be fitted.

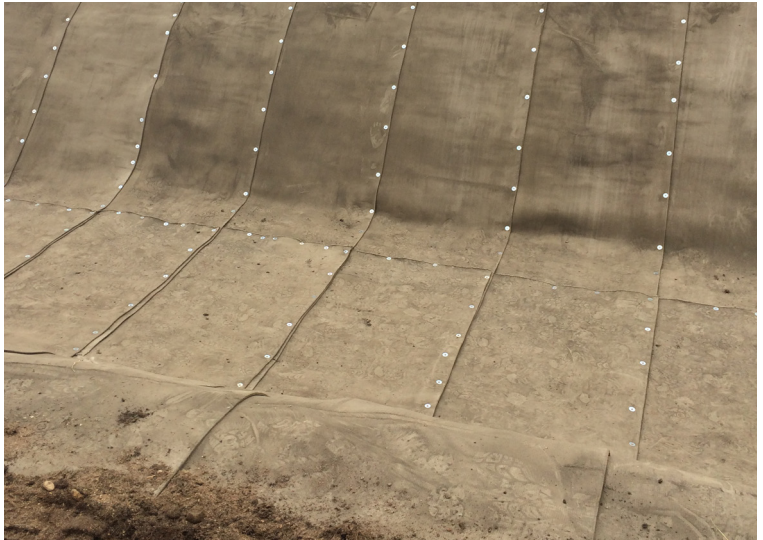
Small penny washers were also used.

Nails were shot-fired into the blockwork of the existing reservoir wall. In the newly dug channel the joints were screwed together, with small penny washers also being used. No anchor pegs were used, however the CC was back filled into an anchor trench. A sump pump was used from the drainage channel above the temporary dam to hydrate the sides and bottom.

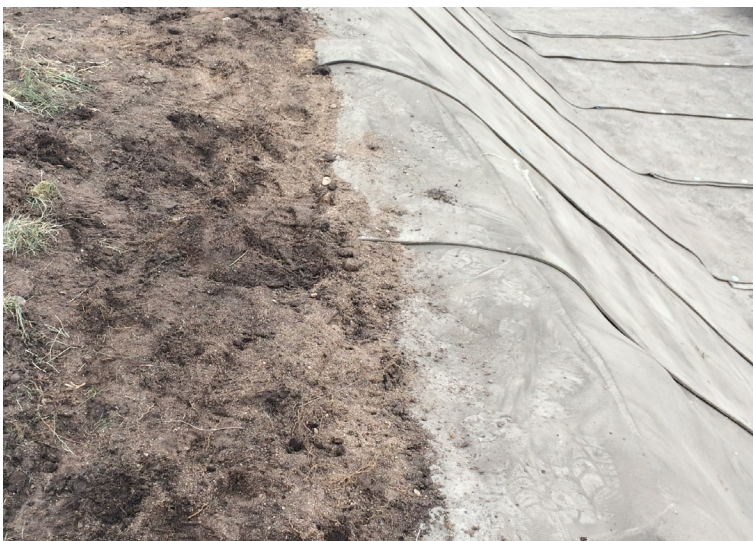
The CC was back filled into an anchor trench.

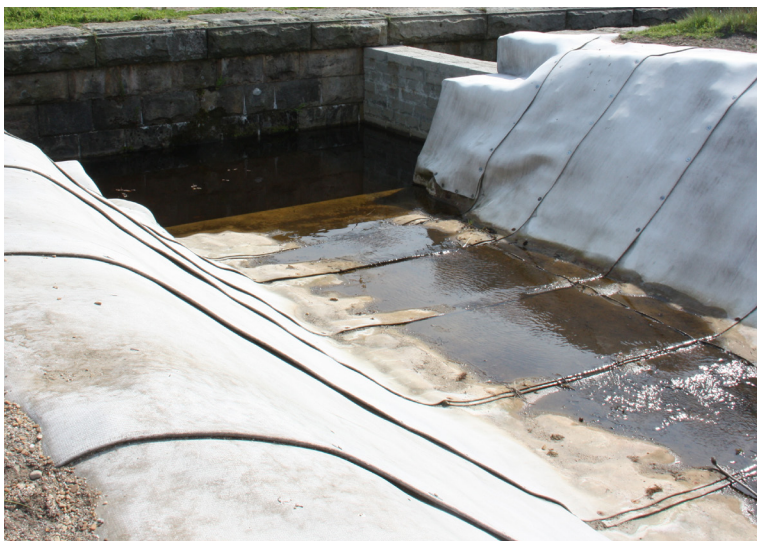
The drainage channel after hydration.

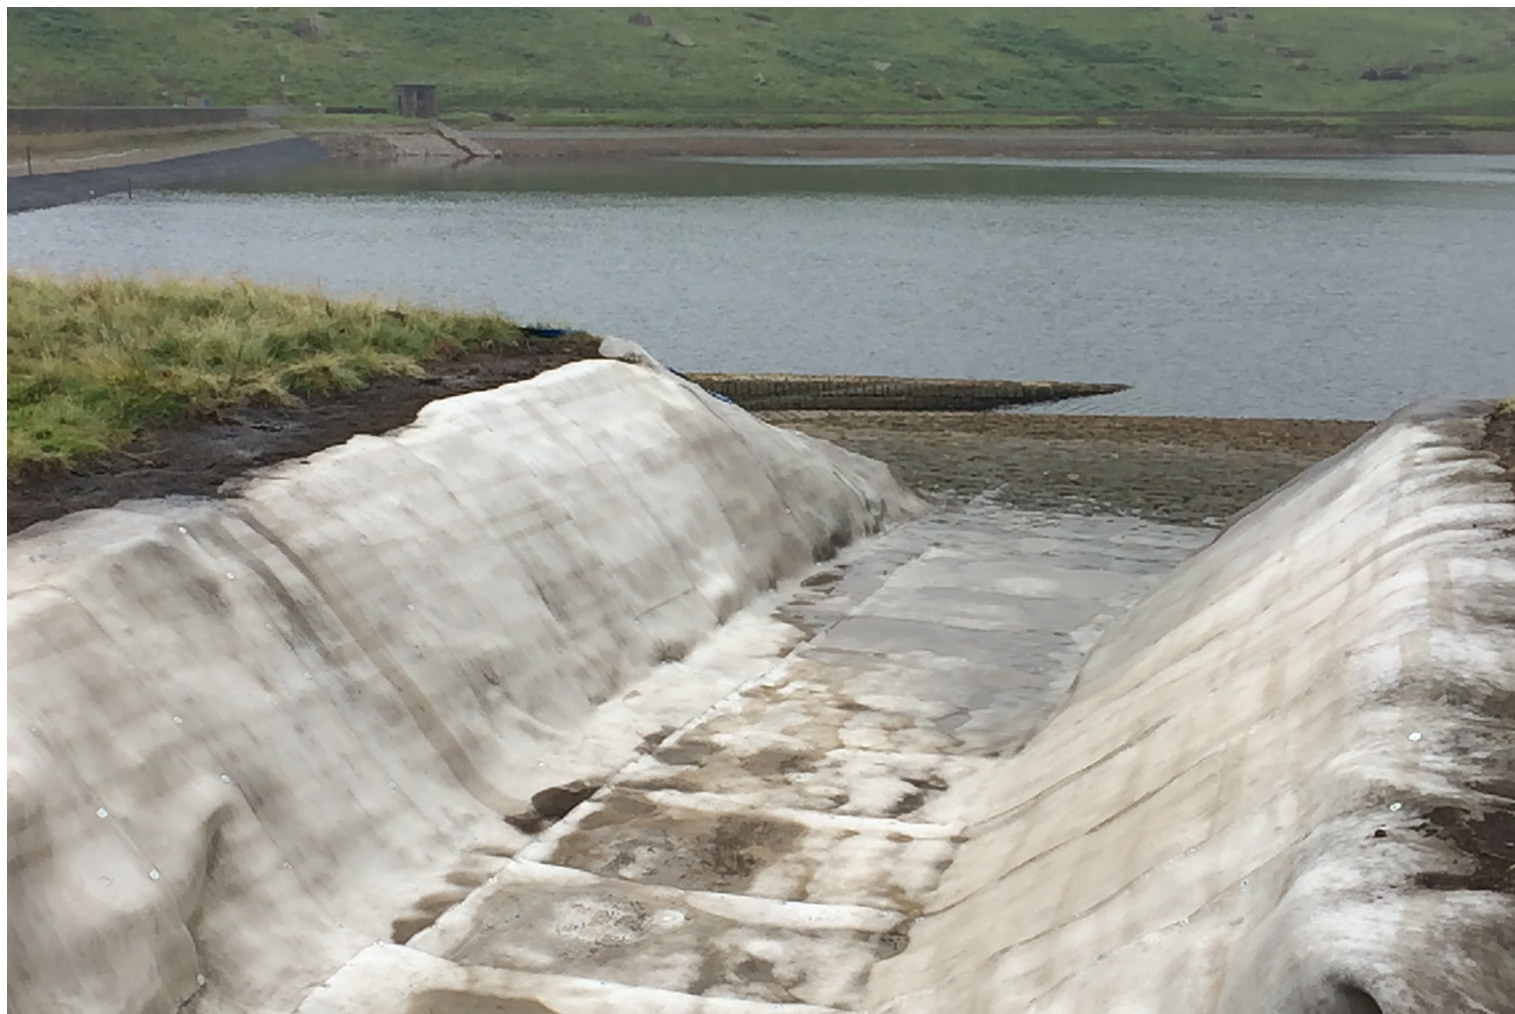
Completed drainage channel installation.

150m² of CC8™ was installed and hydrated in 1 day, with a 67% reduction in labour costs, utilising only 28% of staff that would ordinarily be required using a conventional alternative.
