VENT WALL

In 2012, Concrete Canvas® GCCM* (CC) was used to construct a number of vent walls at Marblaegis Mine, an underground gypsum mine in Loughborough, UK.

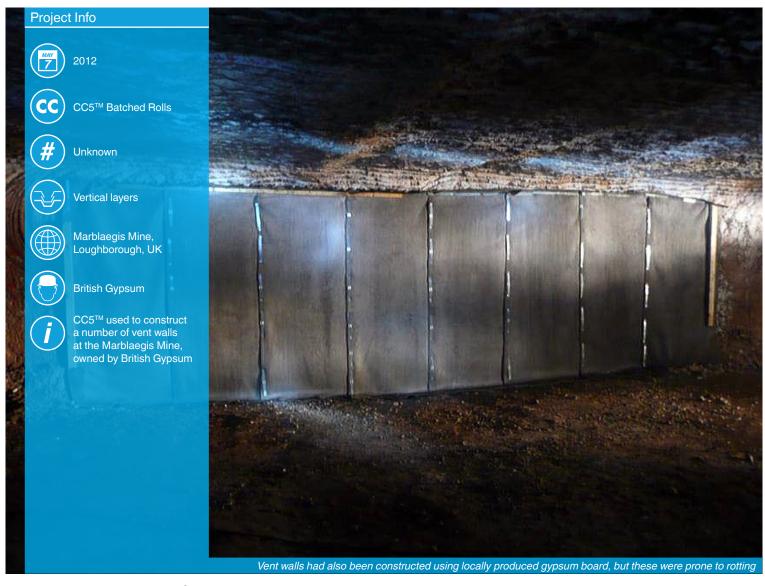
Using batched rolls of CC5™ meant that the 3-man installation team were able to carry the material to site without any plant or specialist equipment. After being cut to length on site using hand tools, the CC5™ was hung, shaped and fixed to a British Gypsum branded aluminium stud wall system and securely fastened using wooden battens, 200mm steel strips and screws. The whole structure was then hydrated using a portable water supply.

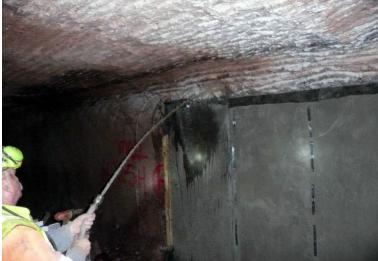
CC hydrated using on-site equipment
