CC8™ Bulk Rolls

Falkirk, UK

Luddon Construction  
on behalf of Petroineos

CC was used as a weed  
suppression solution  
under a complex  
series of pipe tracks at  
Grangemouth Refinery

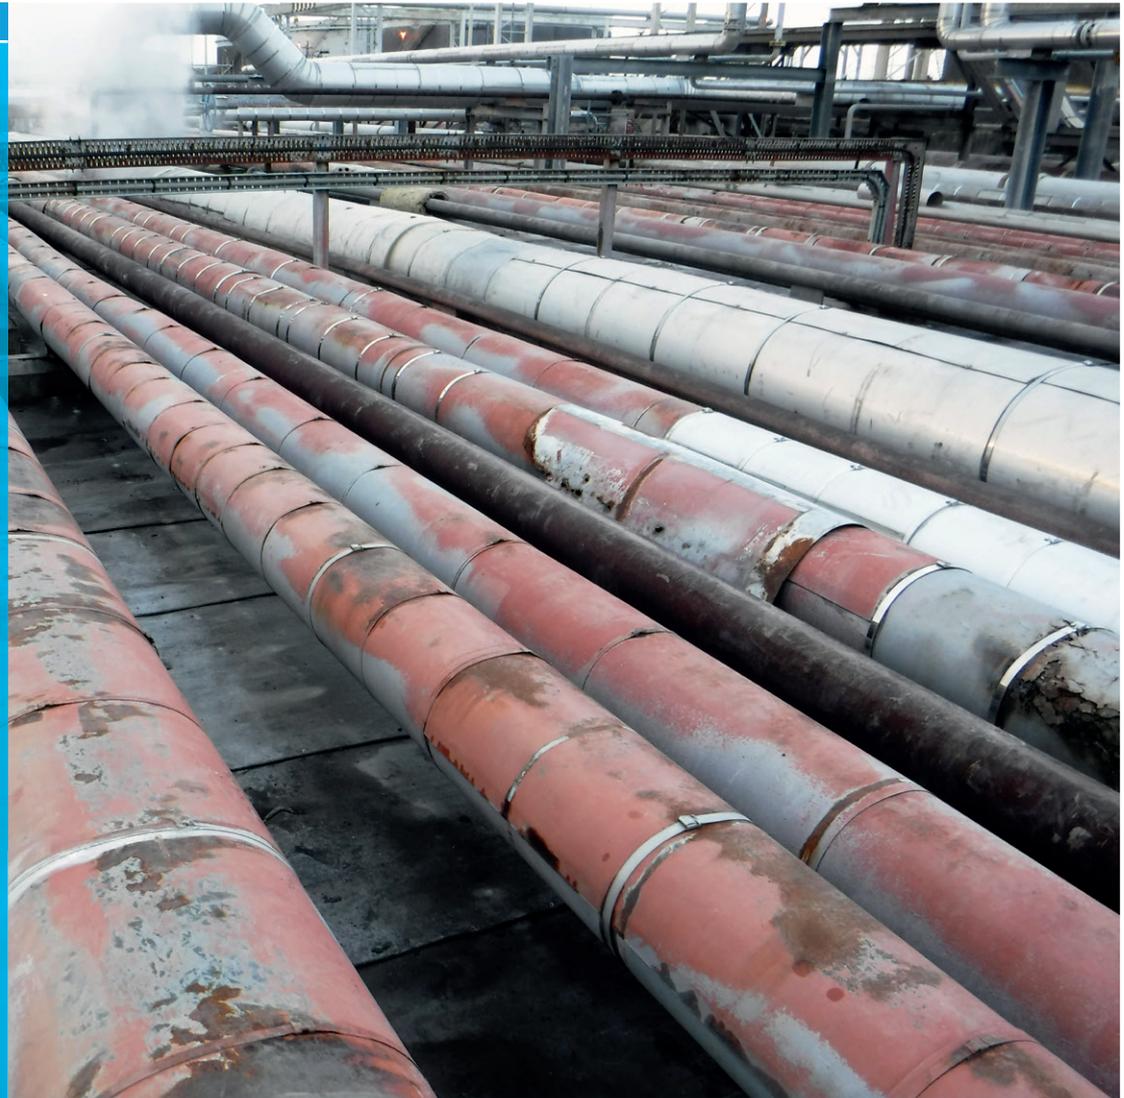
Completed CC lined pipe tracks

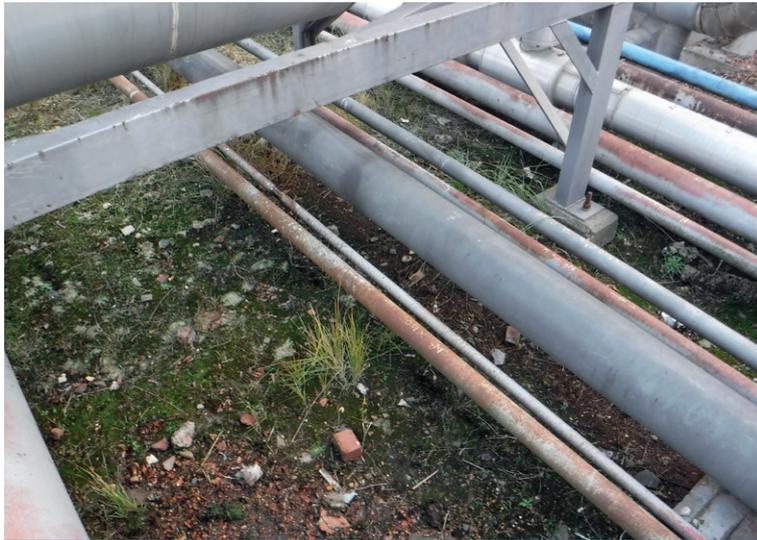
Site prior to clearance and showing vegetation growth

Access under the pipe tracks was significantly restricted with limited clearance between the underside of the pipework and the track floor. The track floor itself was uneven, puddled and of a low CBR value. The pipe track section included a significant number of irregularly placed upstands of varying size and location.

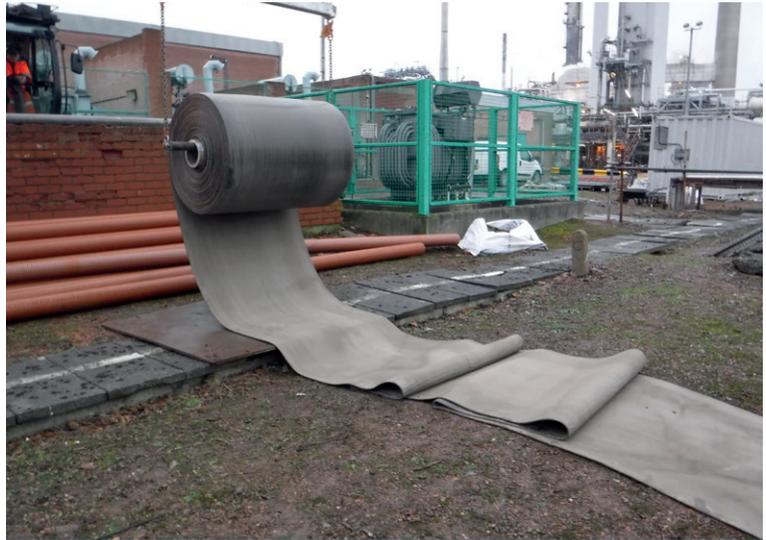
Dispensing of bulk roll CC8 via spreader beam

Prior to deploying the CC, the pipe track area was first graded, made as even as was practical and any vegetation growth removed. Given the low profile and restricted clearance levels between the pipes and the track floor, the CC was deployed where possible using a modified light weight spreader beam to pull the material in lengths under the pipework.

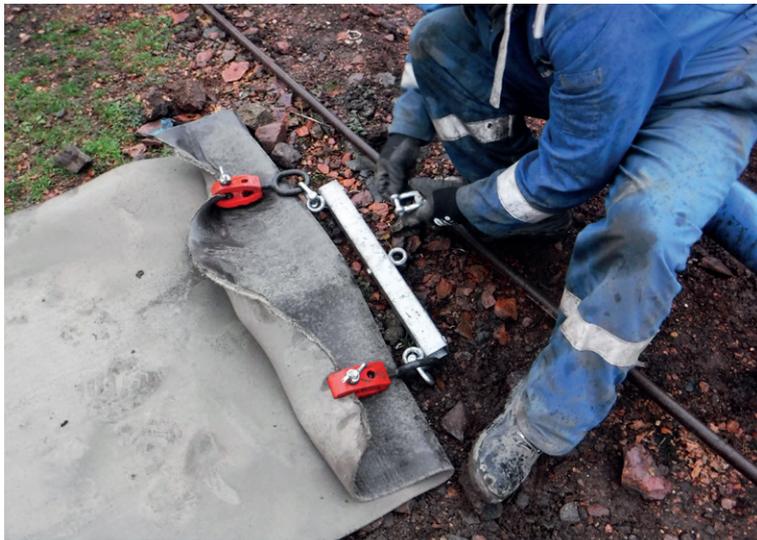
Attachment of low profile pulling jig

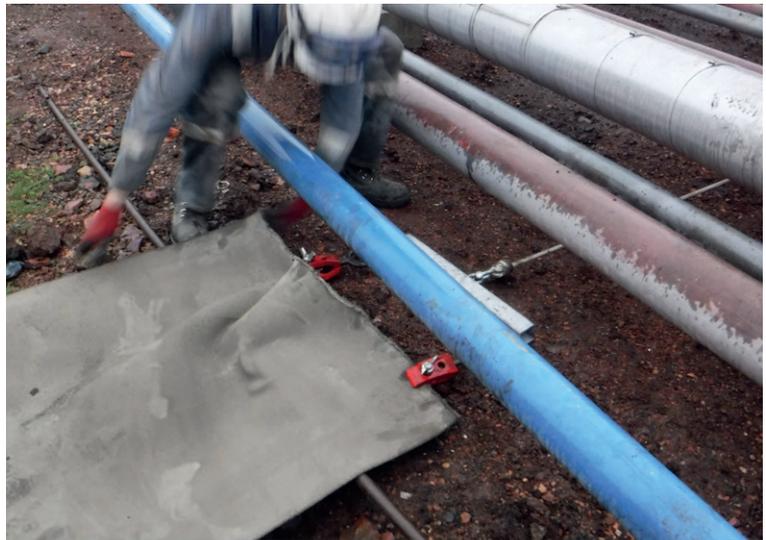
Feeding of CC8 under low profile

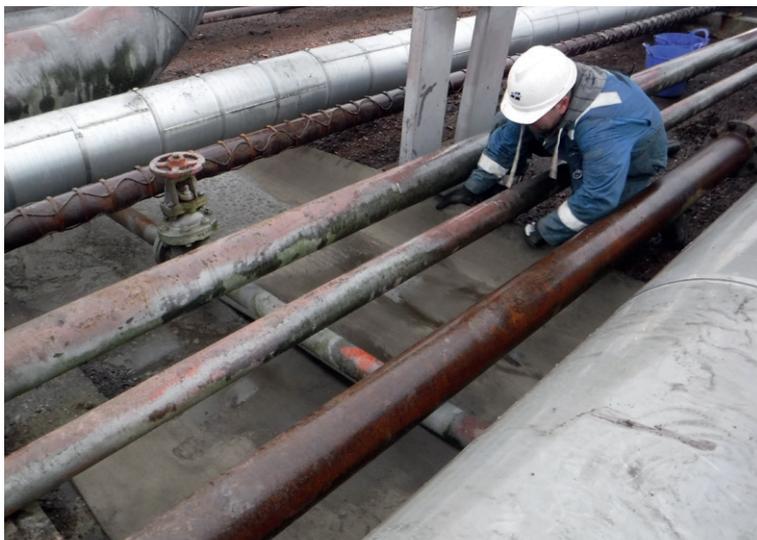
Adjusting position to create 100mm overlaps prior to screwing joint

The CC layers were laid perpendicular to the pipe track to accommodate the majority of pipe upstands and to minimise the length and subsequent weight of each individual layer. Subsequent layers were overlapped by 100mm and screwed together using SS 35mm screws at 200mm centres through the overlap. The material was actively hydrated using the onsite water mains. CC layers were periodically fixed to the substrate using a combination of either steel or plastic ground pegs depending on the ground condition at specific points.

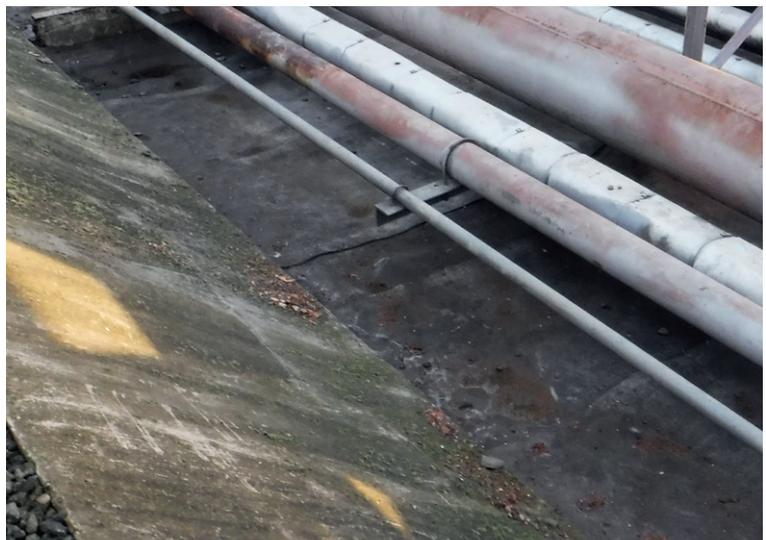
CC8 terminations to existing concrete infrastructure

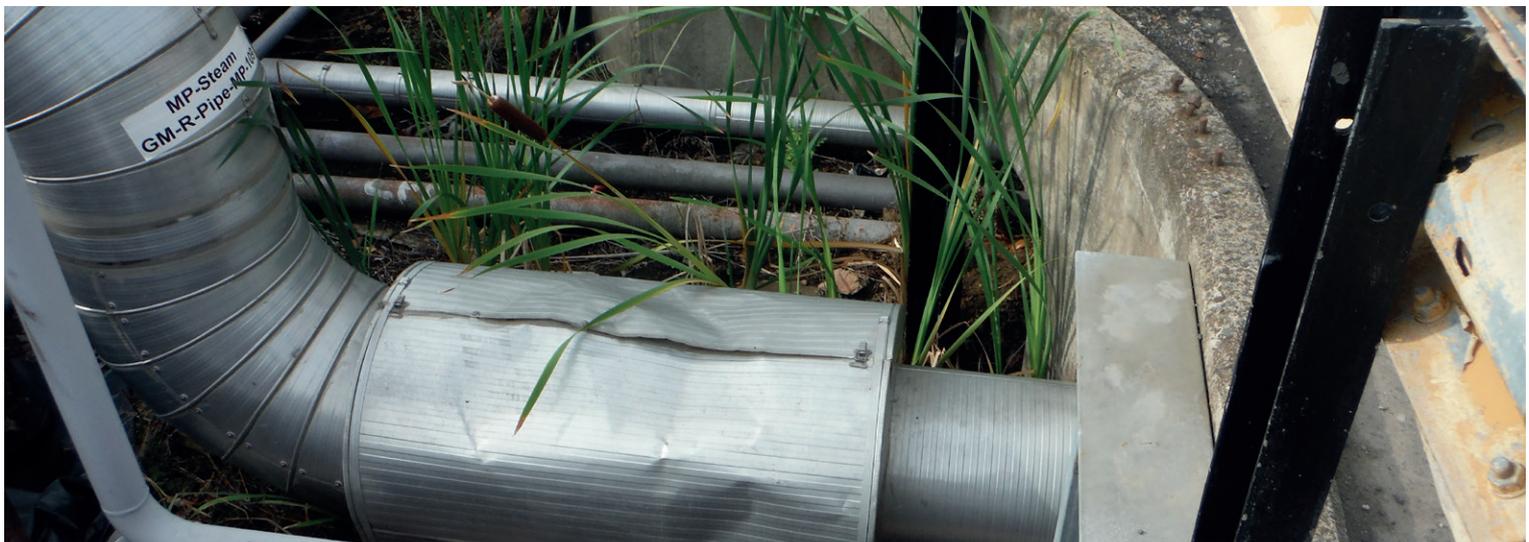
*Example of vegetation growth through dilapidated stonechip/ geotextile option*

Stone chips are the traditional method for dressing pipe track floors due to the relatively lower cost of installation compared to conventional poured concrete floors. However, it has been demonstrated that over time, dirt will build up within the stone chips which would allow root vegetation to grow (as observed in previous phase of the Overton Rd. pipe track remediation project). Stone chips also do not prevent the burrowing of animal and wildlife into what can be sensitive infrastructure. Stone chips also hide pooling of water and hydrocarbons.
