CC CCH8™ Bulk Rolls

G St Quentin Zoo, Aisne Department, France

i CCH8™ was used to line newly constructed ponds in bird and mammal enclosures in St Quentin Zoo, France

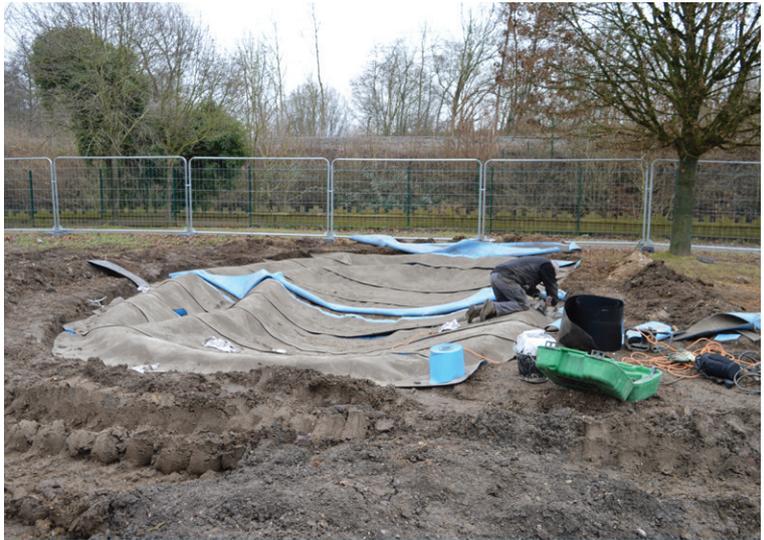
The CCH was laid transversely across the ponds

Once the ground preparation was complete the CCH material was delivered to the site in bulk rolls of CCH8™, which was mounted onto a spreader beam and digger, and unrolled transversely across the width of the ponds. The CCH layers thermally welded using Leister Twinny T and Triac welding equipment and the edges of the CCH material was secured in the anchor trenches using ground pegs. The CCH material was hydrated and the anchor trenches backfilled. This process was repeated for each of the ponds.

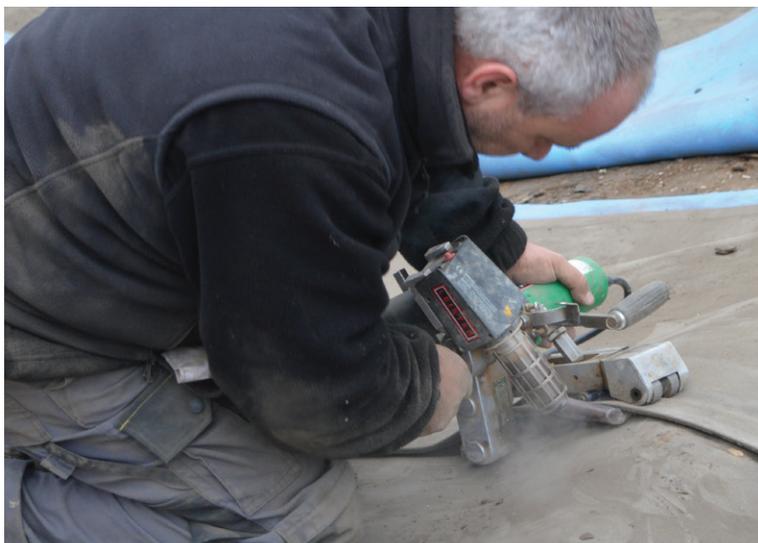
Thermal welding on the CCH joints

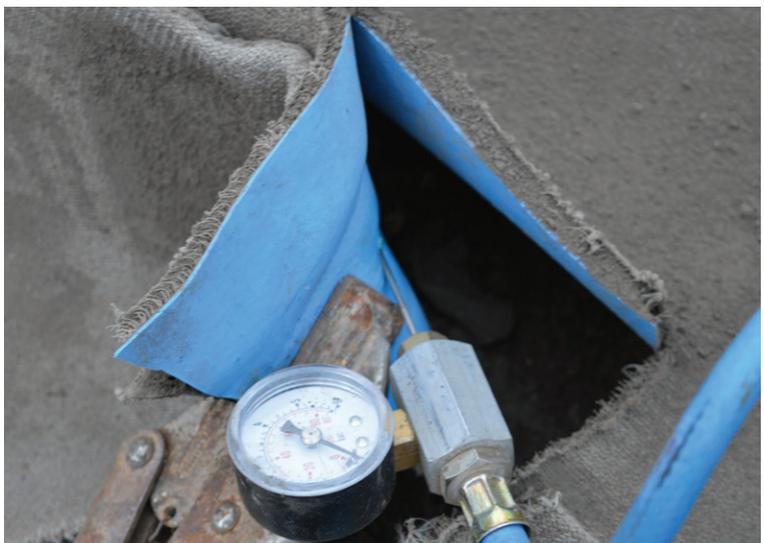
Pressure testing of the welded joints
