CC5™ Batched Rolls

Mosul, Iraq

UN Aid

CC was used to protect the slope from weathering and erosion

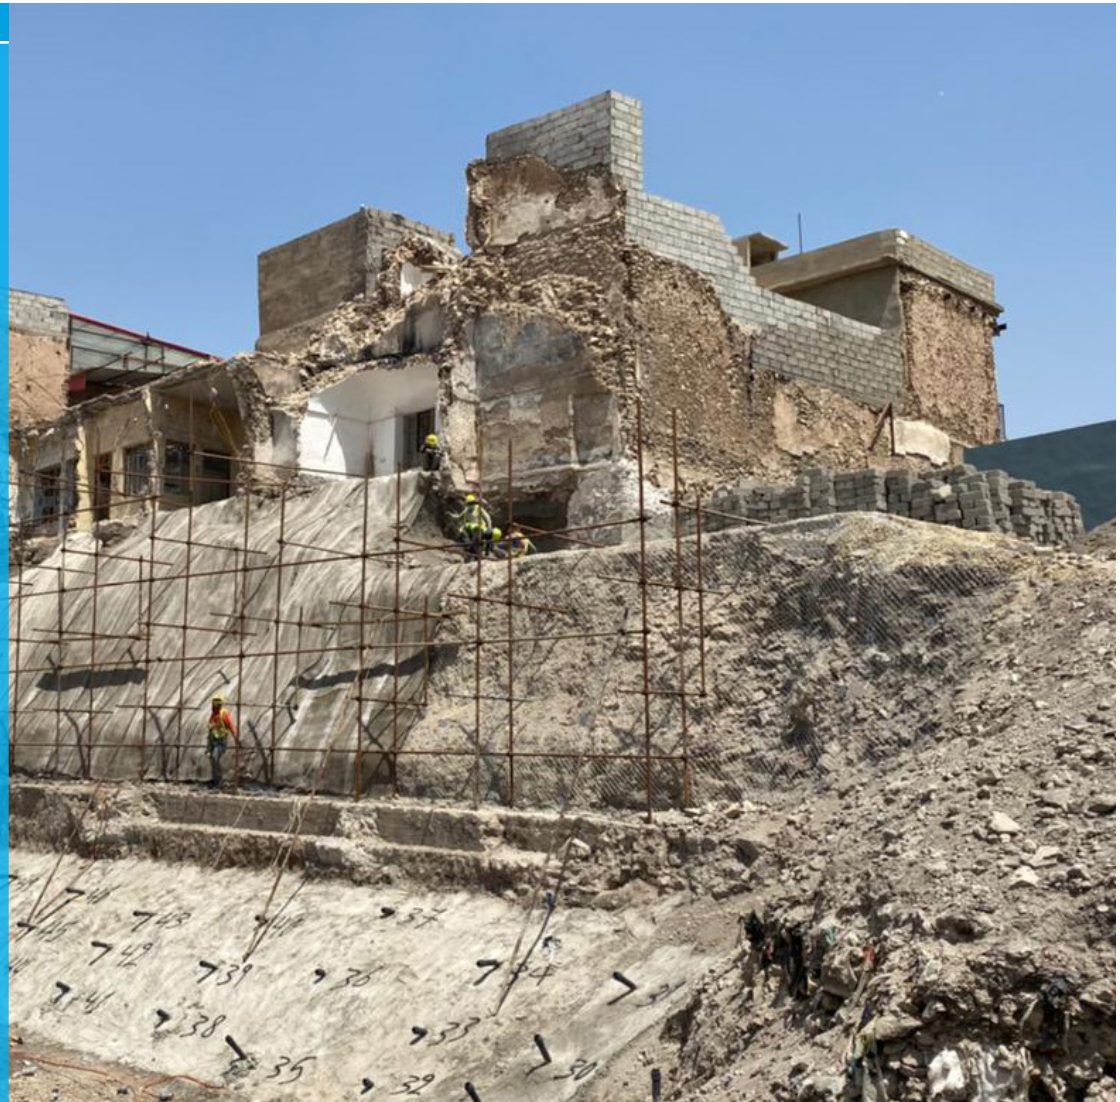
Completed installation

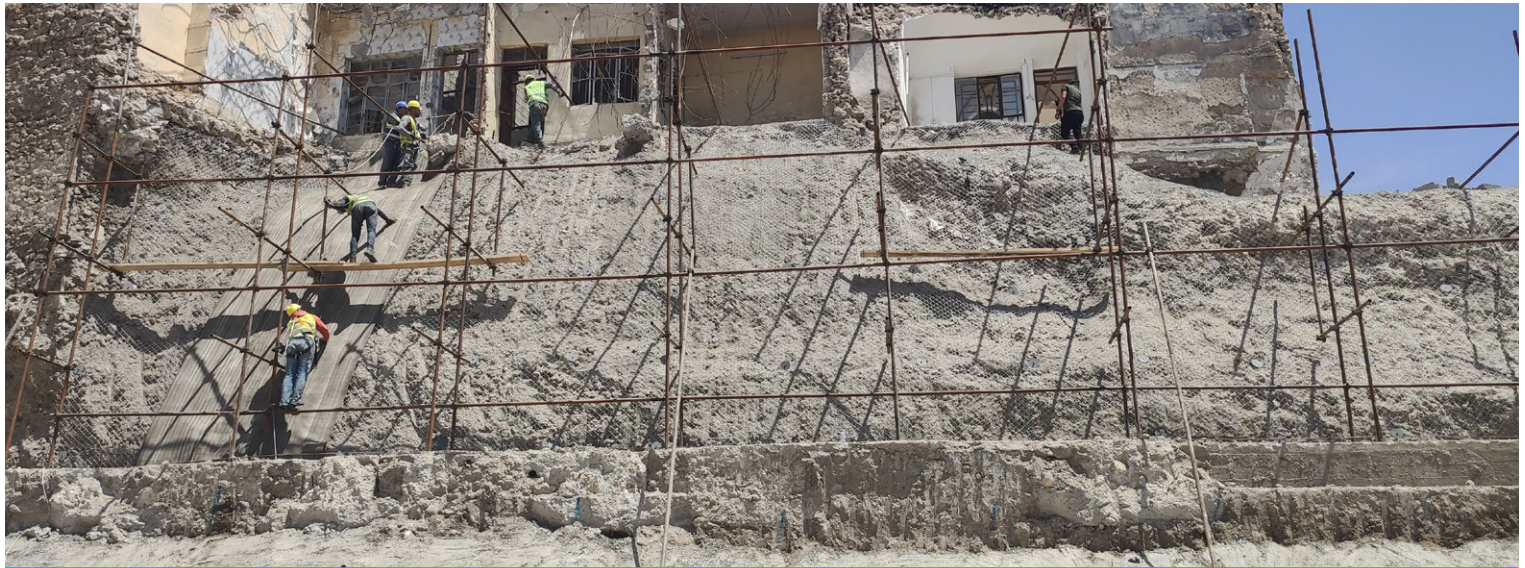
*Initial stages on installation*

With a large section of the buildings being demolished, the ground consisted of a mixture of soil and rubble material. To prepare the ground, the contractor removed some of the rubble and then smoothed the slope profile by installing steel mesh. The CC was laid vertically down the slope, secured at the crest in anchor trenches using 250mm steel pegs and then backfilled with site material. The CC was then hydrated using a local water supply in the area.

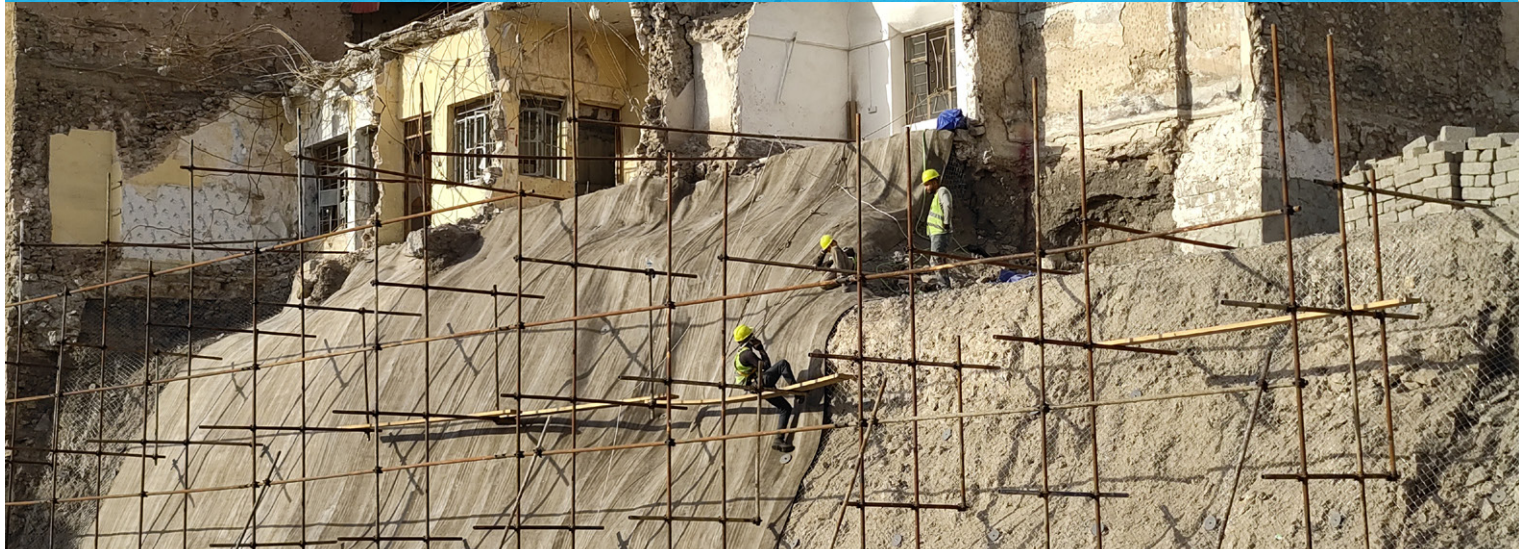
*Steel mesh was installed under the CC*

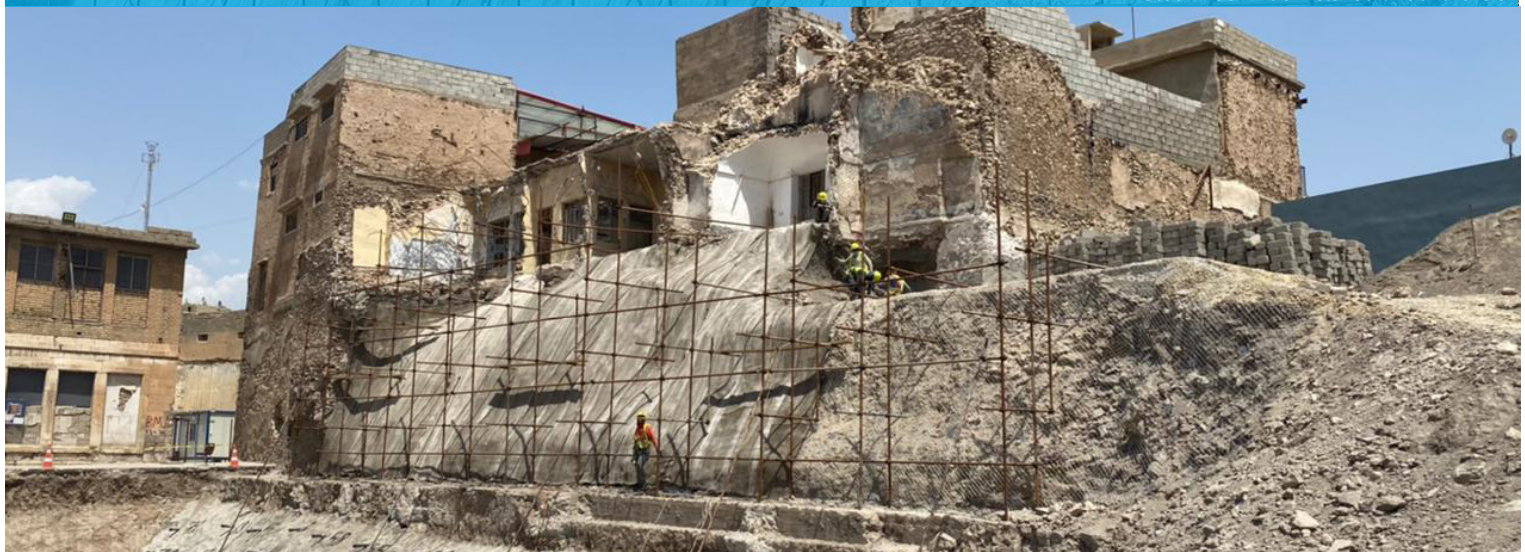
*To the right of the image is an example of the rubble*

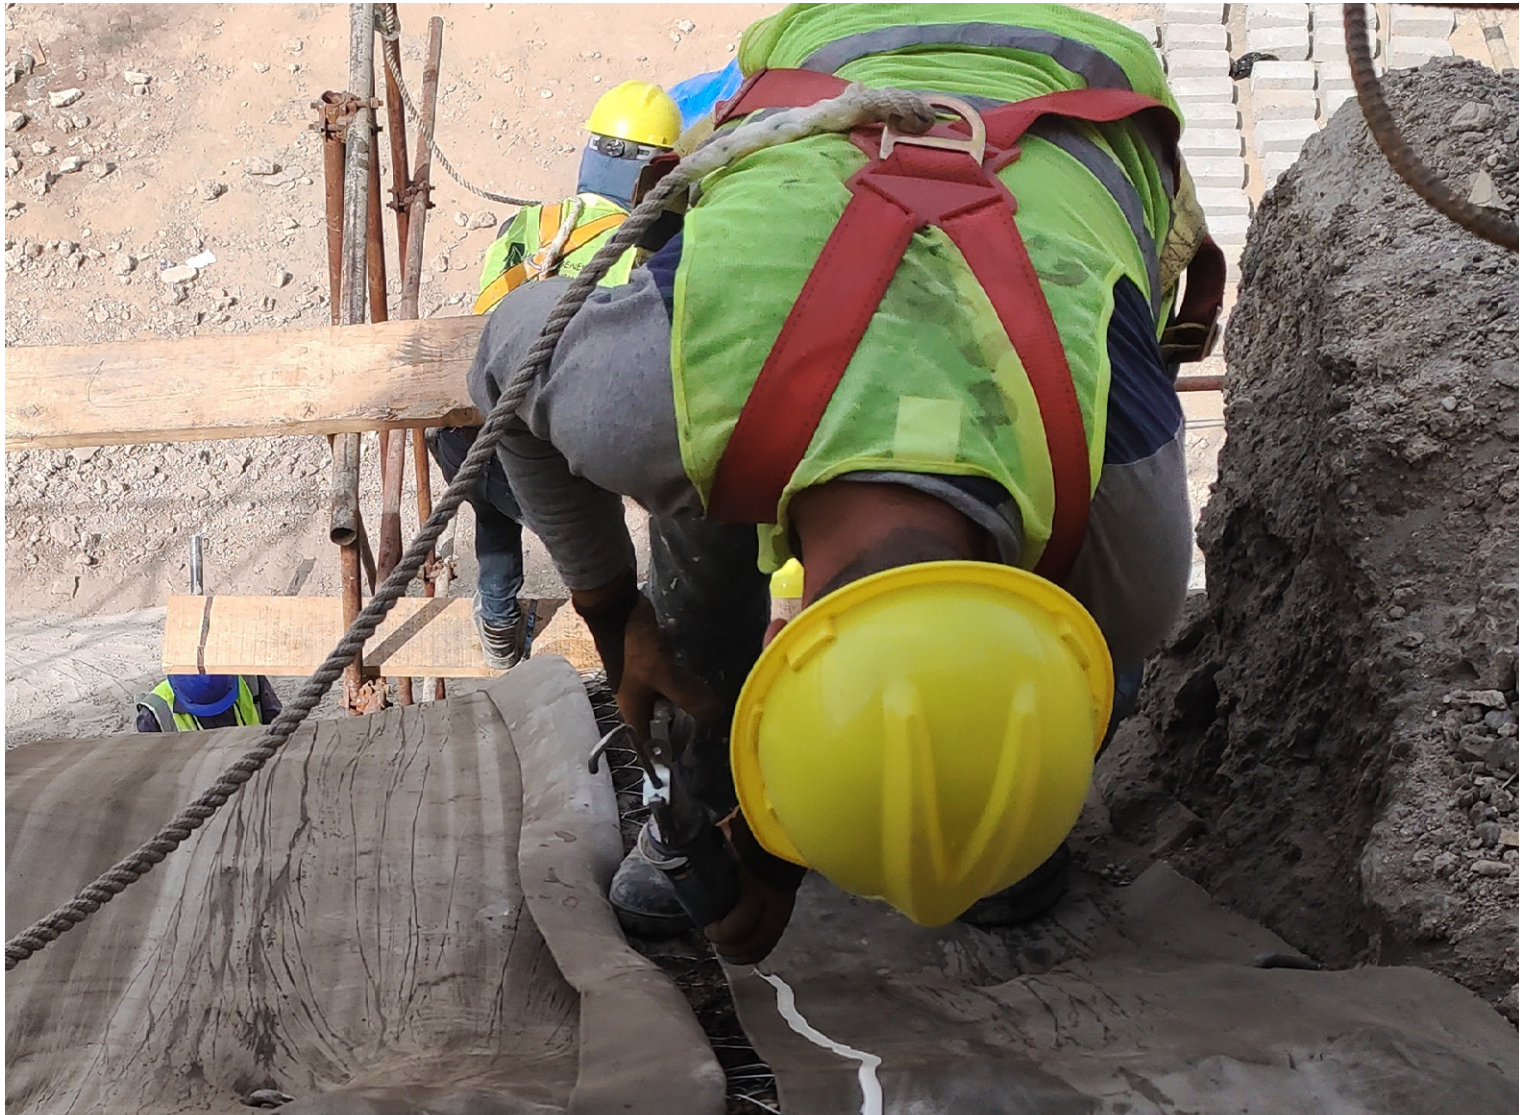
*Using an adhesive sealant*
